Quality Roundtable at Solar Power International 2017

Quality first: an industry-wide discussion of the path forward

Backsheet and encapsulant failure

A failure of backsheets and encapsulants at a solar project resulted in various module- and cell-level problems and power loss, leading to a dispute between the module maker and the company which procured the modules.

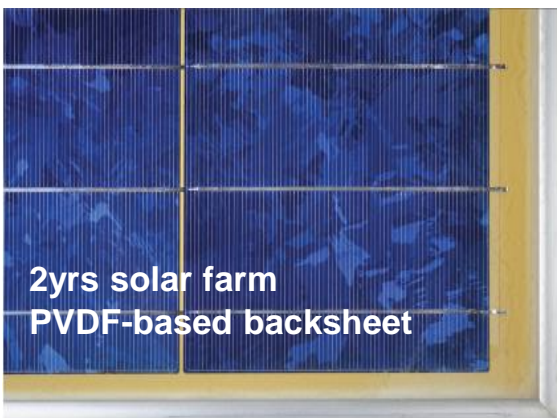
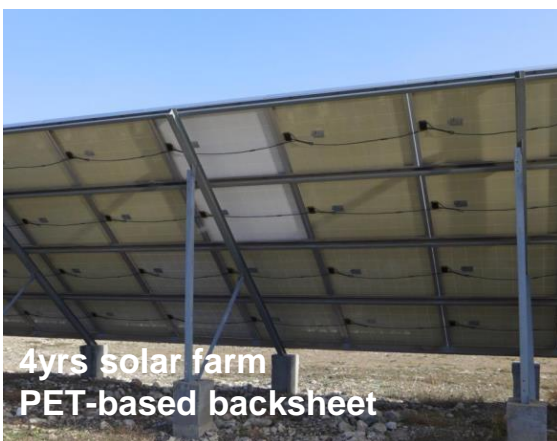
Yellowing: Indicates Polymer Degradation and correlates with loss of Mechanical Properties

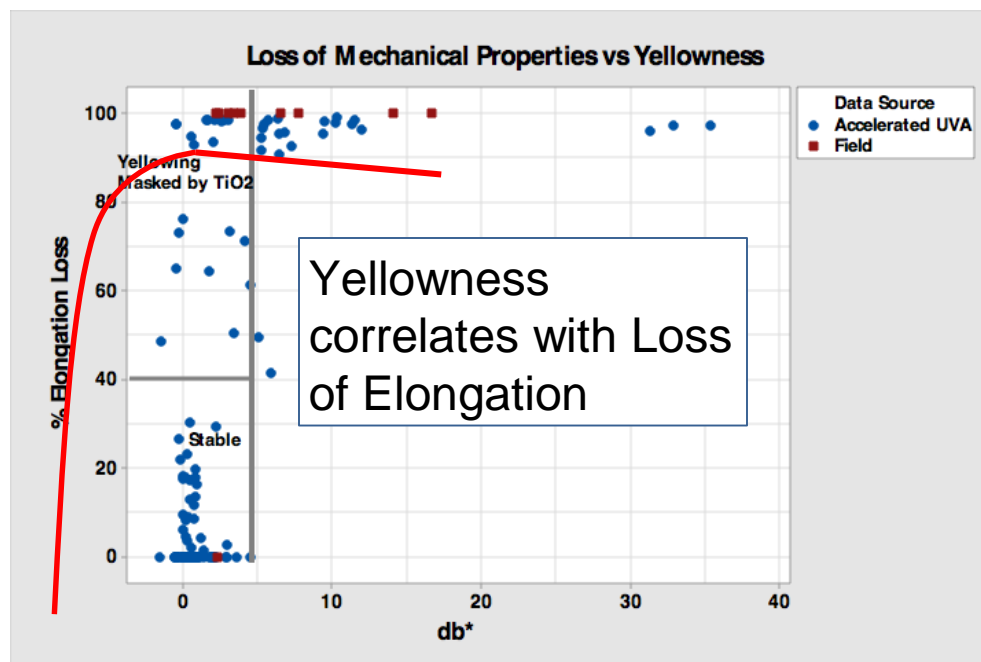
- Yellowing witnessed in many different fields, in > 6 different countries with less than 5 years in the field
 - China, USA, Germany, Belgium, Spain, Israel

Yellowing is an indication of polymer degradation and can place modules at risk for failure and safety.

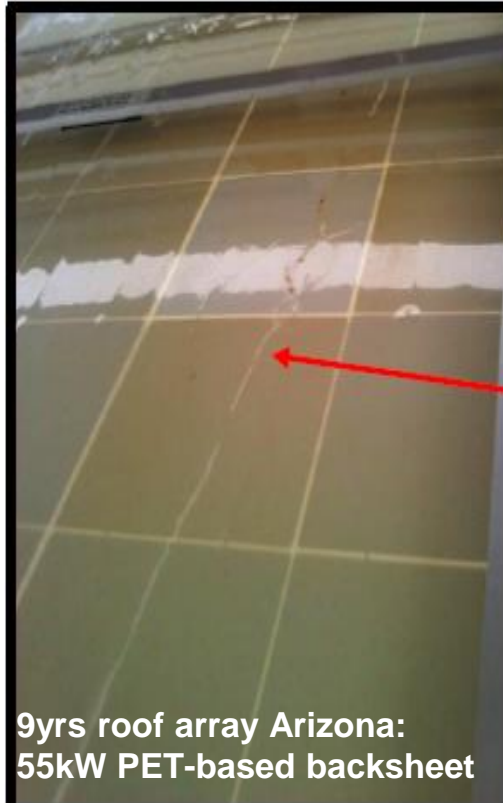
**9yrs roof array Arizona:
55kW PET-based backsheet**

PET based backsheet ~15% of modules cracked, 100% airside yellowing.

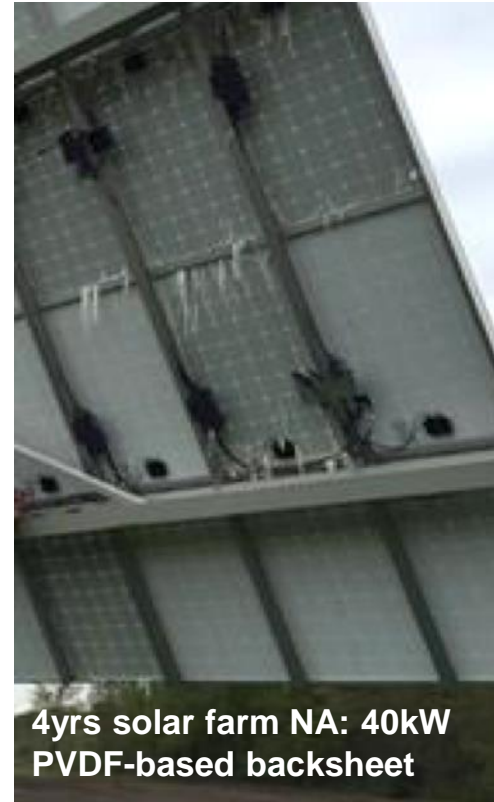
**4yrs solar farm NA: 40kW
PVDF-based backsheet**

PVDF-based Backsheet cracking & delamination 57% of modules cracked

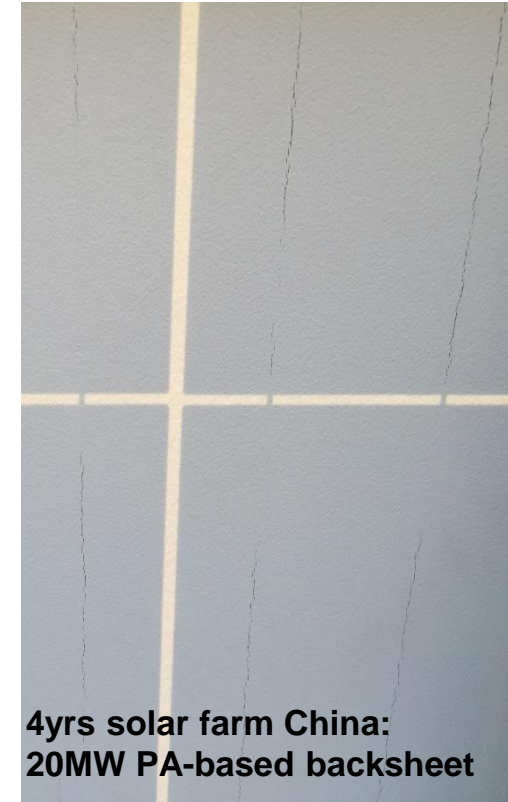
**4yrs solar farm China:
20MW PA-based backsheet**

PA-based Backsheet large amount of cracking with ~40% of modules cracked.

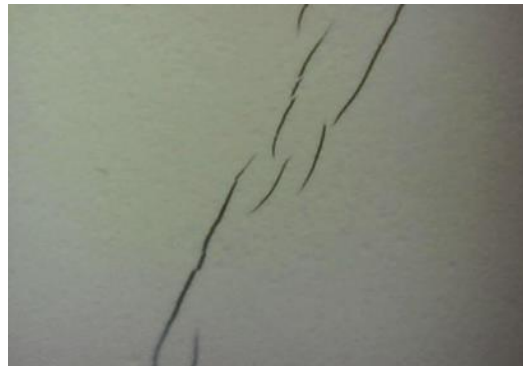
1s PVDF Cracking

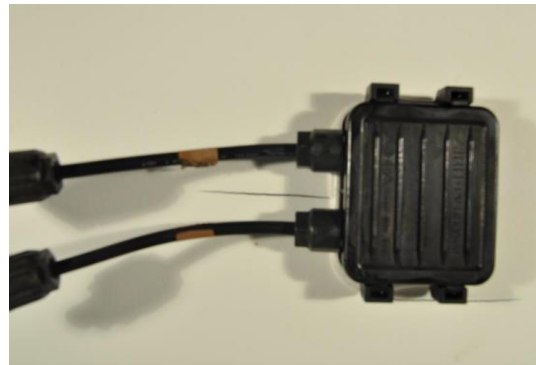
AAA Cracking

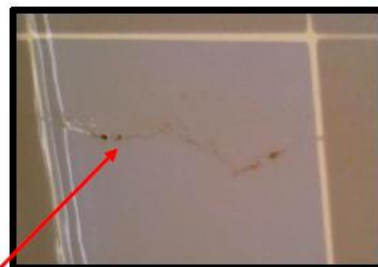
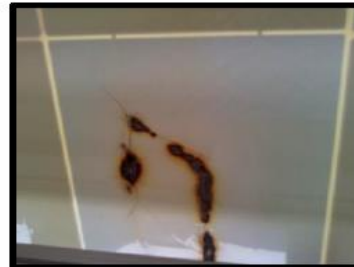
3. Backsheet cracks
potential safety issue

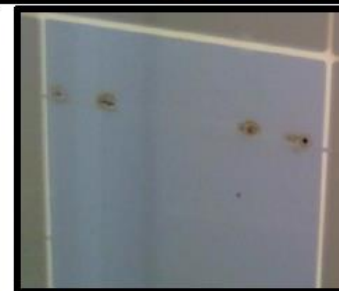
4. Burn-marks created
most likely by
shunting and/or arc
fault from loss of
insulation

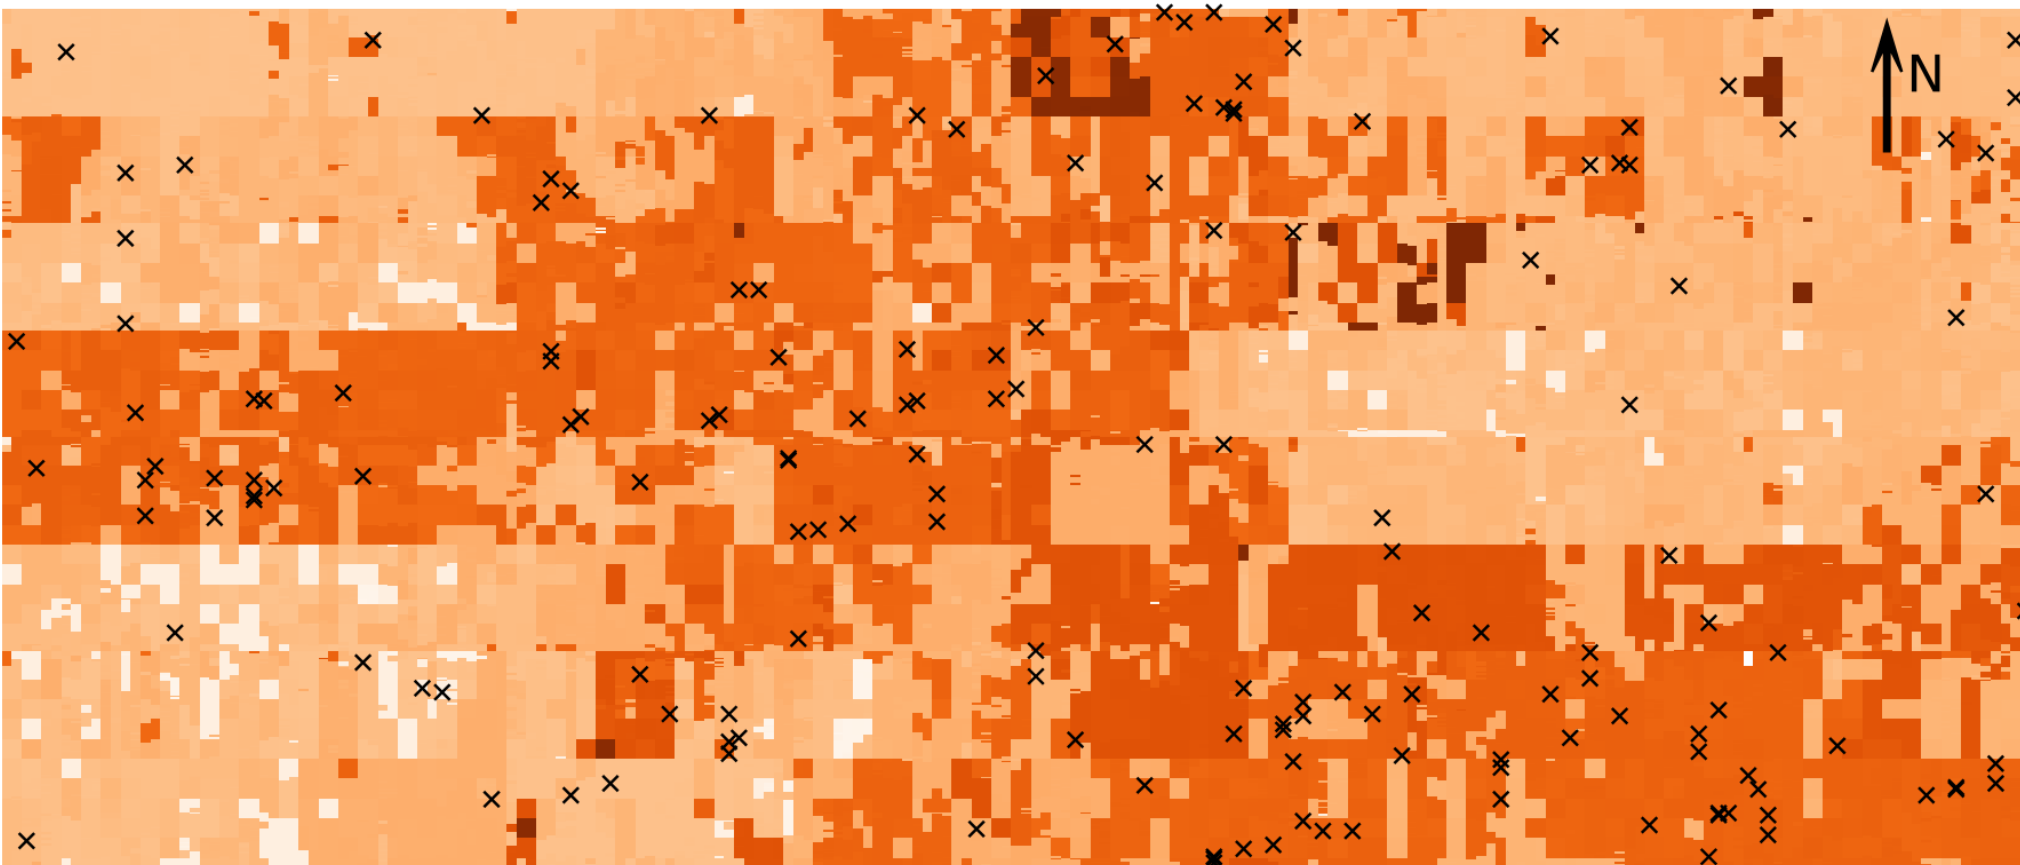
- Data from the inspection was processed with a validated post-processing algorithm and produced the following map of system faults
- The string failures were found to be due to mis-matched connectors
- The diode failures could be traced back to individual batches of modules, as the client had retained information on module serial numbers and their location within the array
- This information formed the basis of a warranty claim, however, the module maker had gone out of business
