Sept 20 2018

# Field Evaluation of Backsheet Quality

Dr. Hong-Jie Hu

DuPont Photovoltaic Solutions

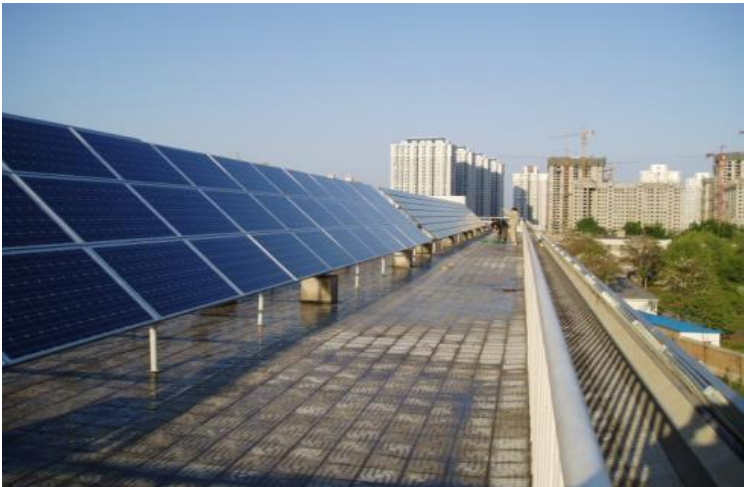
18yrs field module with TPT backsheet shows low power loss rate (0.7%/yr)

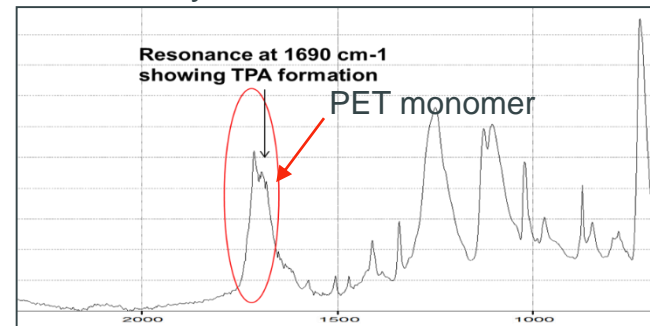
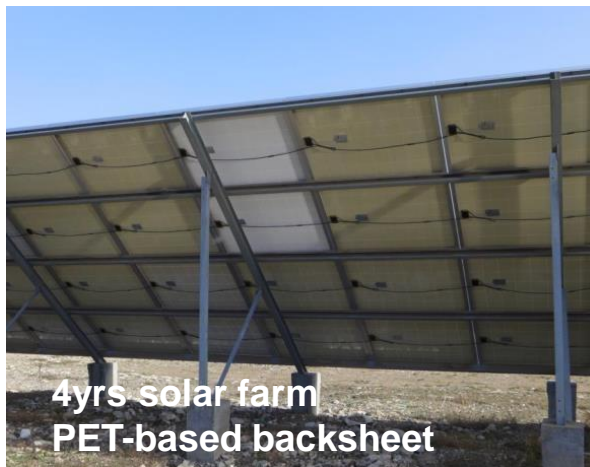
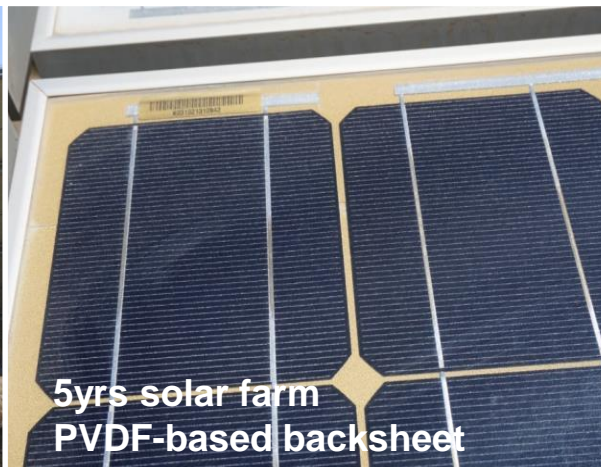
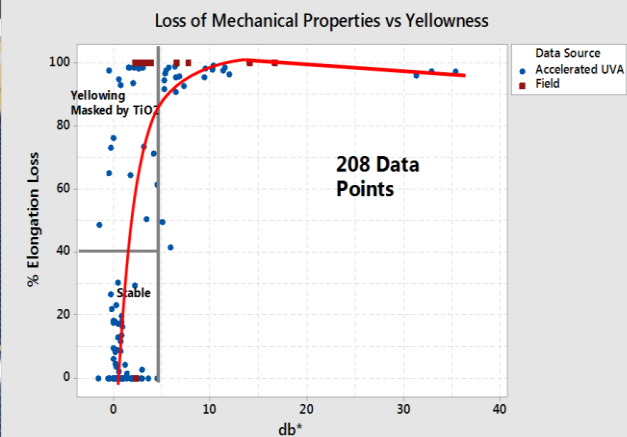
- Yellowing witnessed in many different fields, in > 6 different countries with less than 5 years in the field
  - China, USA, Germany, Belgium, Spain, Israel

**Yellowing is an indication of polymer degradation and can place modules at risk for failure and safety.**

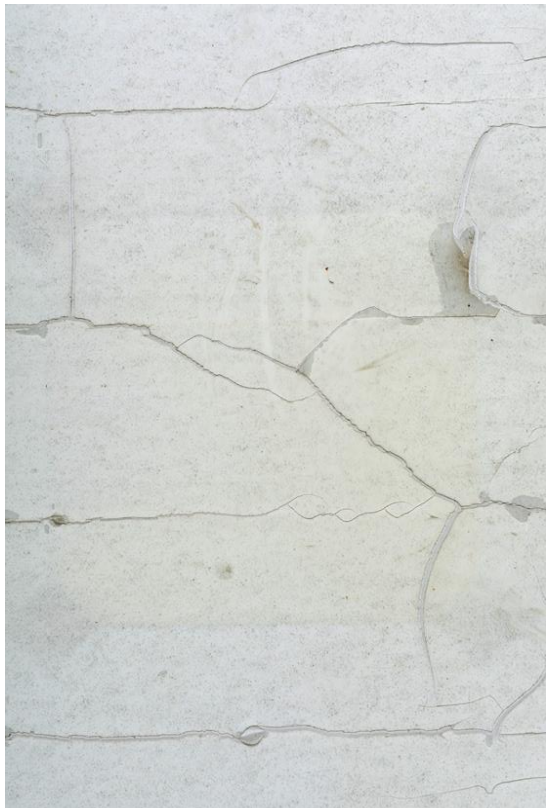
- 4yrs solar farm in Spain, 2.3MW;
- **Polyester**-based Backsheet cracking with ~**50%** of modules cracked. Some cannot pass wet leakage test.

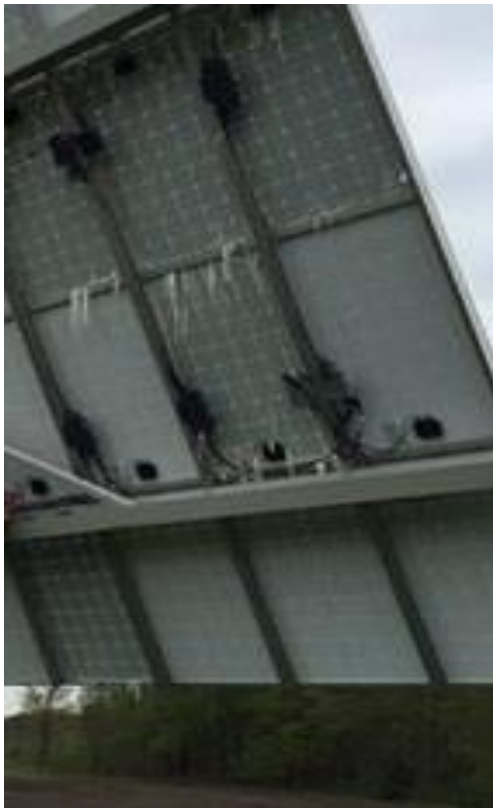
- 4yrs solar farm in north American, 40kW;
- **PVDF**-based Backsheet cracking & delamination **57%** of modules cracked

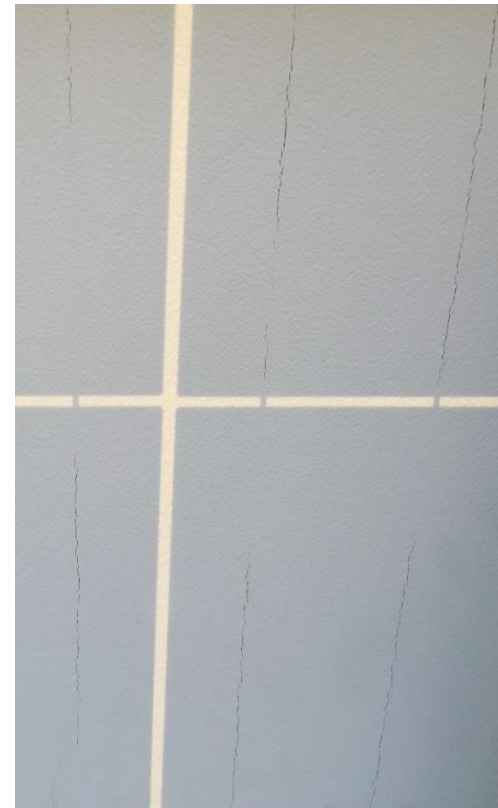
- 4yrs solar farm in west China, 20MW;
- **PA**-based Backsheet large amount of cracking with ~**40%** of modules cracked.

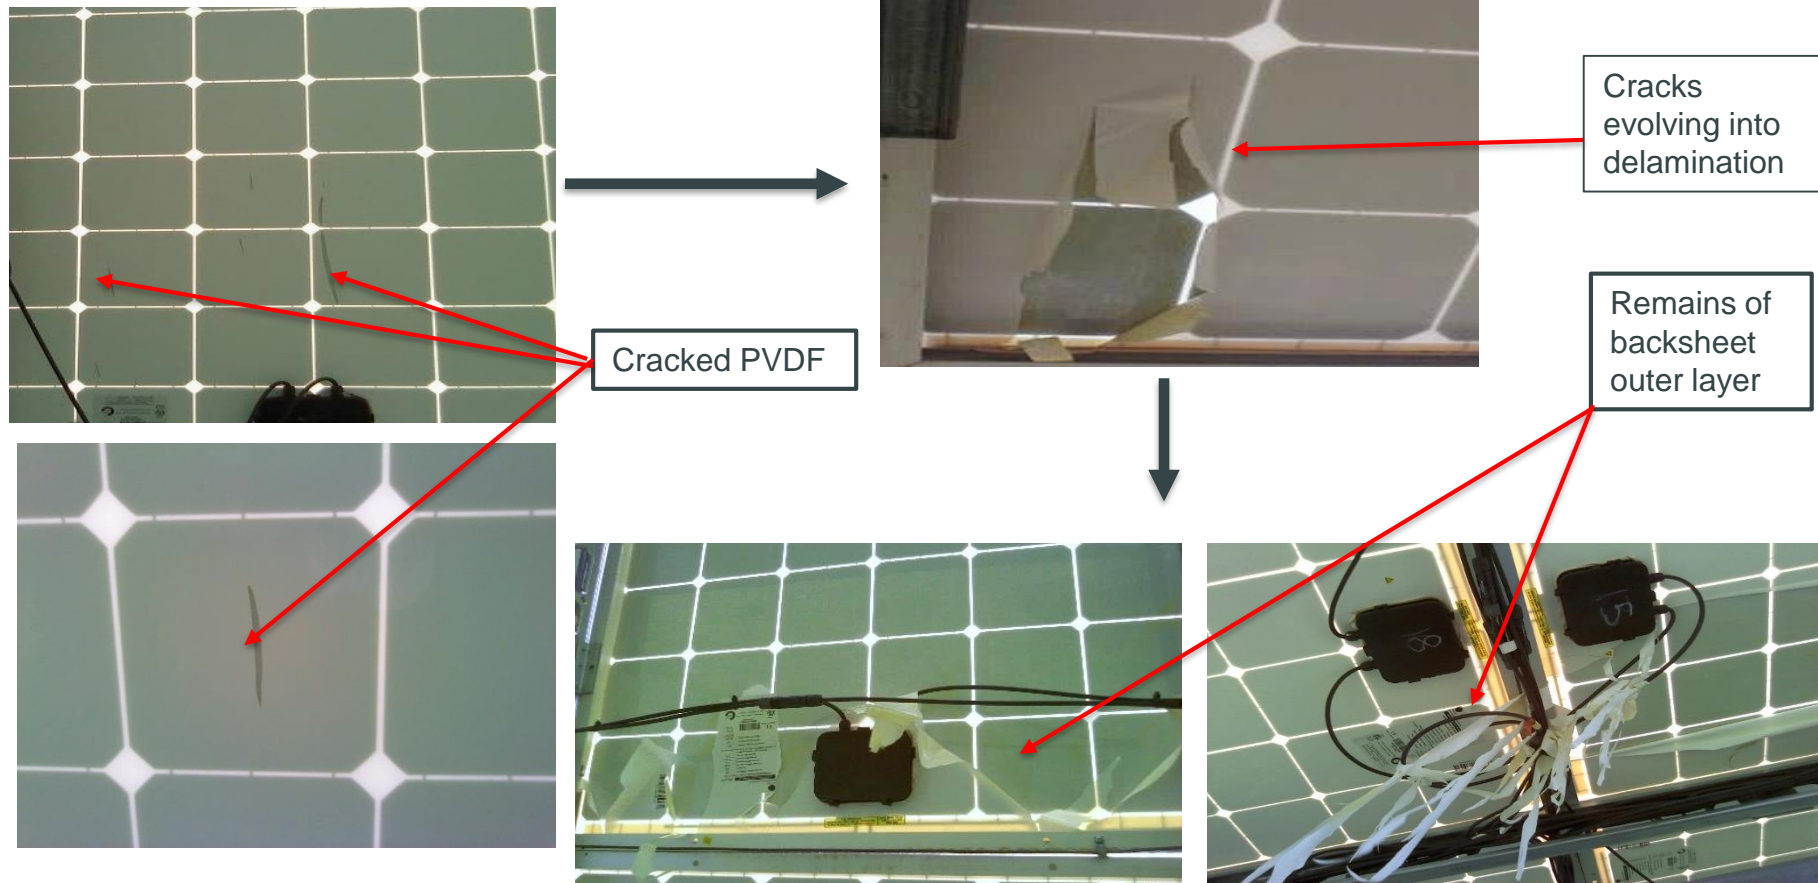
Significant level of PVDF degradation

- Starts with cracking
- Evolves into delamination and large area peel-off

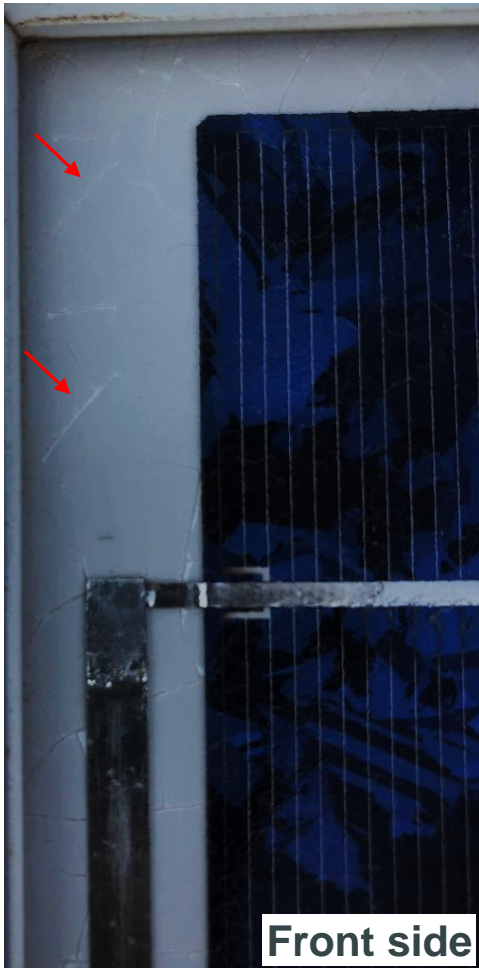
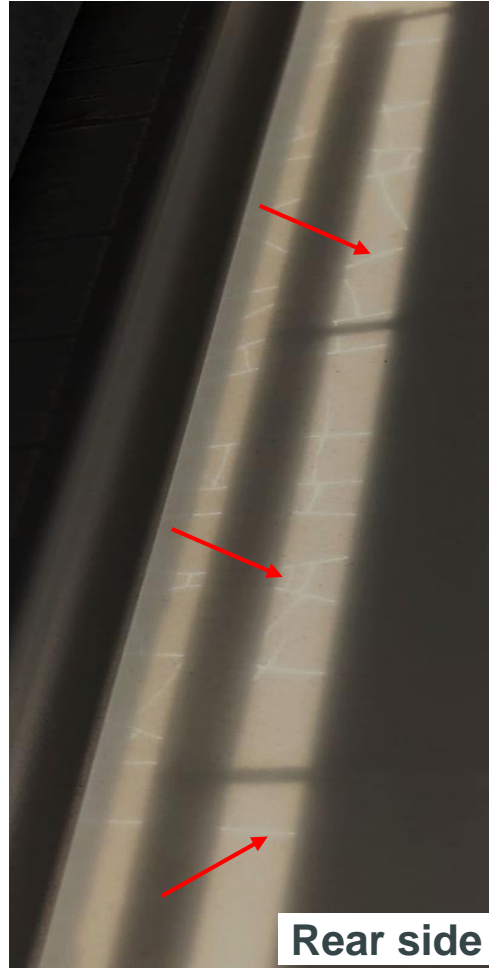
Fielded module with 5 years service in India, FEVE-coated backsheet

- ~70% of the inspected modules with FEVE backsheet show inner layer and backsheet outer layer cracking
- Ground faults and inverter tripping occurred during winter mornings and rains

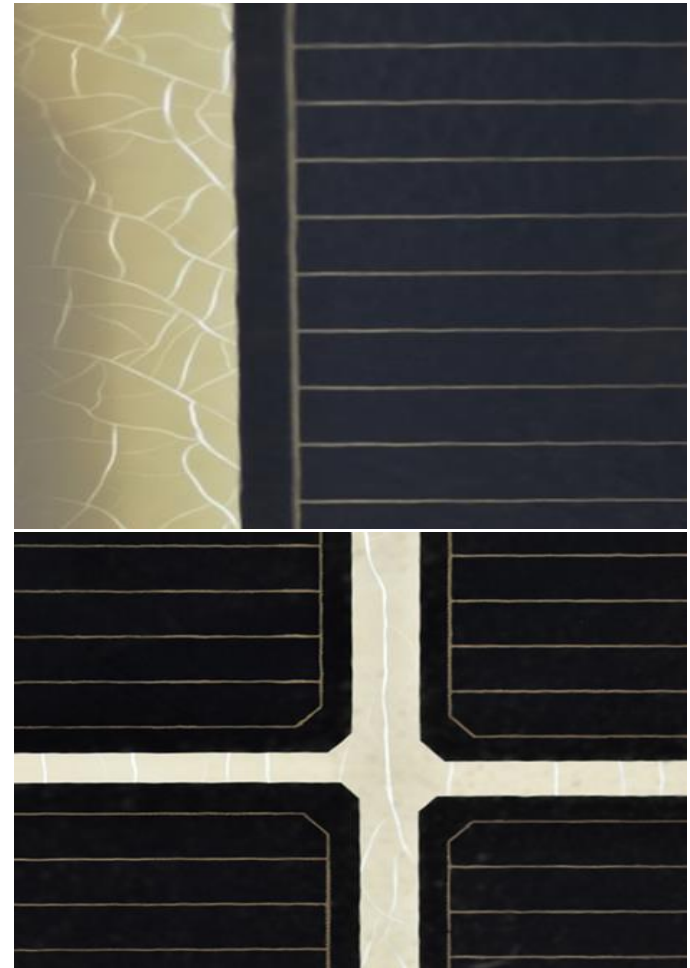
Fielded module with 6 years service in NA, PET backsheet, 30MW

- 30% Power Loss in 5 years of service
- 6% linearized power loss per year

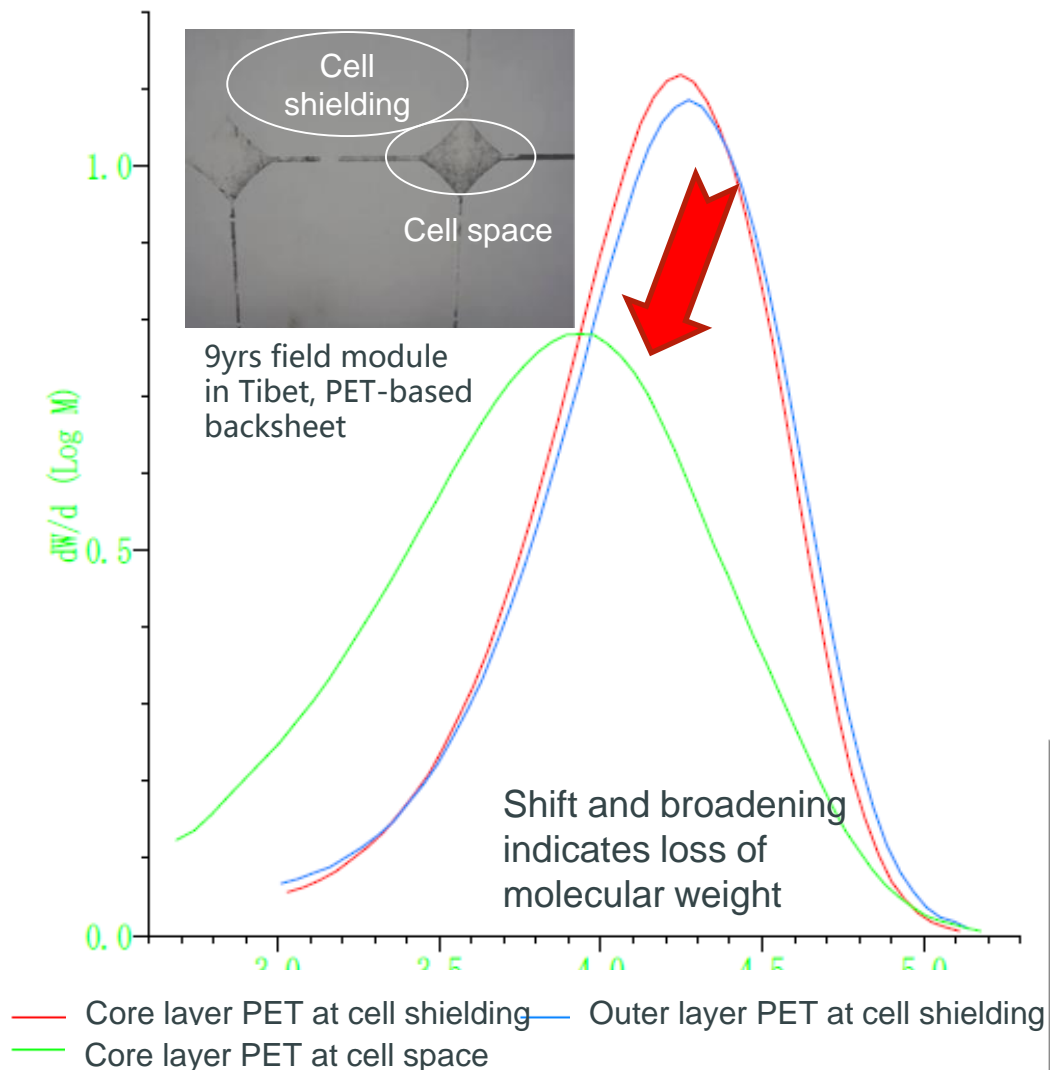
- **Loss of PET Mol wt and viscosity at cell spacing indicate polymer degradation from frontside UV light**
- **Backsheet was highly degraded. Backsheet could not be removed from module due to high brittleness**

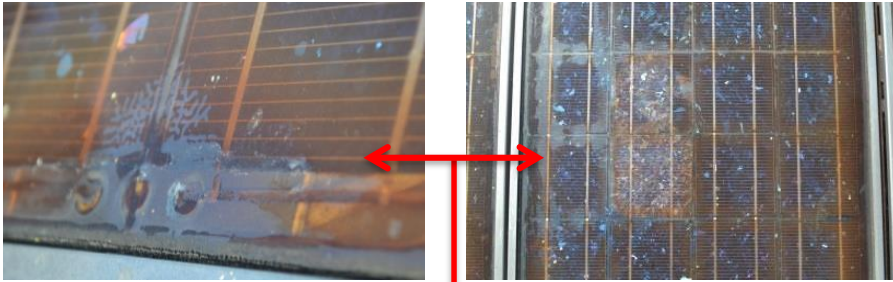
**Location:** Hainan (China), **Time:** 15 years

**Observation :** Bus bar & cell Corrosion, EVA browning

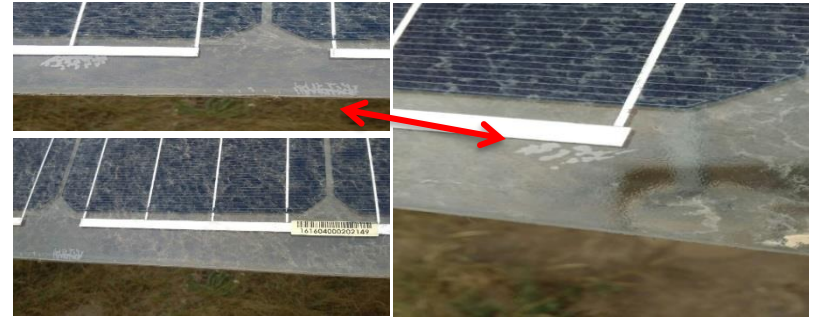
**Location:** Shanxi (China), **Time:** 1 year

**Observation:** Bus Bar Corrosion/delamination

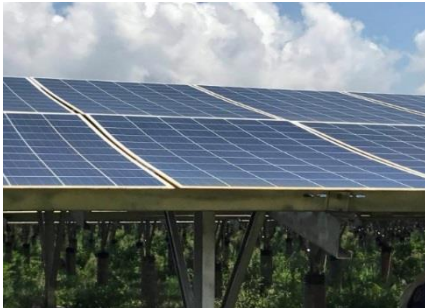
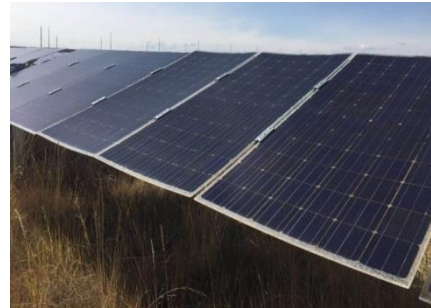
**Location:** Guangdong & Qinghai (China), **Time:** 1yr

**Observation :** Bending & Breakage

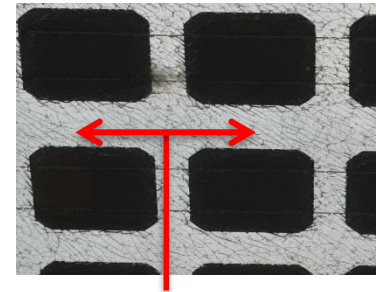
**Location:** Yunnan (China), **Time:** 10 years

**Observation :** Extensive breakage

- Multiple failures: Power Loss & Breakage across regions, and Applications (roof + ground)
- Higher corrosion rates are likely due to trapping of acetic acid by the glass backpanel

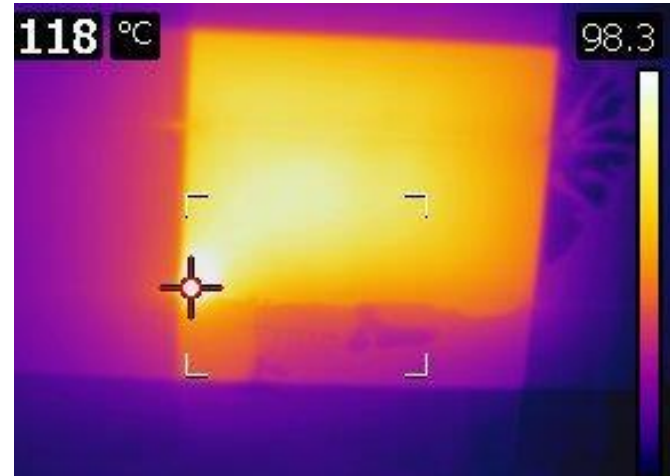
**Bubble**

**Crack**

**Burn Through**
