# Backsheet cracking – a global phenomenon

# PROBLEM OF BACKSHEET CRACKING OVERVIEW OF POSSIBLE REPAIR SOLUTIONS

Gabriele C. Eder & Yuliya Voronko - OFI, Austria

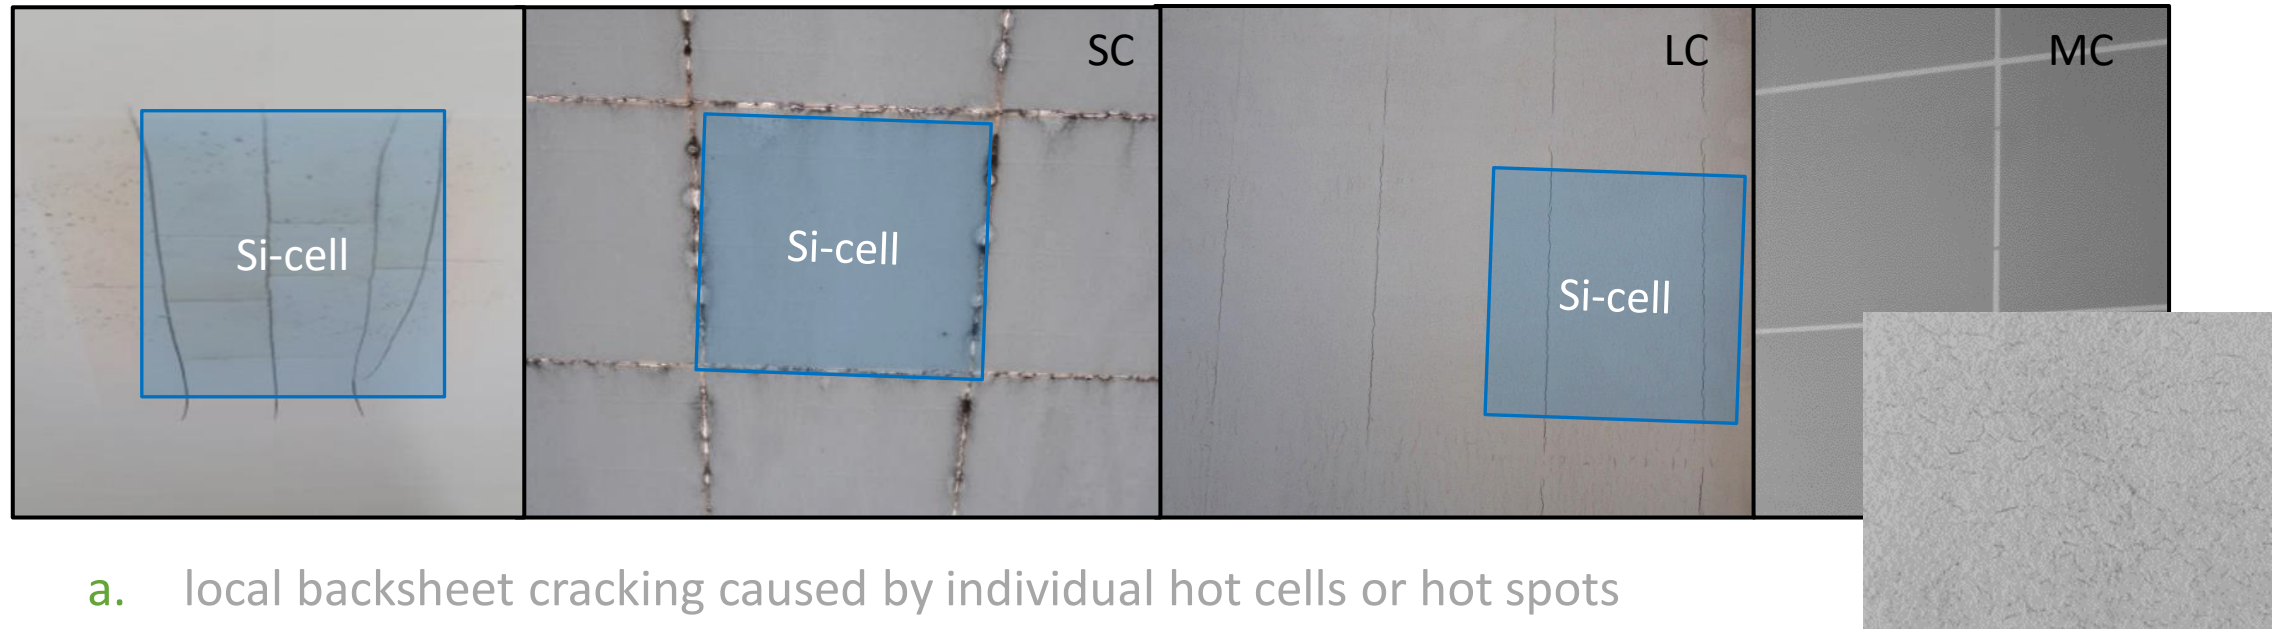
- a. local backsheet cracking caused by individual hot cells or hot spots
- b. Tile-shaped, square cracks – between cell areas; SC
- c. Longitudinal cracks (along the busbars of the cells); LC
- d. Microcracks in the outer layer; MC

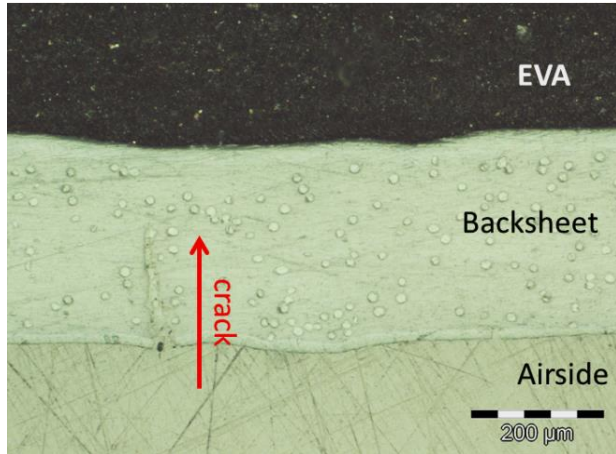
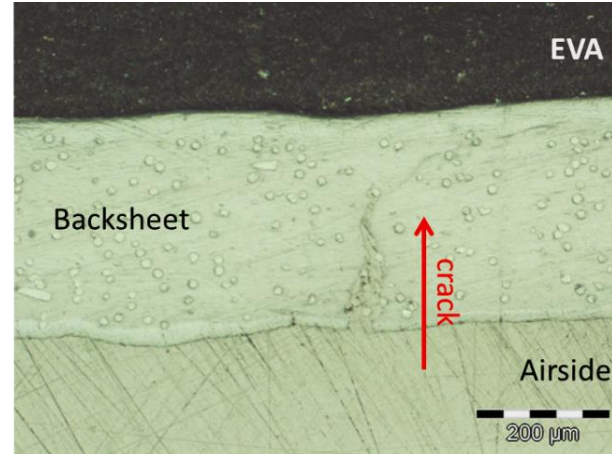
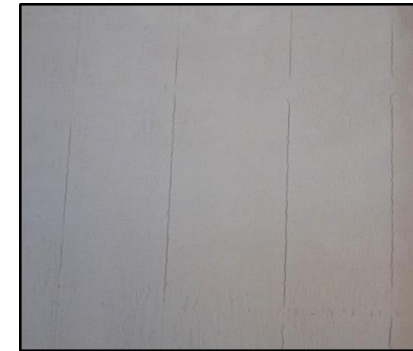
LC, MC, CH

physical cracks in PA outer layer and core layer

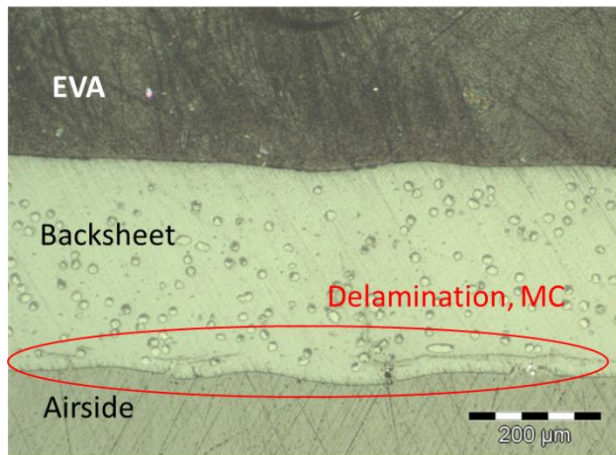
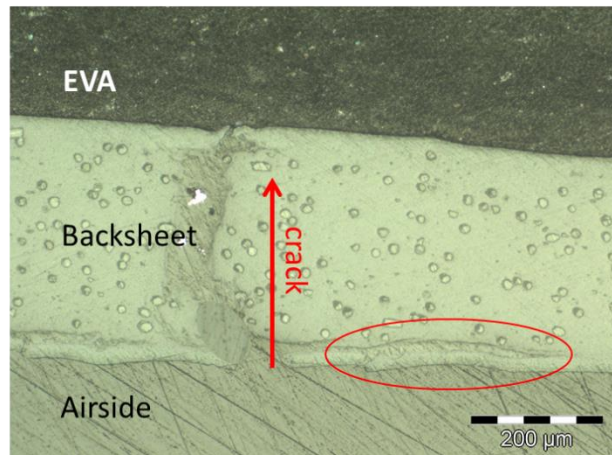
LC, MC

delamination of PA outer layer,  
cracks in PA outer layer and core layer  
no chemical degradation

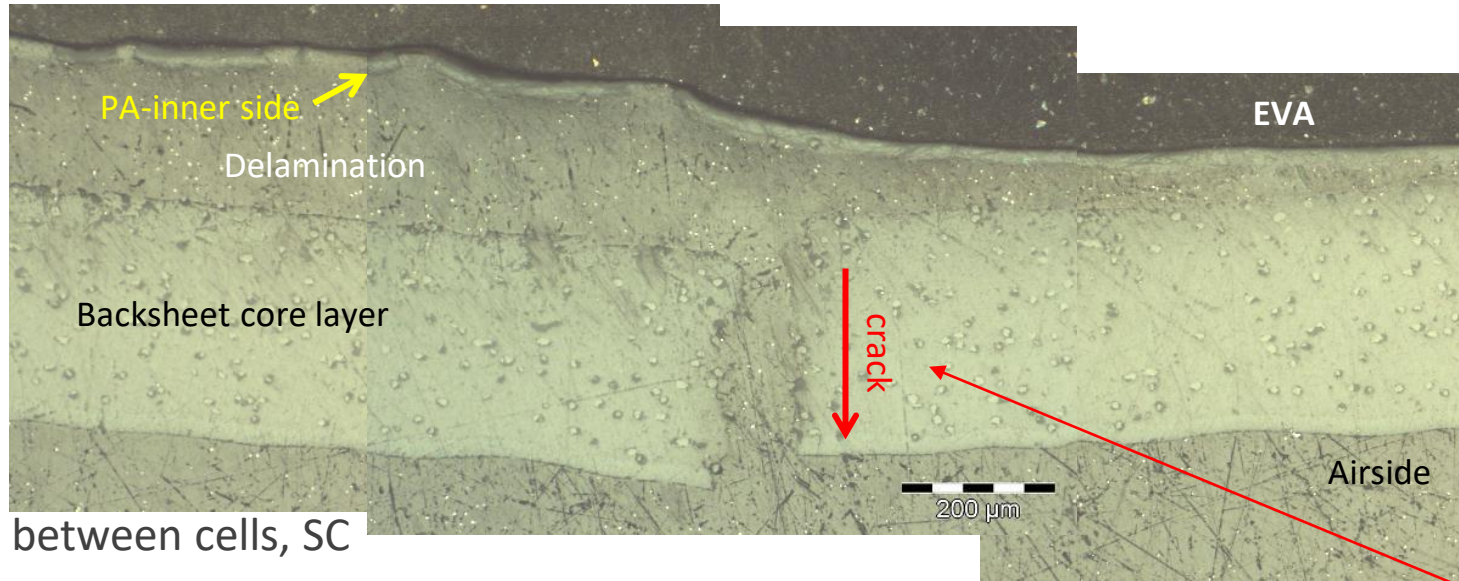
- Delamination inner layer / core layer + chemical degradation
- crack in core layer + chemical degradation

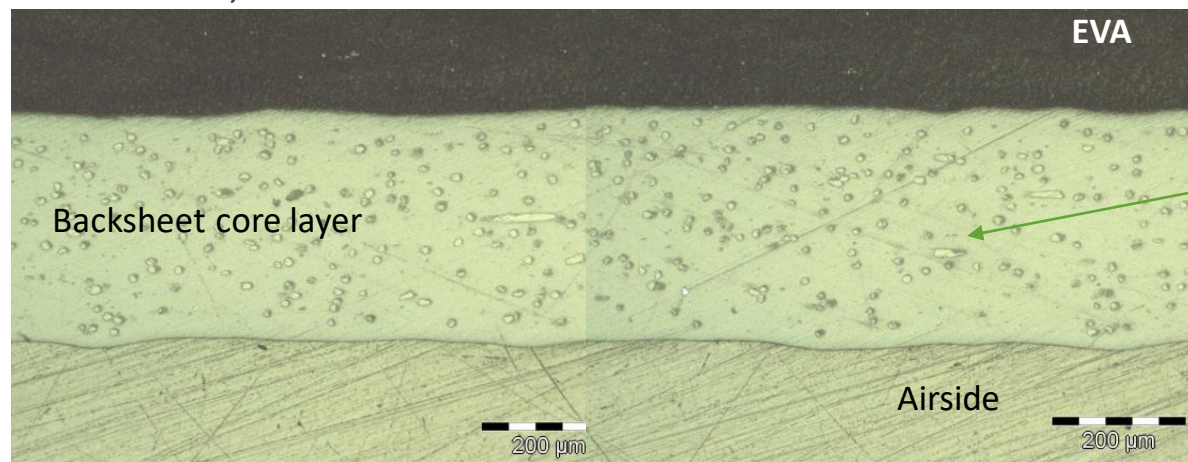
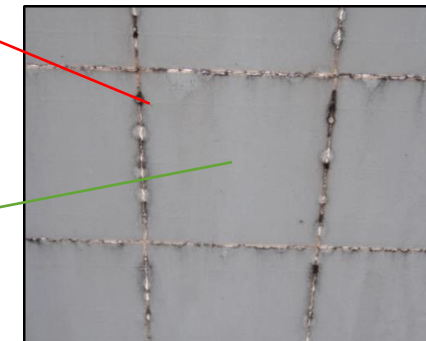
below cells, SC

BUT: below the cells, all backsheet layers are intact

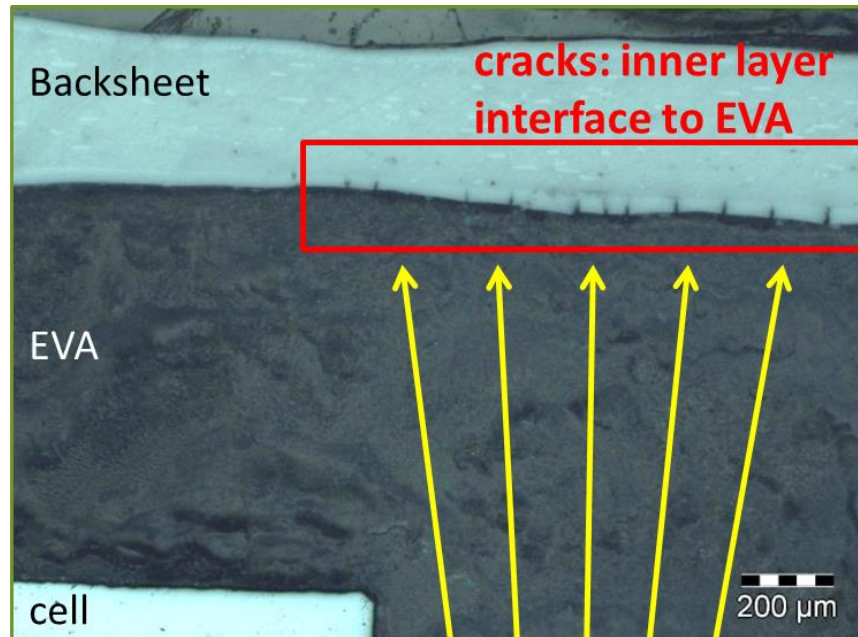
**Problem: if EVA is without UV-stabiliser is used**

SC: Cracks in the inner PA-layer / EVA-interface

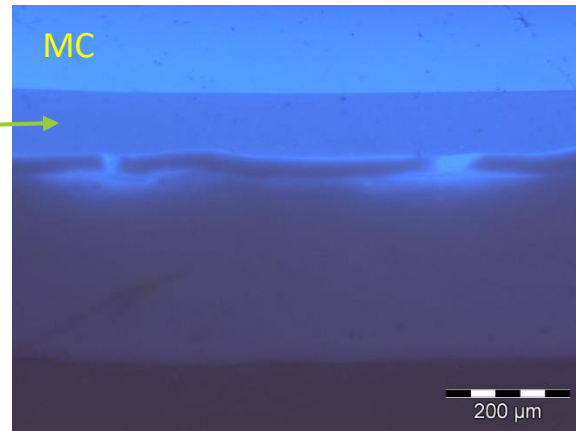
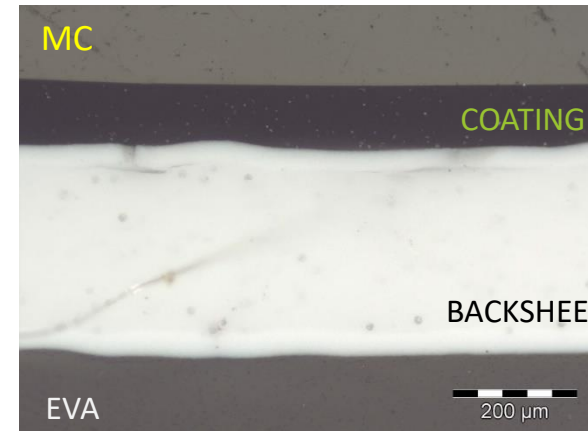
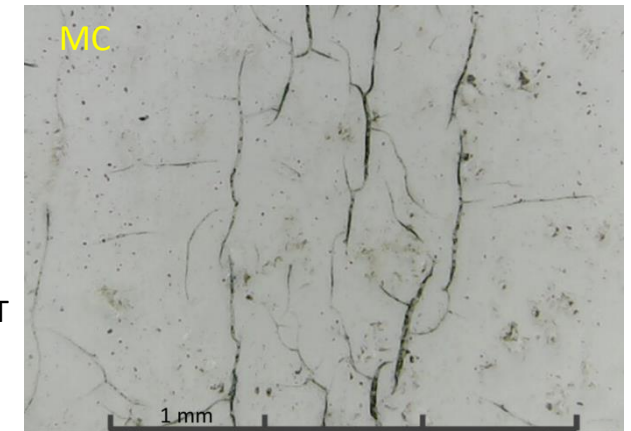
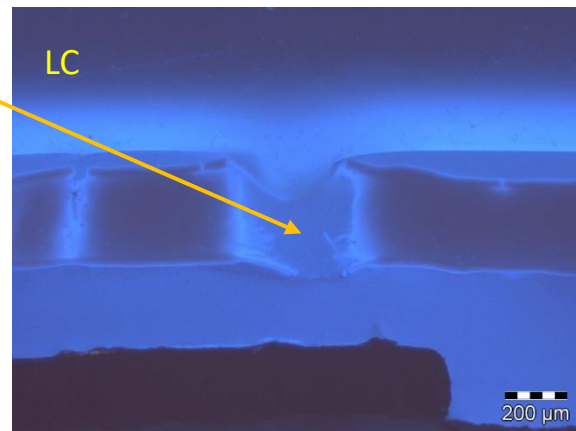
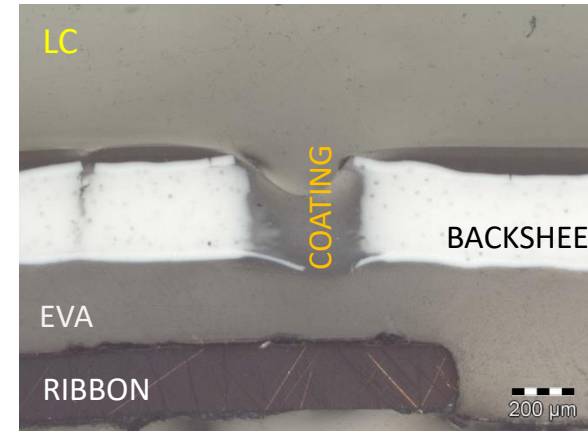
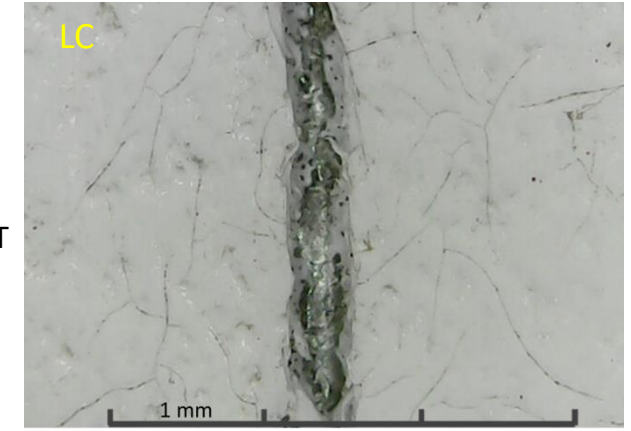
Sealing /protection barrier layer

Crack filling (no voids)

1. Cleaning
2. Filling of cracks + drying
3. Barrier layer of weather-resistant coating

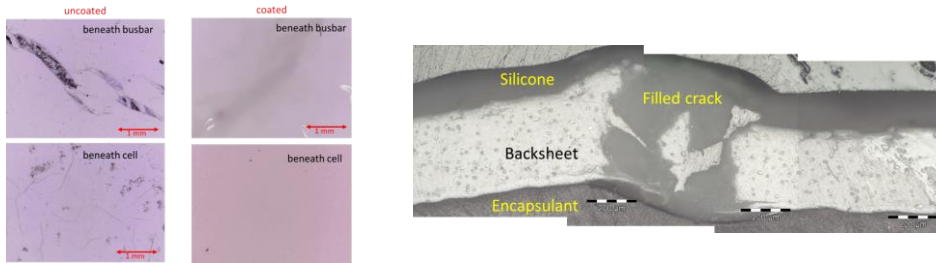
- Test modules:
  - PV modules with AAA backsheets
  - Had operated in PV plant in Southern Europe for 7 years
  - Deep longitudinal cracks, causing leakage currents and decommissioning
- Coating
  - Module horizontal, backsheet facing up
  - Spreading and smoothing with spatula

Before repair		After repair	
'Dry' $R_{iso}$ : (no water immersion)	Wet leakage $R_{iso}$	Wet leakage $R_{iso}$	Wet leakage $R_{iso}$ after Damp Heat 85/85
> 1000 M $\Omega$	Failed $R_{iso}$ = 0 M $\Omega$	Passed $R_{iso}$ >1000 M $\Omega$	Passed $R_{iso}$ = 254 M $\Omega$

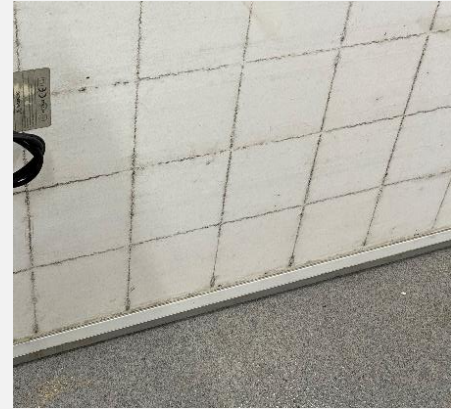
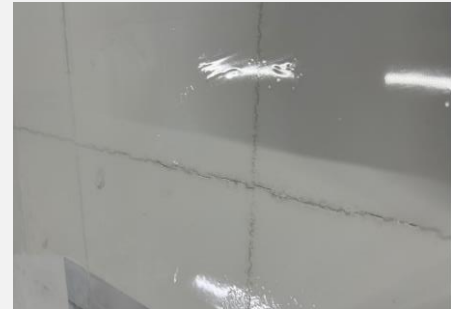
- Modules of 245 W nominal power, Tier 1 manufacturer
- Operated 8-10y in a solar park, now decommissioned
- Severe degradation observed:  
Deep cracks in checkered pattern, signs of corrosion
- Worst case scenario of repairable backsheet
- Applied DOWSIL™ PV-9001 Backsheet Coating (Spray / Spread).  
Nominal coating thickness 400 µm
- Modules sent to independent testing lab (AIT, Austria)

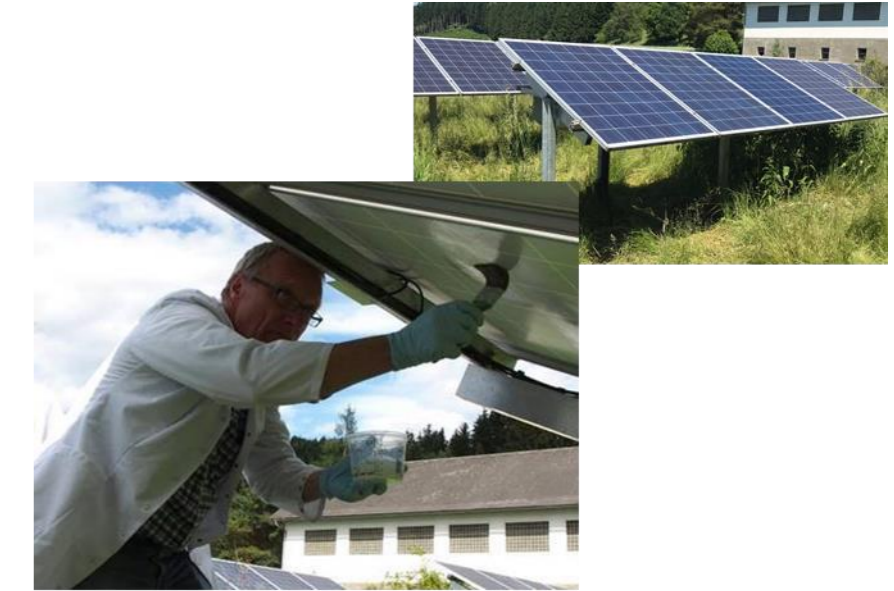
- NO electrical performance degradation, NO insulation problems under wet conditions;
- Material degradation -> **chalking and micro-cracking** of outer backsheet layer (polyamide)

**The aim to prevent further growth of surface near MC and their evolution to LC could be achieved**
