Quality Roundtable at Renewable Energy India Expo 2017

Spend a little, save a lot: Smart investments yield higher PV
performance

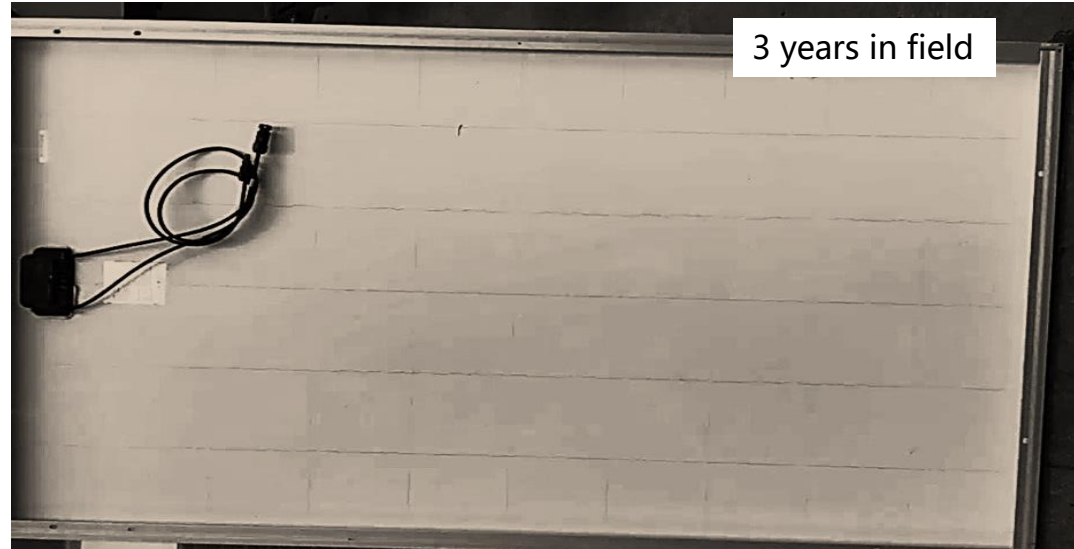
- Installed in 2012, inspected in 2015
- Backsheet cracking and delamination and corrosion as water ingress

- Solar farm installed in 2012
- Micro-cracks on backsheet found in 2013
- Cracks of backsheet found in 2016

- 100MW fishpond application, installed in 2013
- Around 10% less power generation than expected in 2nd year in field
- 49.4% power degradation of sample module as PID
- Backsheet cracking

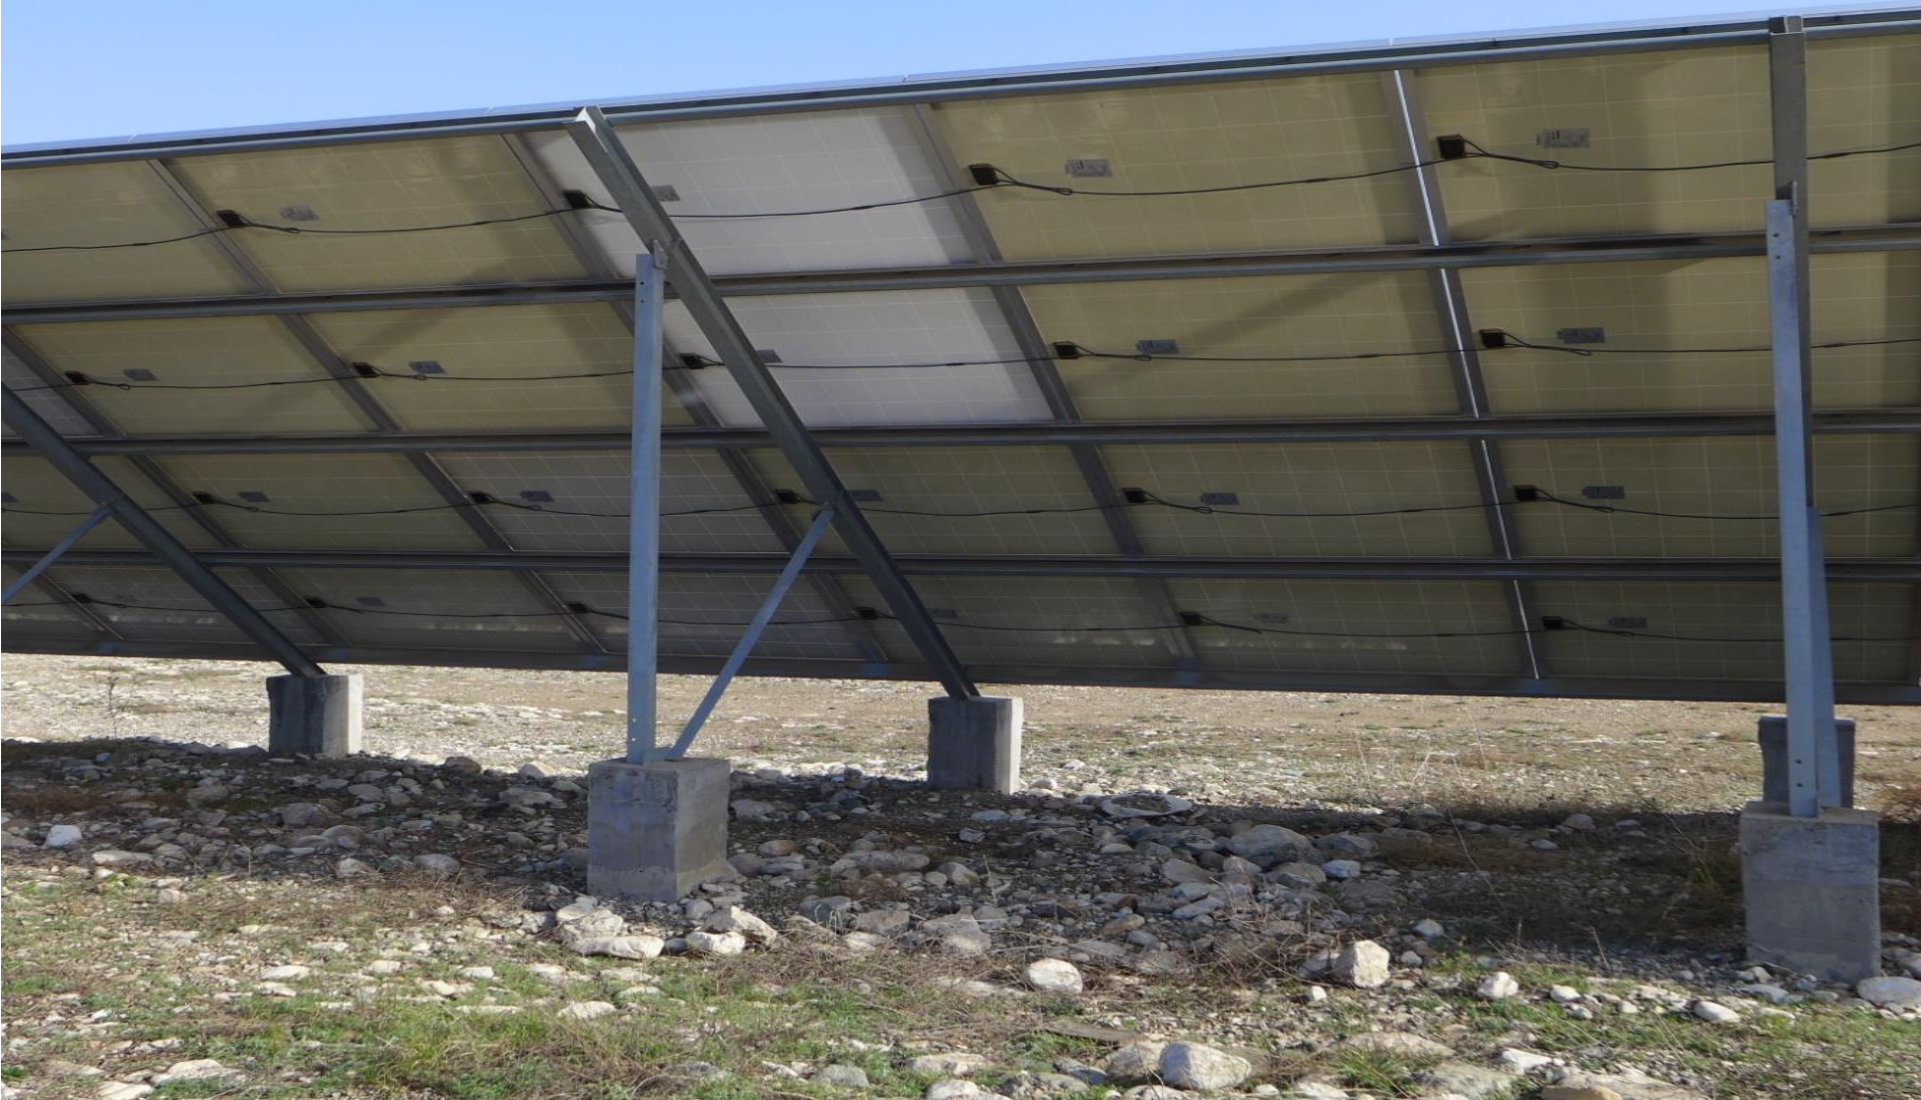
**4 Years in Gobi Desert
PET Backsheet
Severe Yellowing & Delamination**

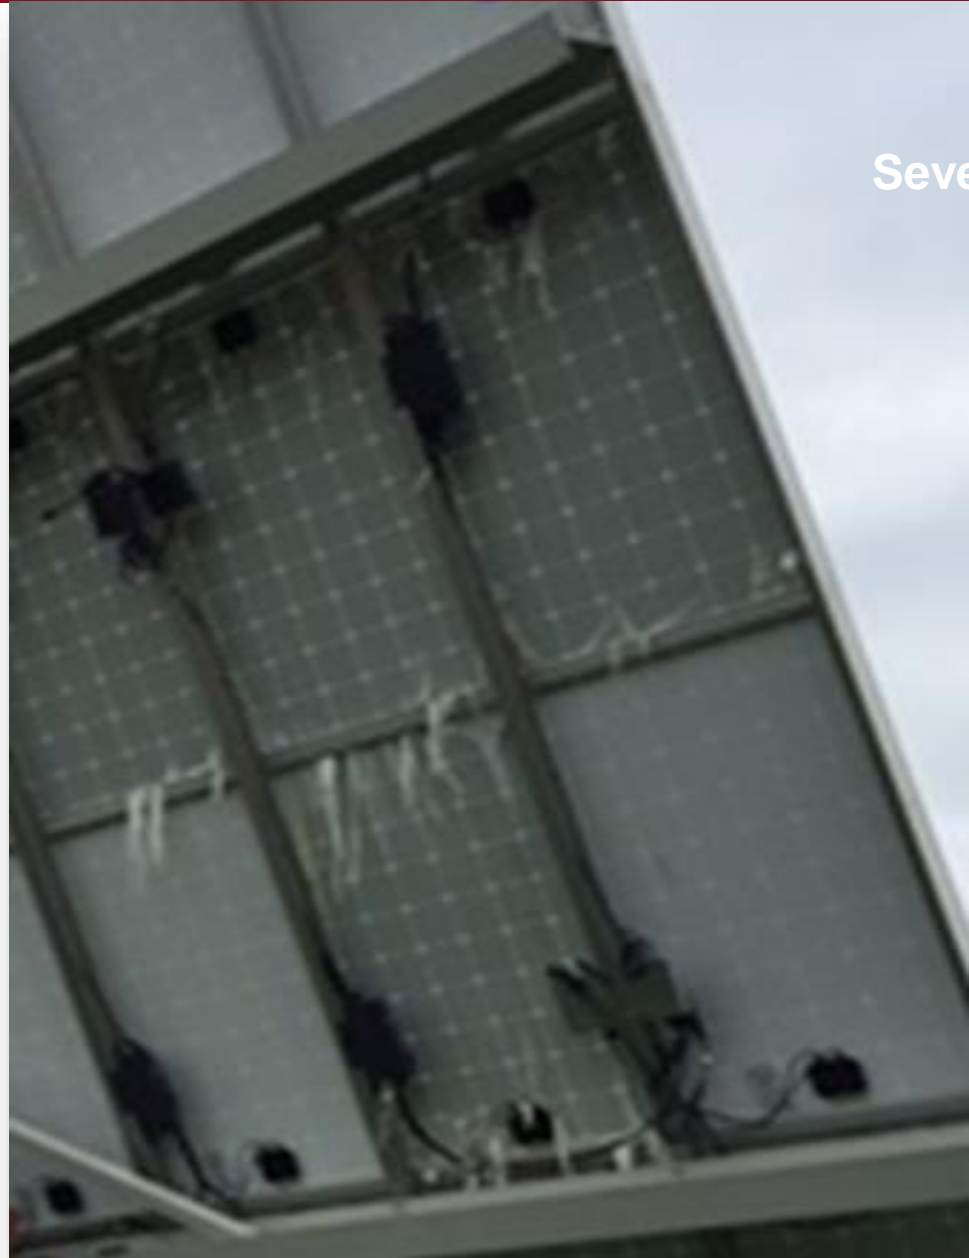
4 Years in North America
PVDF Backsheet
Severe Cracking and Delamination (57%)

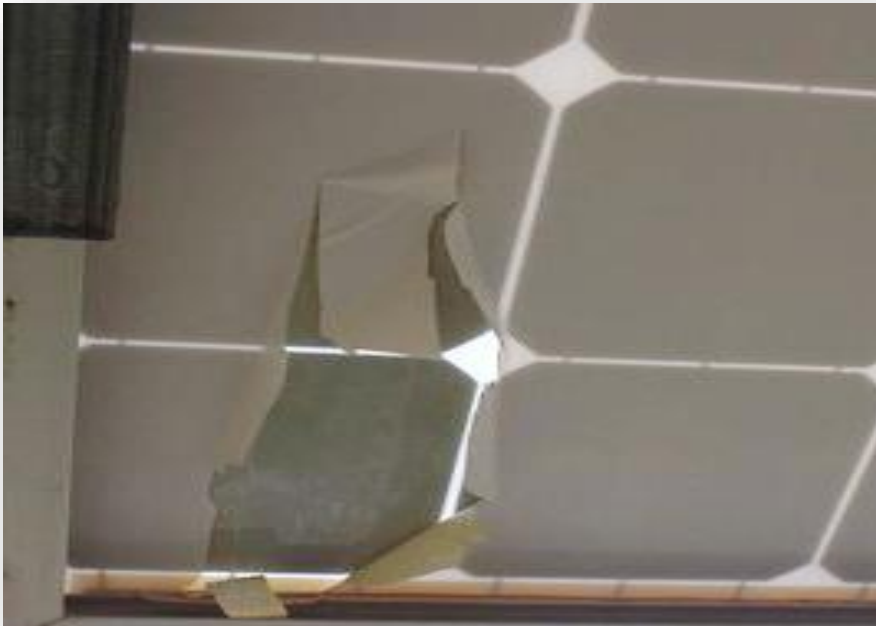
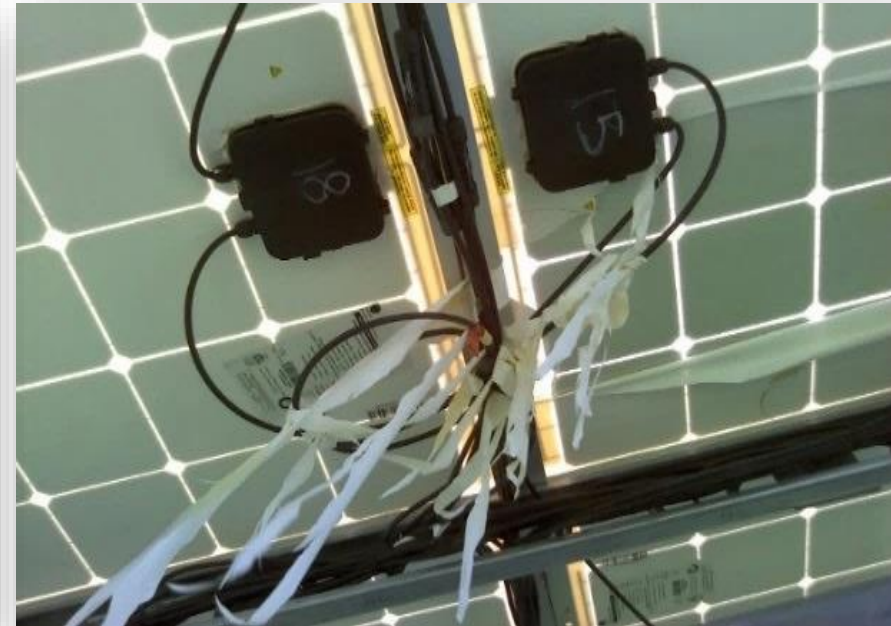
Severe delamination and power degradation of framed double-glass module in tropical climate

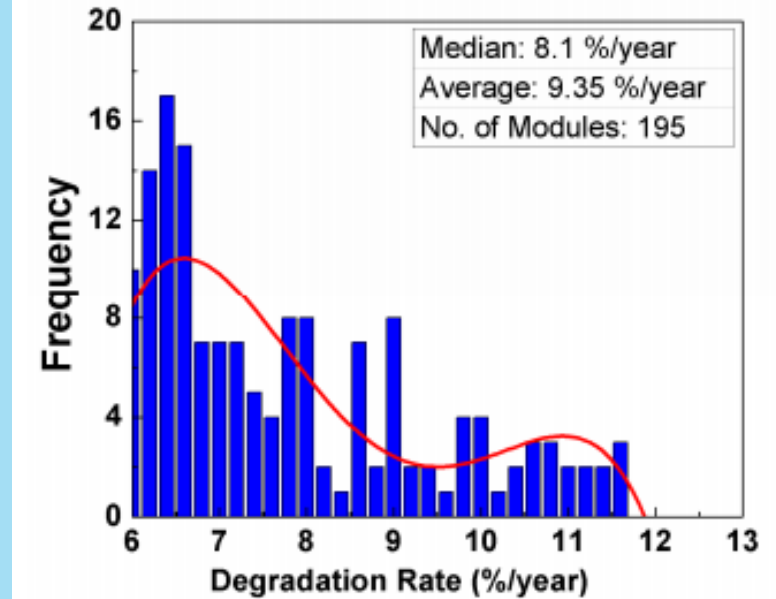
- **23%** of the crystalline silicon had an average degradation rate of **9%/year** in this region
- **3 – 3.5%** of this can be attributed to soiling and other installation malpractice
- **5.5 – 6%** of the losses are due to PID
- Average degradation rates are in the range of **2%/year**, compared to the warranty provided by the manufacturers which amounts to **~ 0.8%/year**

Histogram of Pmax distribution crystalline silicon modules

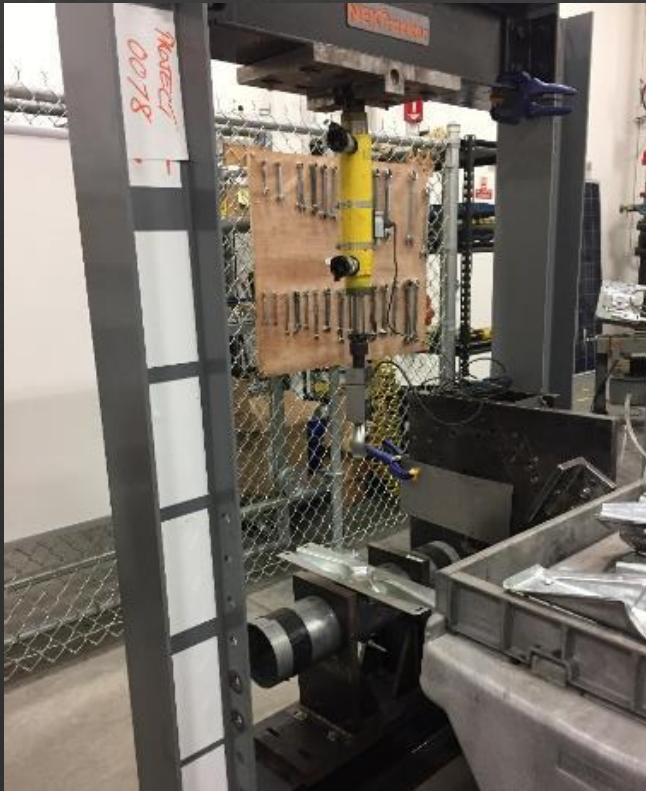
3 Ultimate Failure Test Fixtures

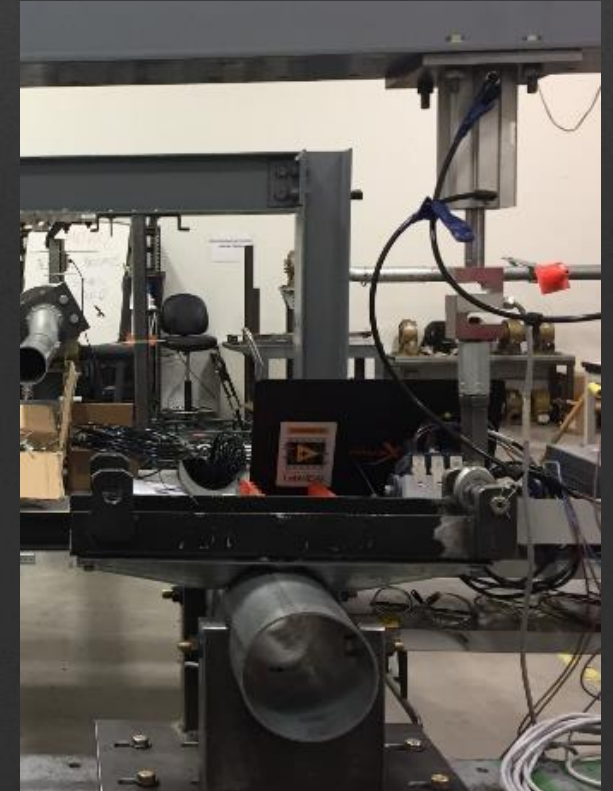
3 Cyclic Test Fixtures

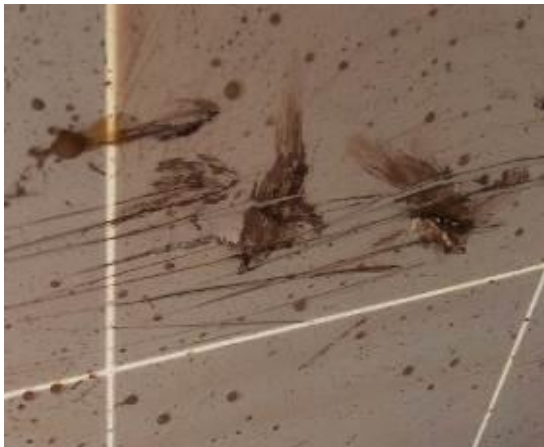
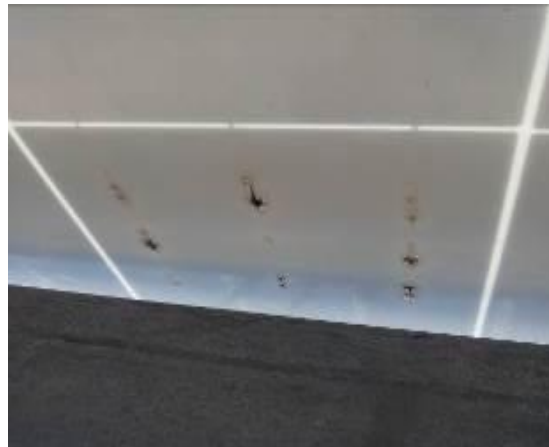
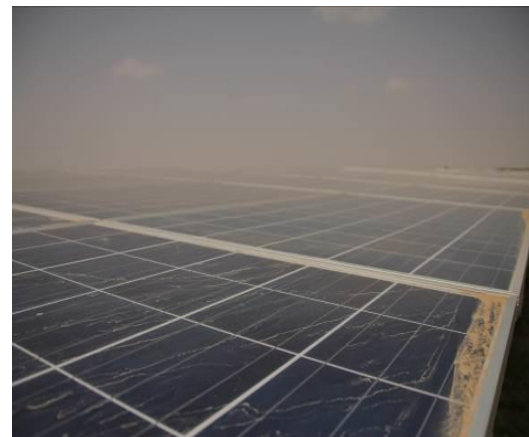
PID **SOLDERING** BACKSHEET
SOILING **SNAIL****TRAILS** *CRACKS*

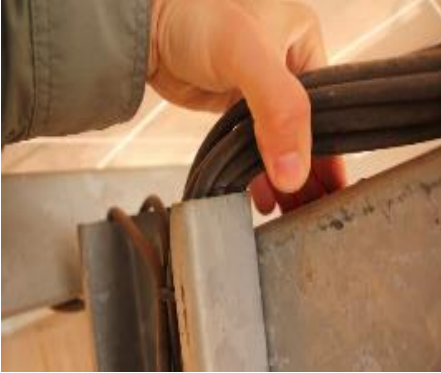
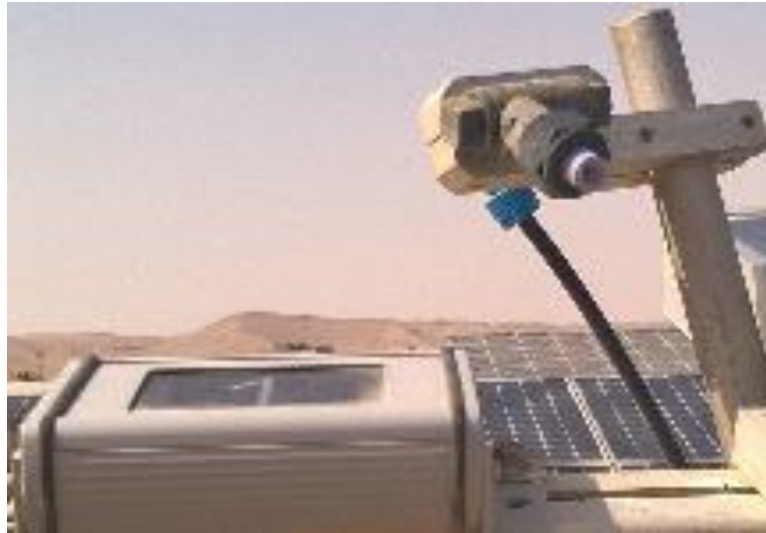
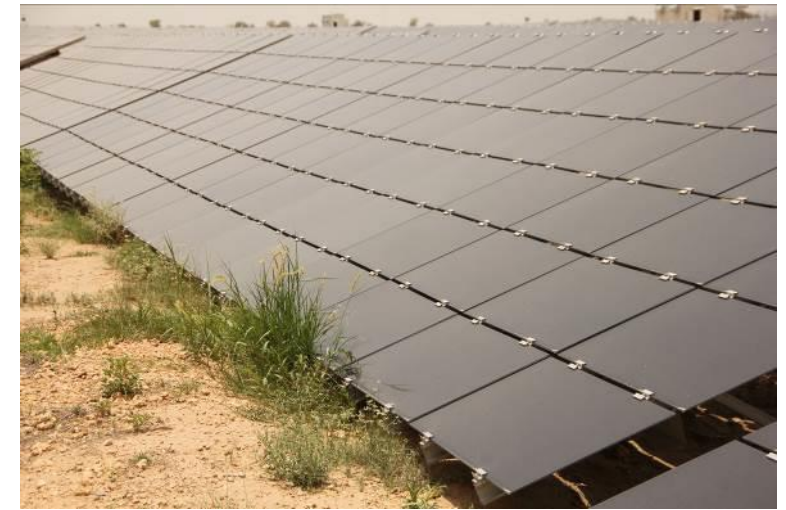
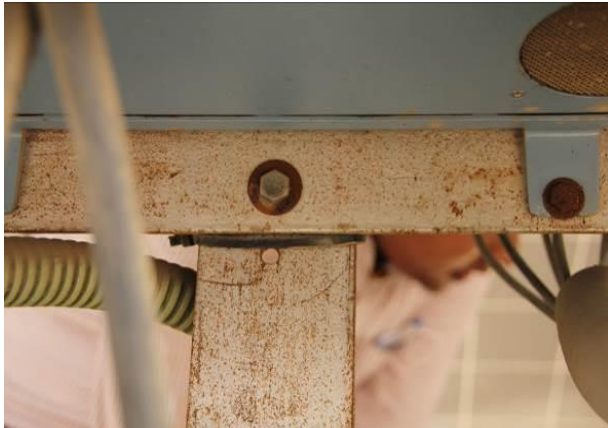
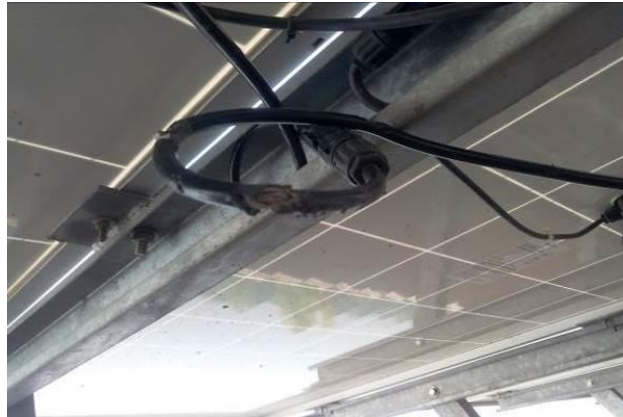
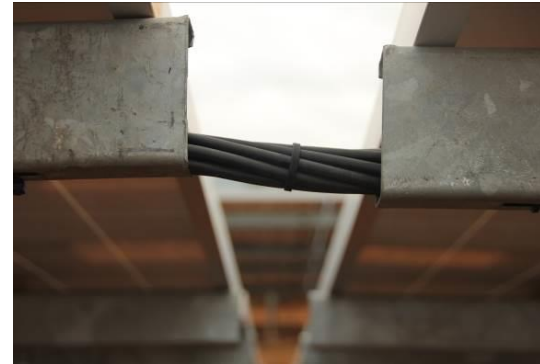
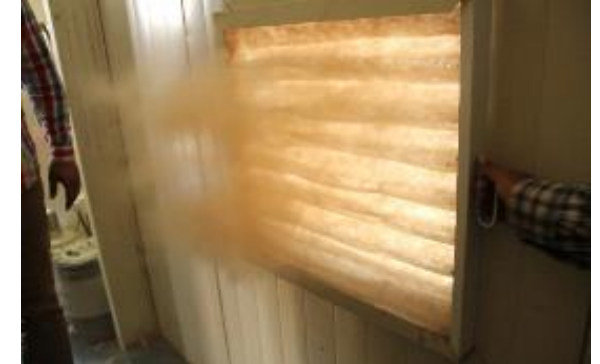
Cabling
Rust
Vegetation
Filters
UV / Dust
Irradiation

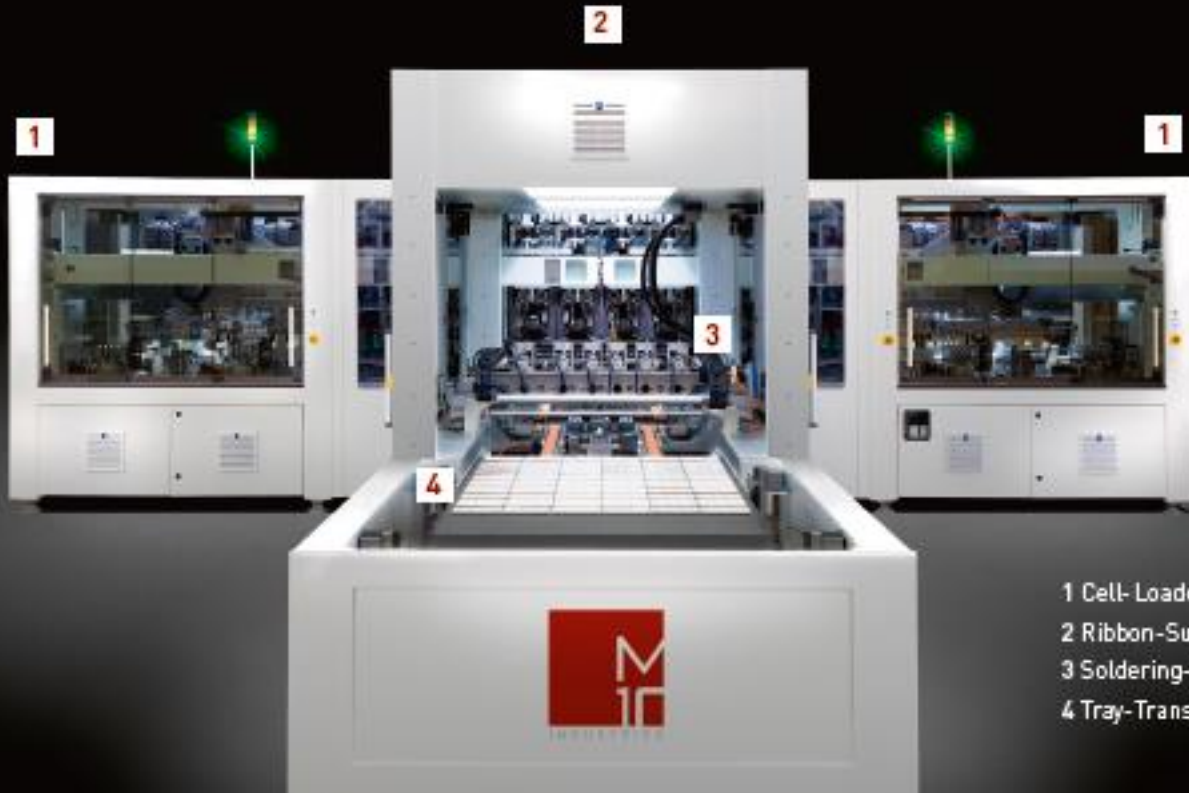
- Maximum productivity of 5,500 cells/h
- 3, 4, 5 or 6 busbar; half-cells, PERC
- Minimal space requirements
- One-man operation

- 1 Cell- Loader
- 2 Ribbon-Supply
- 3 Soldering-Unit
- 4 Tray-Transport
