PV Module Degradation Root Cause Analysis: Case Study

Date: 5 November 2020
Distribution: All Energy Australia
Author: George Touloupas, Director
Department: Technology and Quality
Version: 1.1

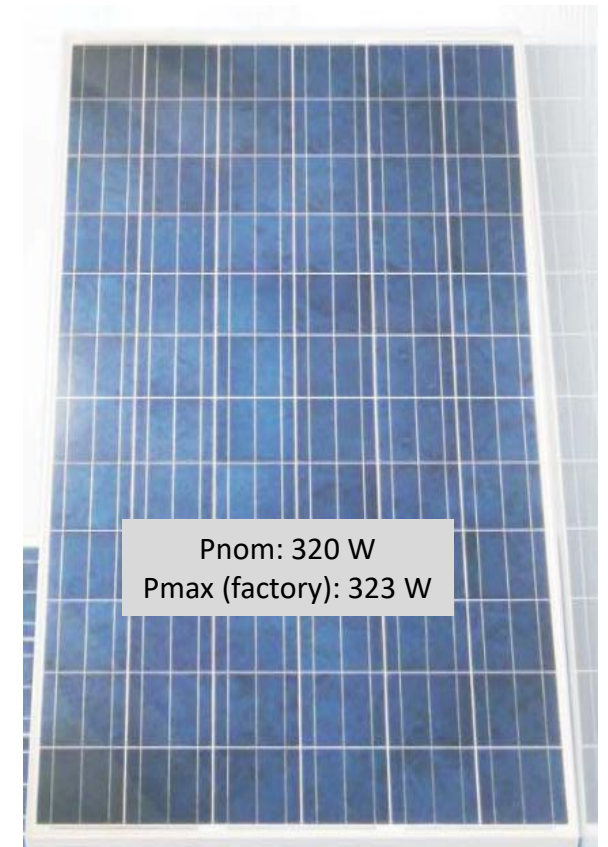
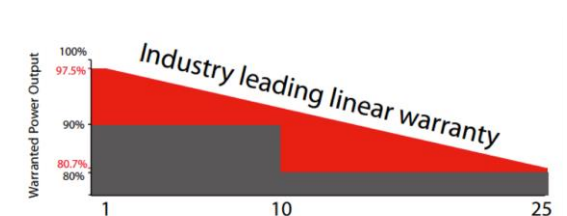
As PV modules are typically produced in 5 W bins with positive tolerance, the actual “flashed” Pmax of a production module **should** be higher than the Nominal Power, by an average of ~2-3 W (may be higher in some cases, e.g. when extra tolerance has been agreed, or when low power cells are not available).

Typical warranties start with a steep first year maximum degradation (~2.0% - 2.5%), with immediate effect, mostly due to LID after exposure of the PV module to light and explained by the forming of Boron-Oxygen defects in Boron doped cells.

From the 2nd year on, a constant yearly degradation (~0.7% - 0.4%) comes into play.

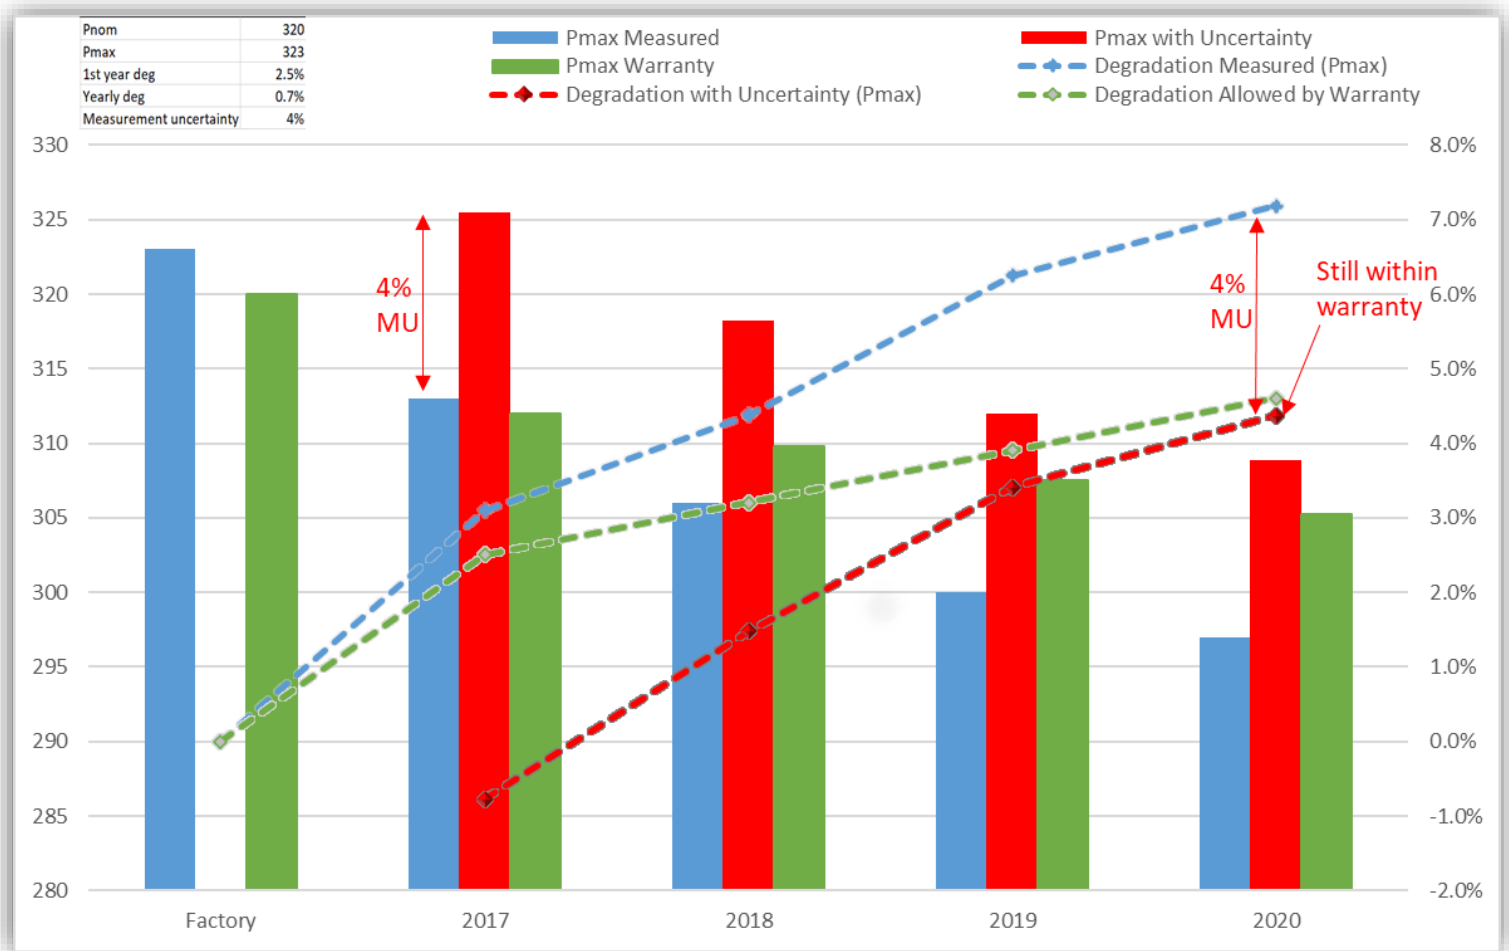
The measured Pmax value of a PV module is subject to a measurement uncertainty.

Measurement (IV tracing) in the field has higher uncertainty than measurement in a controlled lab environment.

Source: CEA, example of power measurement to identify degradation

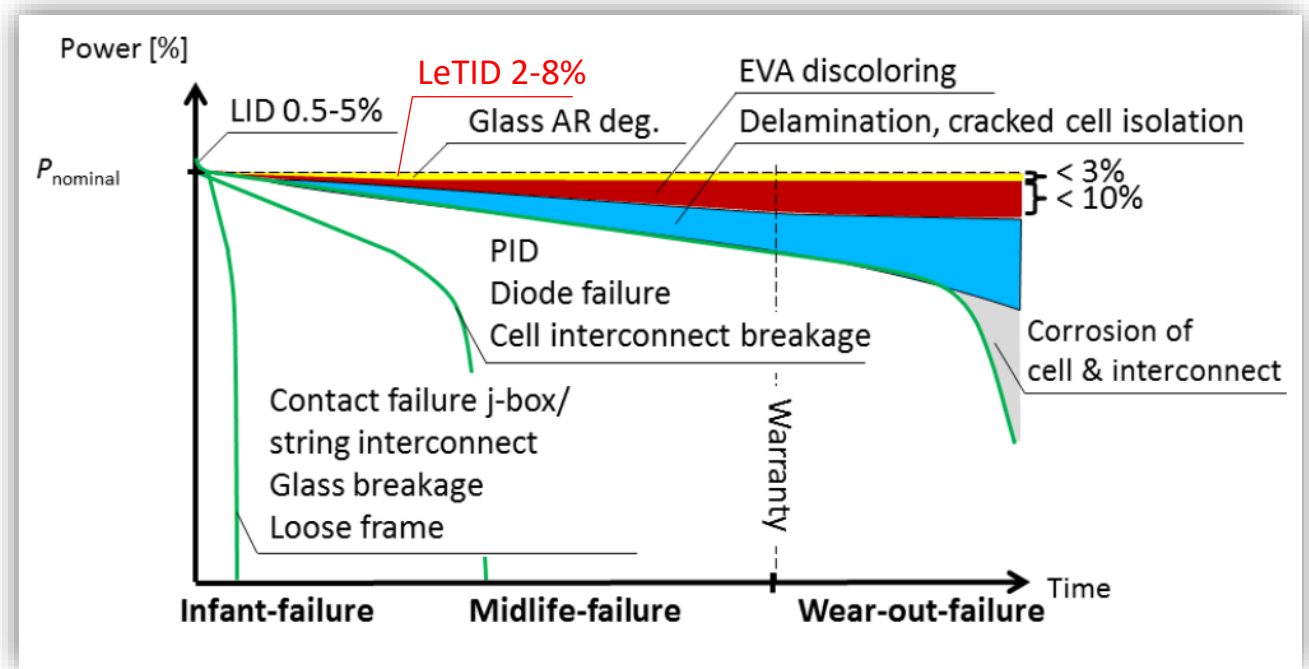
PV modules can degrade from many causes. Many of these are easy to identify, especially if they are accompanied with visual effects, and might be straightforward to claim if they fall under workmanship or serial defect warranty clauses.

However, some types of degradation, such as LeTID (Light and elevated Temperature Induced Degradation) are more difficult to diagnose and include in a warranty claim.

Source: IEA PVPS 2013, LeTID added

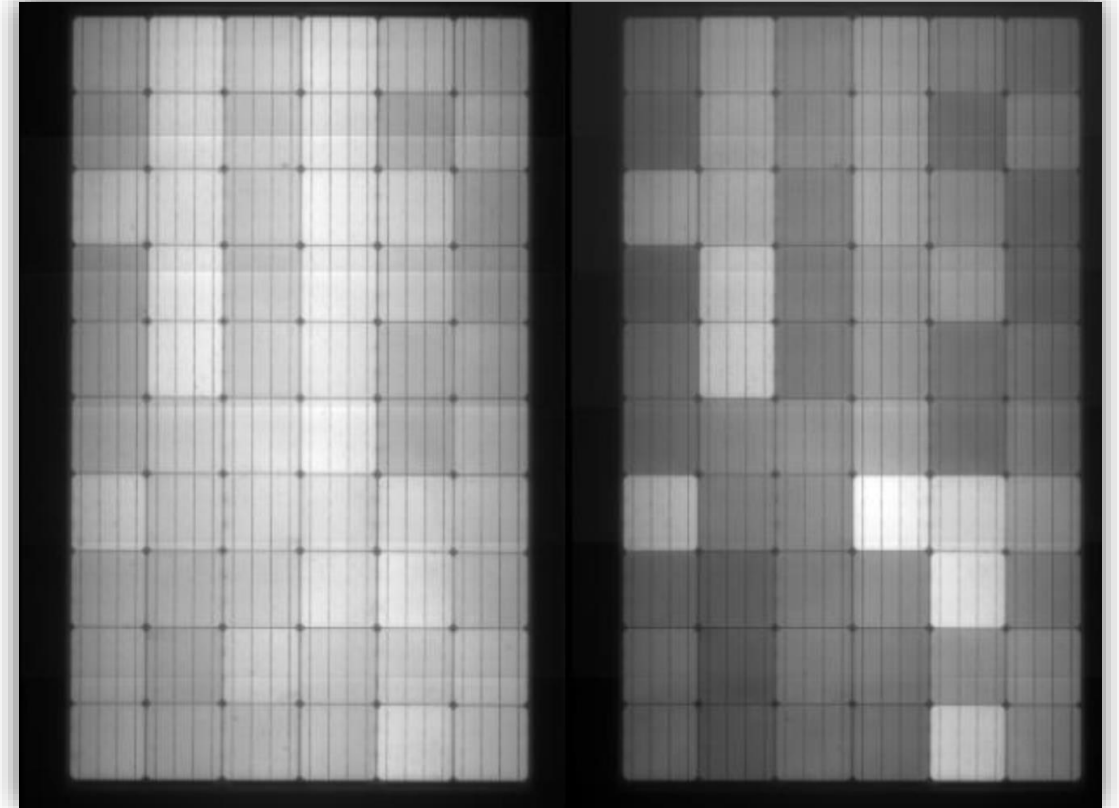
Besides degradation, LeTID affected modules develop characteristic “checkered” EL image patterns, due to the uneven degradation of individual cells (easy to distinguish from similar PID-related patterns by excluding PID).

If other causes can be excluded (LID, PID, mixed cell power classes), this can be a strong indicator for LeTID.

EL images @ 0.1 Isc, before and after 690 h LeTID testing
LeTID test: Current injection (Isc-Imp) at 75 °C
Source: Fraunhofer CSP, 36 EU PVSEC

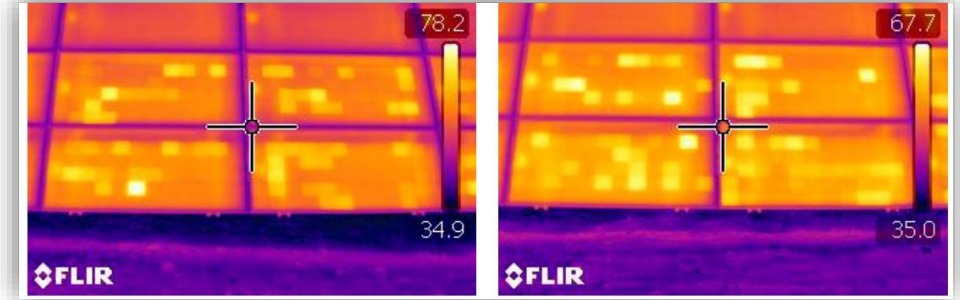
Cell power inhomogeneity was identified by thermography and EL imaging.

Thermography of short-circuited strings revealing cell mismatch

Remedies under power output warranty, field regeneration, serial defect clauses and other options are under negotiation.
