## Quantify the impacts of cell cracking in the field

# Si PV Modules – Microcracks and Power Loss

**PV Magazine Cell Cracking Webinar – 25 May 2020**

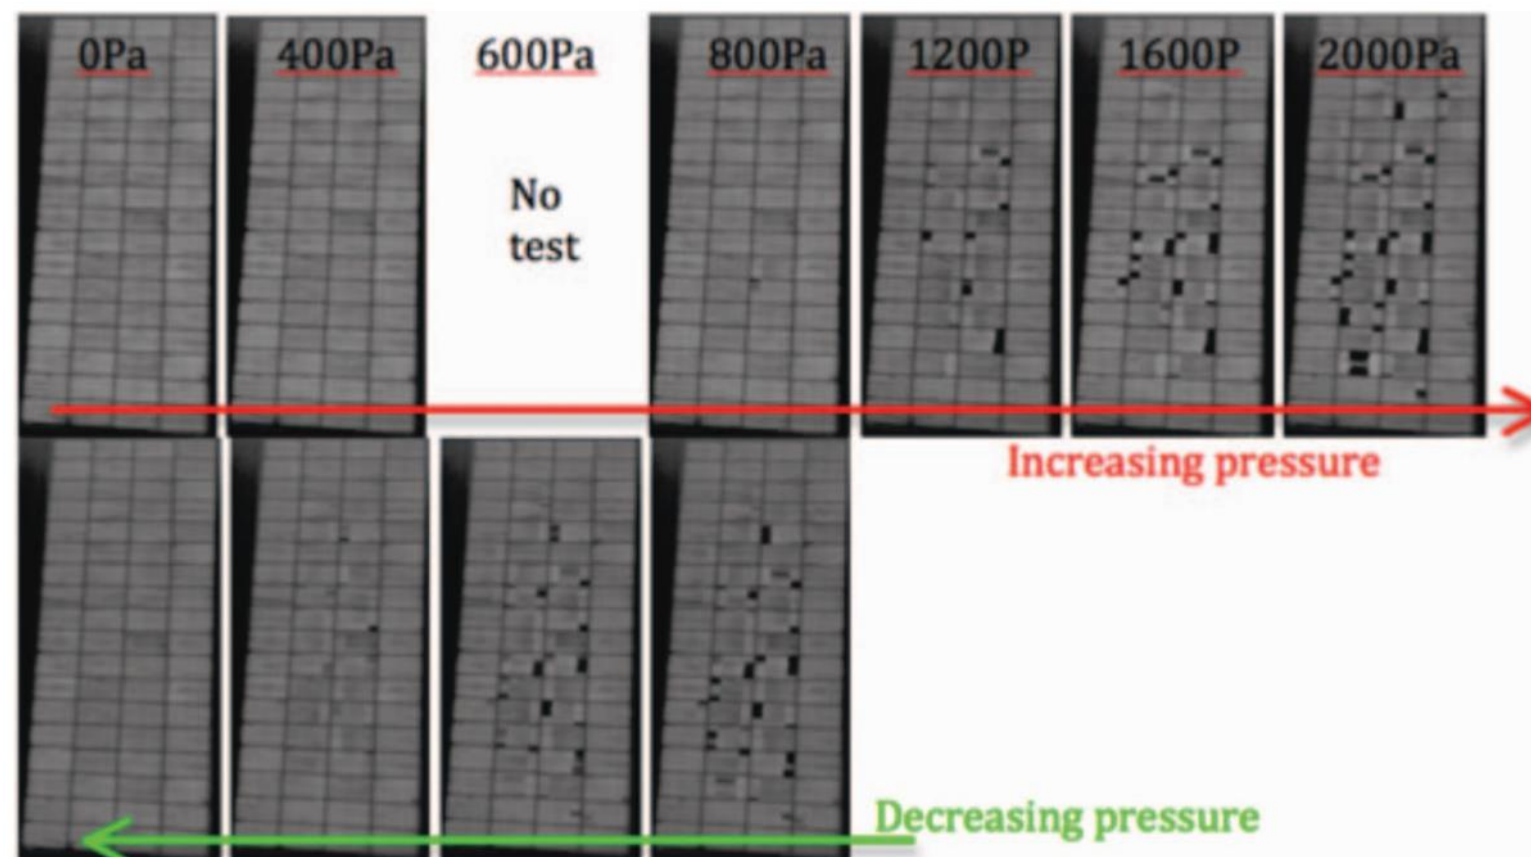
- Appearance of cracks in EL images decided by the pressure on the panel at the time of imaging
- The same applies to impact of cracks on performance

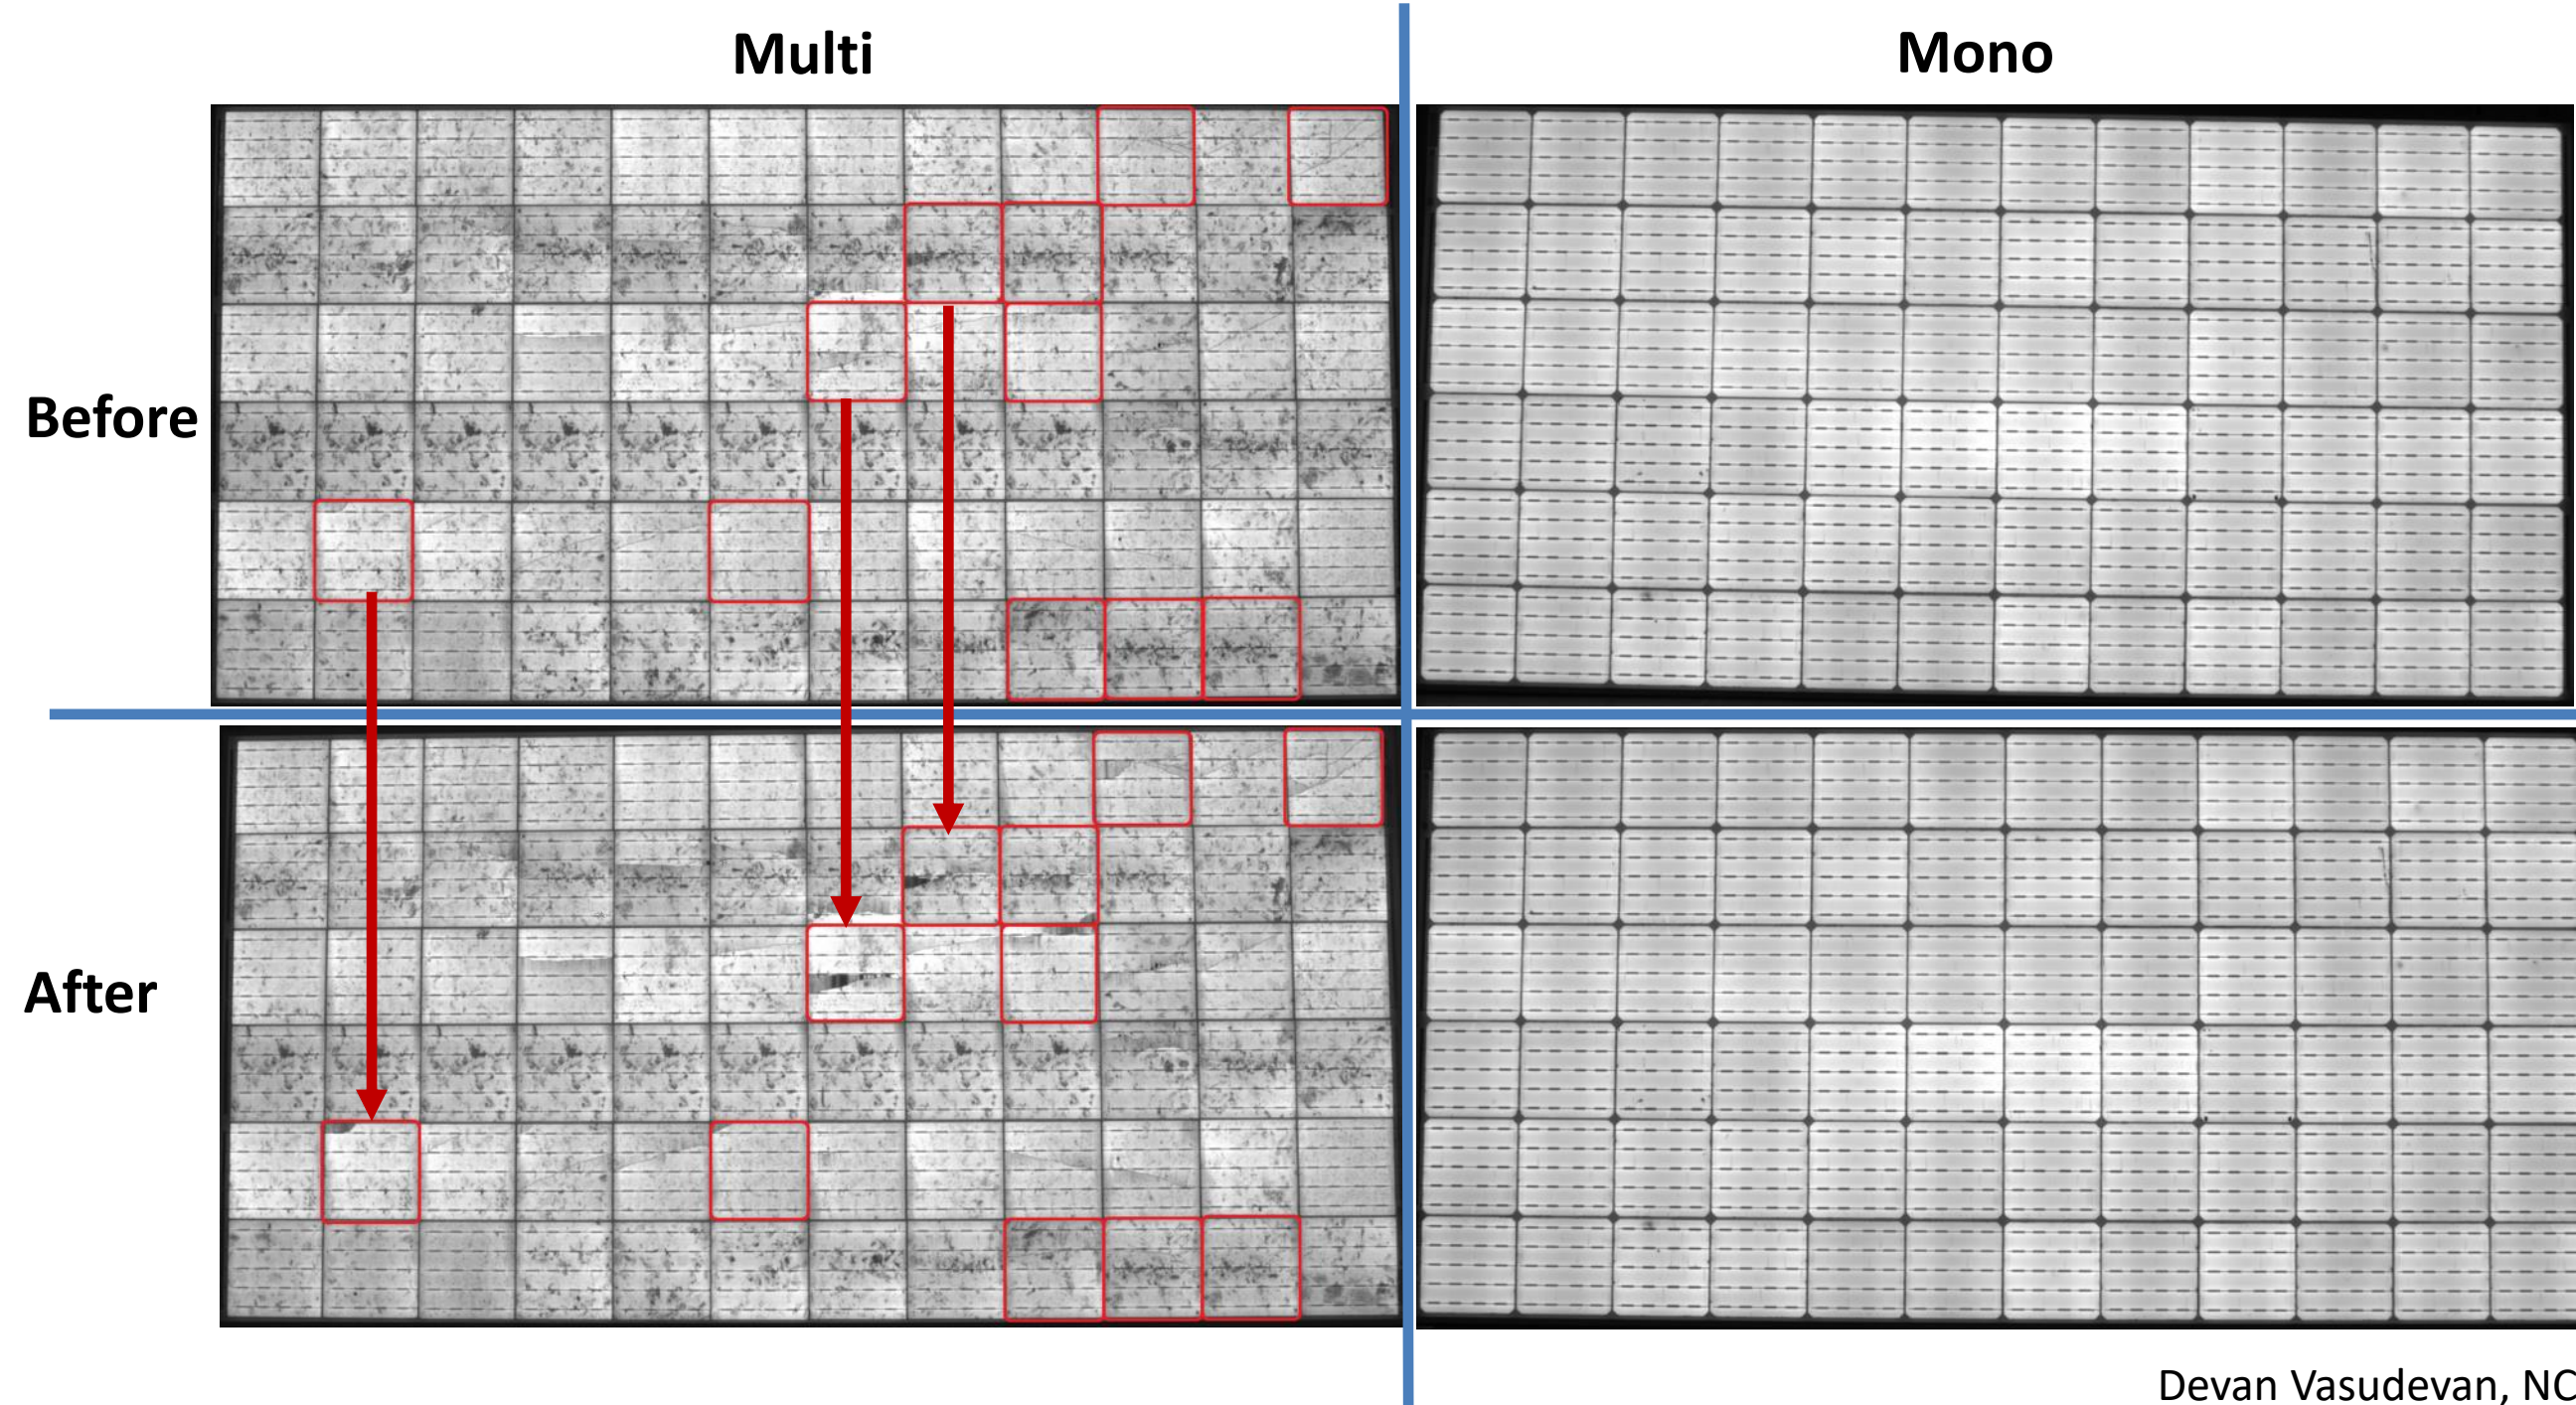
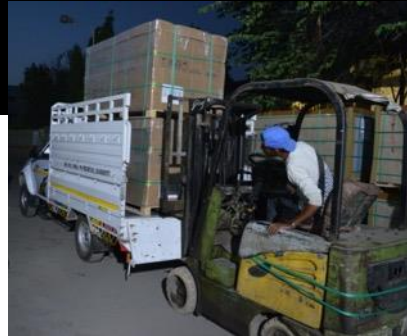
Modules subjected to identical transportation stress.

- Mono is more robust to mechanical stress
- Indian market share of mono in 2017 was 5% ([www.pv-tech.org](http://www.pv-tech.org), Sep. 2019.)

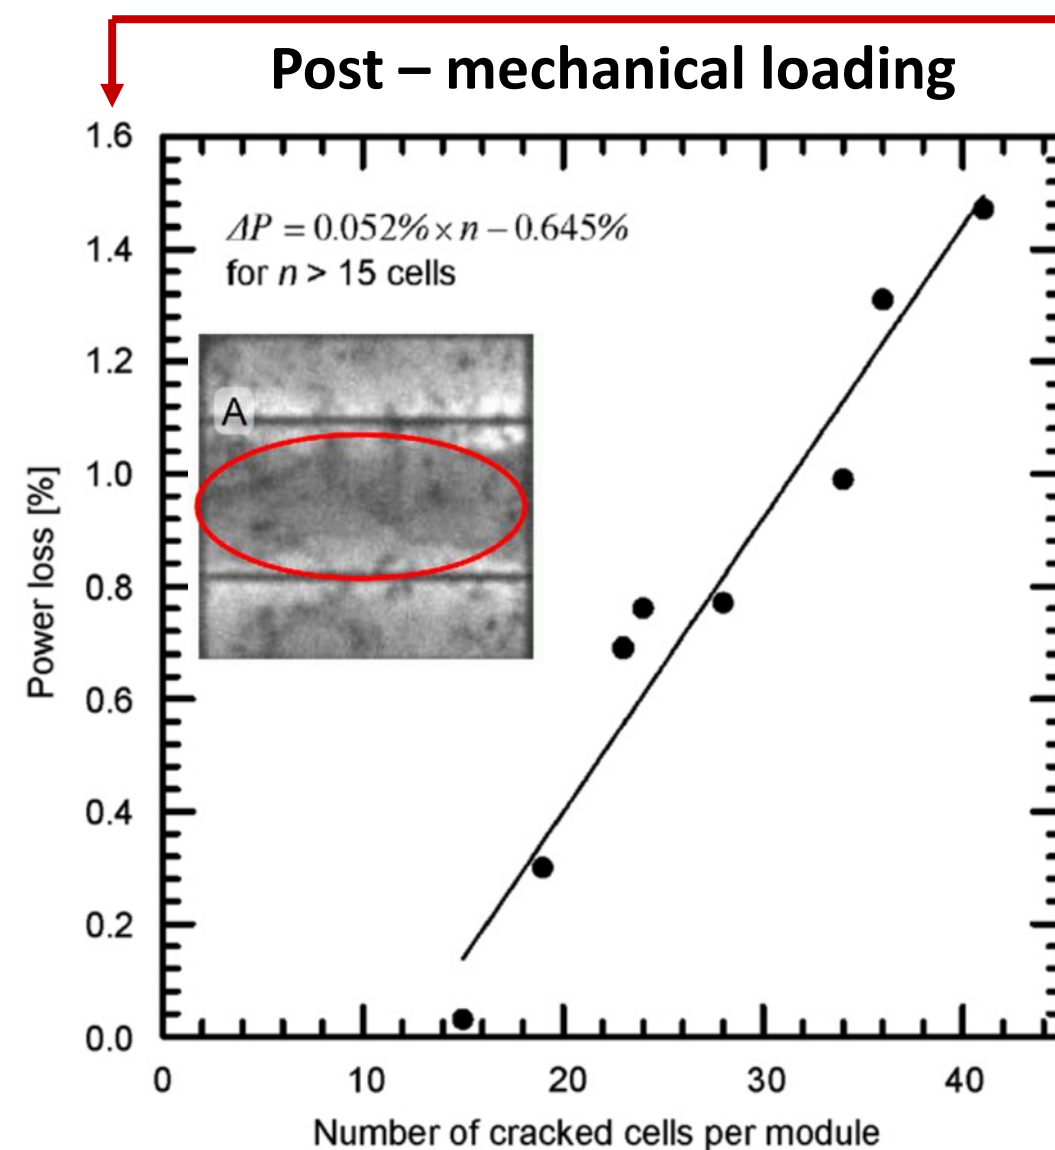
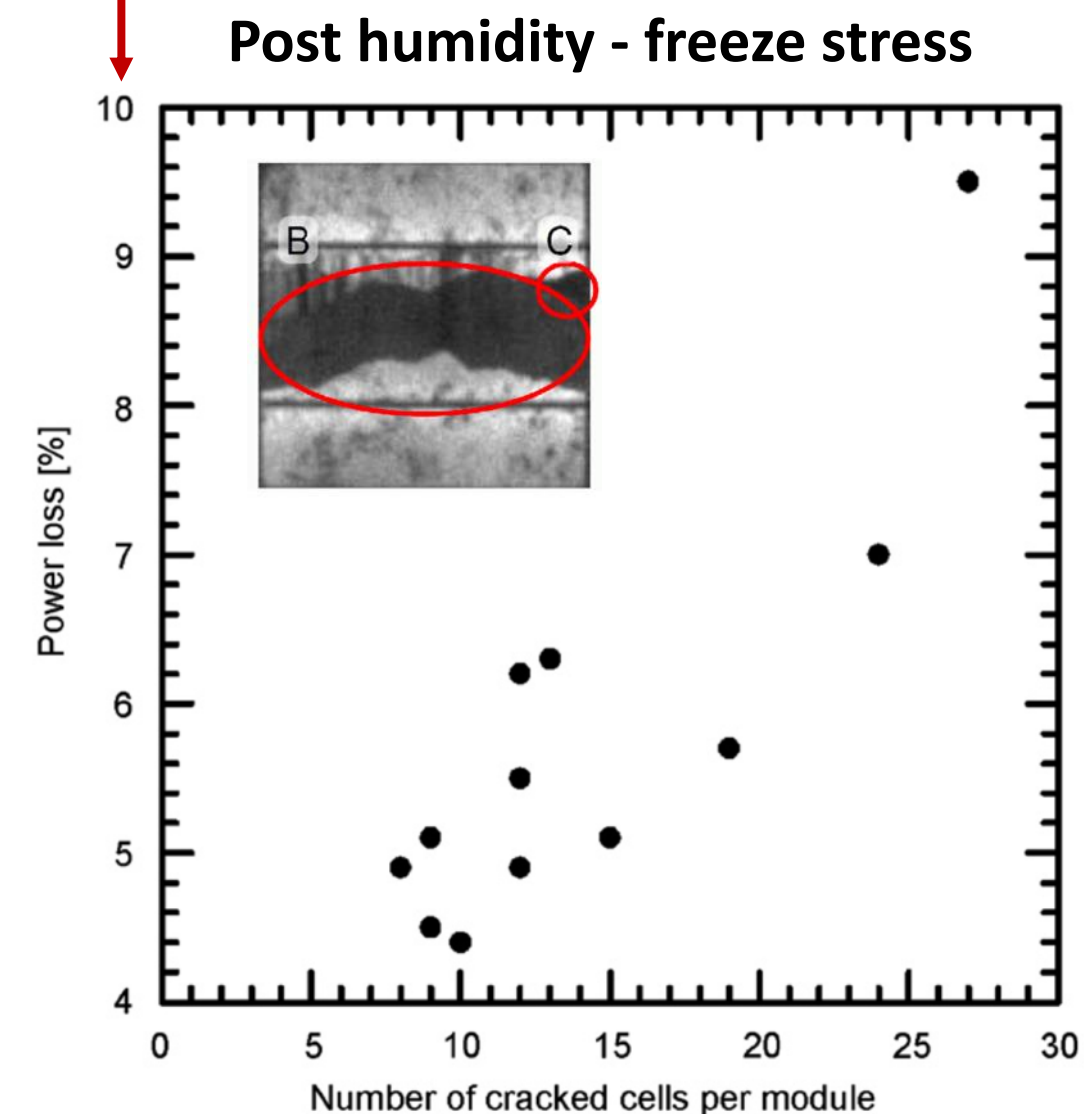
# Post Crack Generation Stress Enhance the Cracks and Their Impact on Performance

- A-type cracks converted to B- and C-type with larger area after HF stress
- Leading to significant powerloss enhancement after HF stress

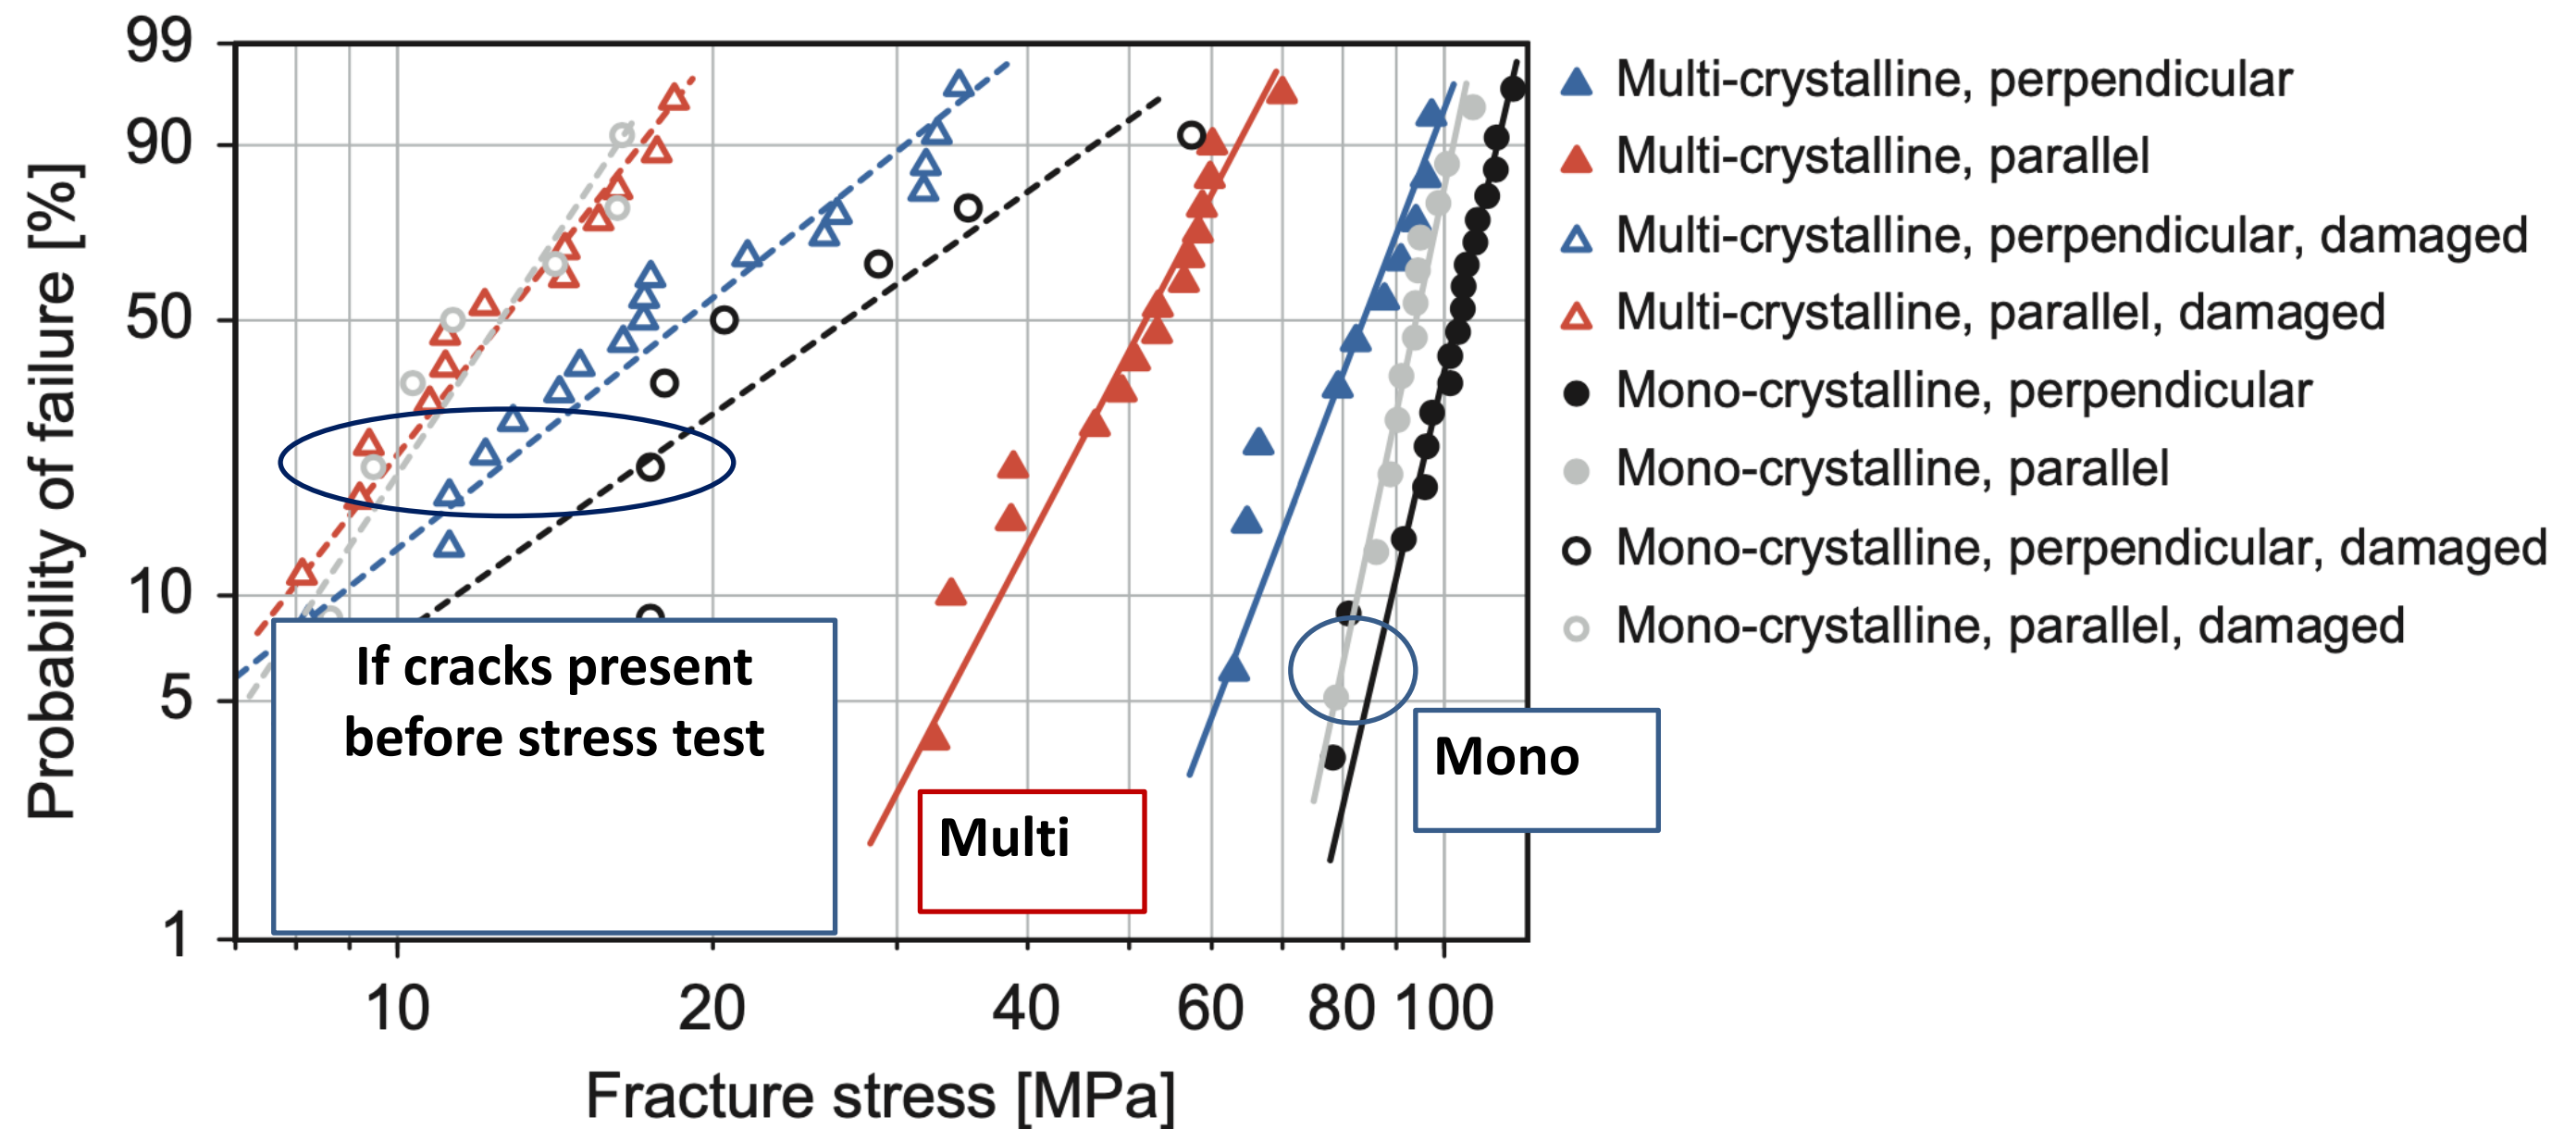
# Cracks robustness of Mono and Multi Silicon Modules
