Waterproofed: new cable testing, standard for FPV

Cable reliability considerations and electrical issues in Floating Solar – Experiences from 5 years' of operation of the FPV testbed in Singapore

Lokesh Vinayagam, Research Associate

Solar Energy Research Institute of Singapore (SERIS), National University of Singapore (NUS)

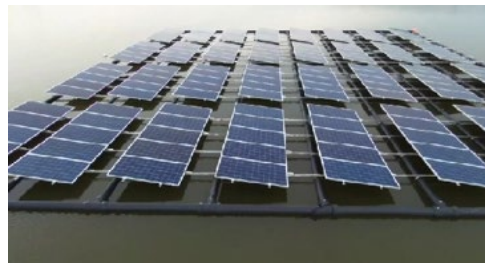
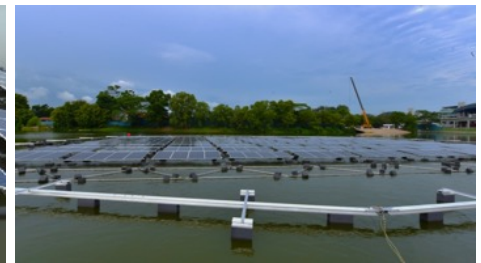
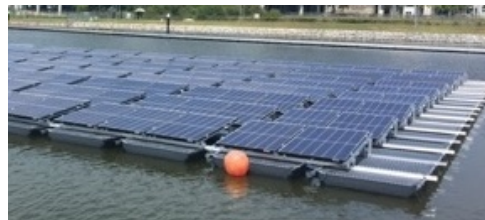
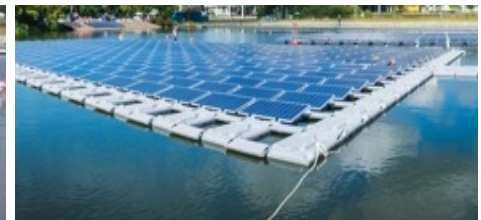
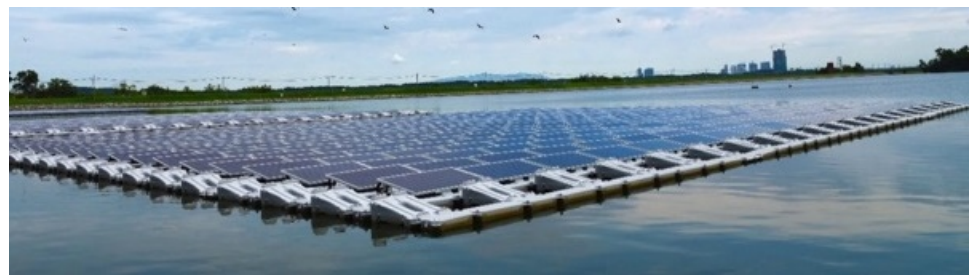
Issue 1: Cables touching water

DC module and string cables

- Low clearance from water surface as well as mismatch in module cable length compared to floats dimension
- Wave amplitudes due to wind or boat movements

- Degradation (corrosion) of DC cables and module connectors
- Possible leakage and low insulation resistance.

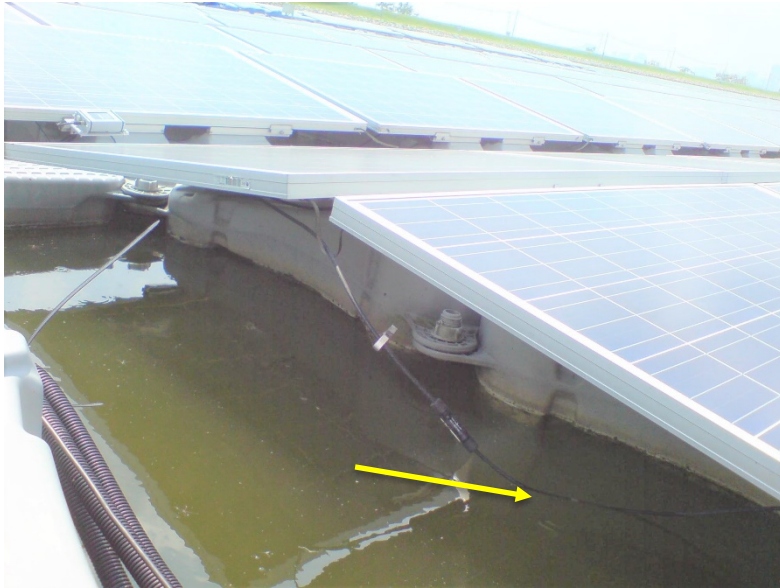
Issue 1: Cables touching water

❑ Insulation degradation is observed.

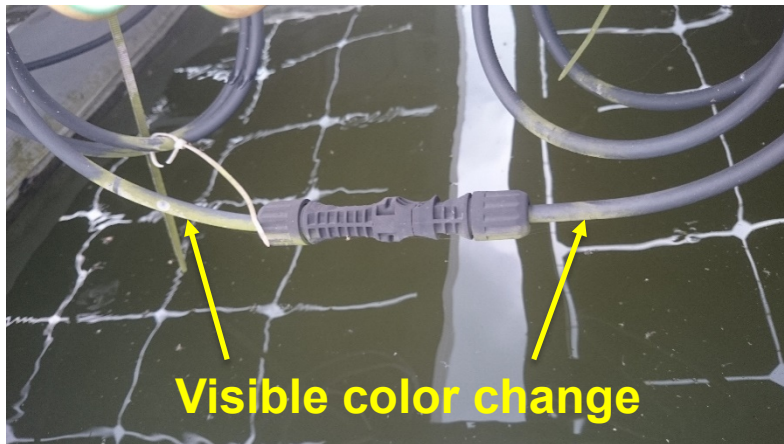
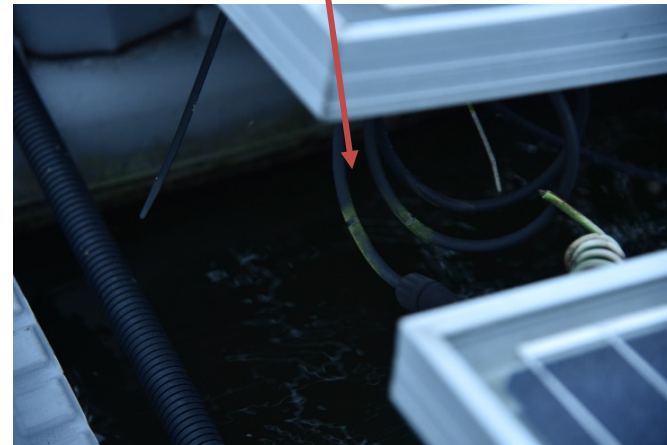
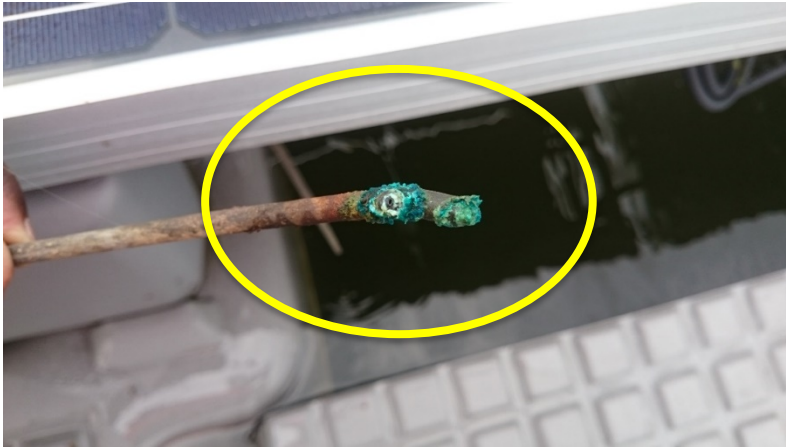
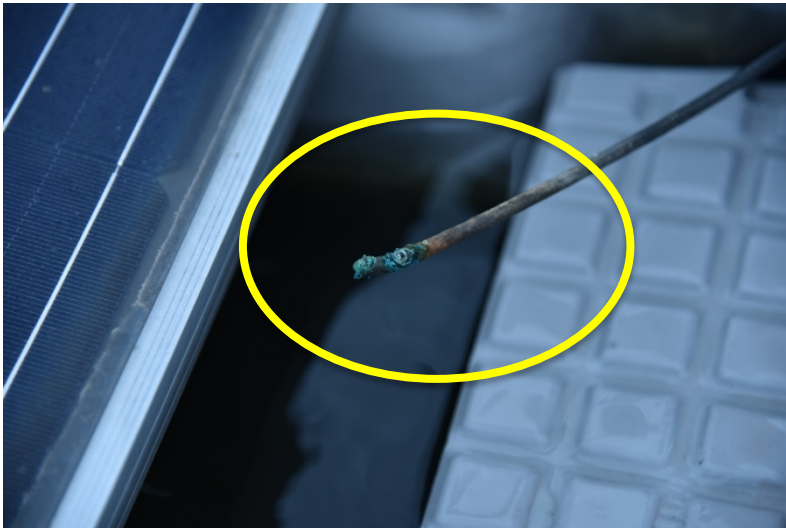
Degraded and damaged cables

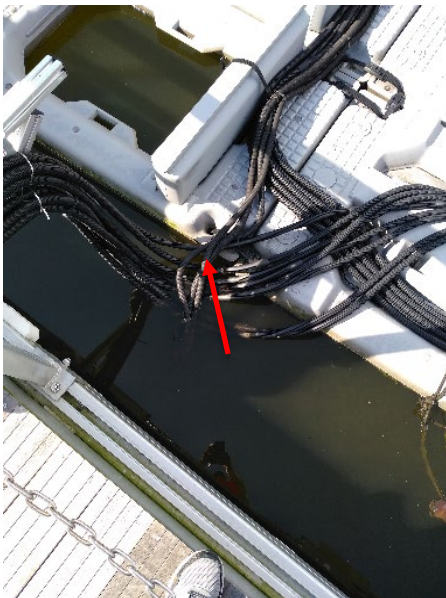
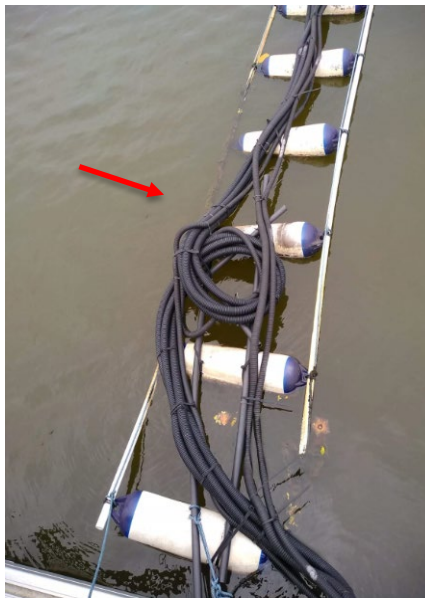
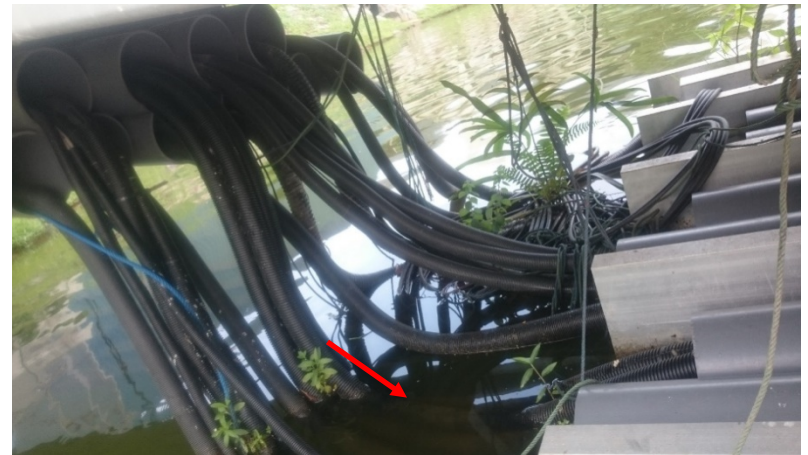
Issue 2: Cable management

Cabling from FPV islands to shore/inverters often submerged in water

- ❑ Causes: Slackness needed to accommodate platform movement
- ❑ Consequences: Risk of electrical safety, arcing, fire hazard and leakage path to current

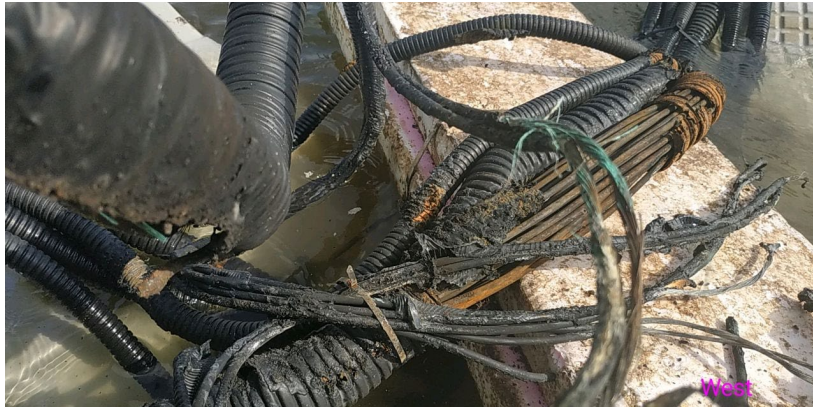
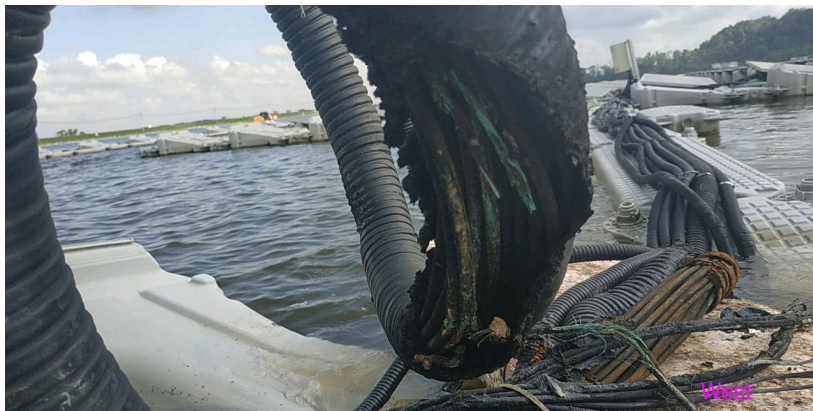
Issue 2: Cable management

- ❑ Excessive cable slackness results in cables and the cable conduits getting submerged in water intermittently.
- ❑ This results the degradation of sheath / cladding and that can further lead to the possibility of electrical leakages, arcing or a fire hazard.

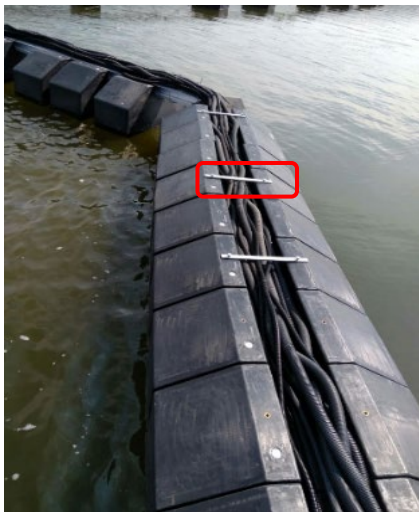
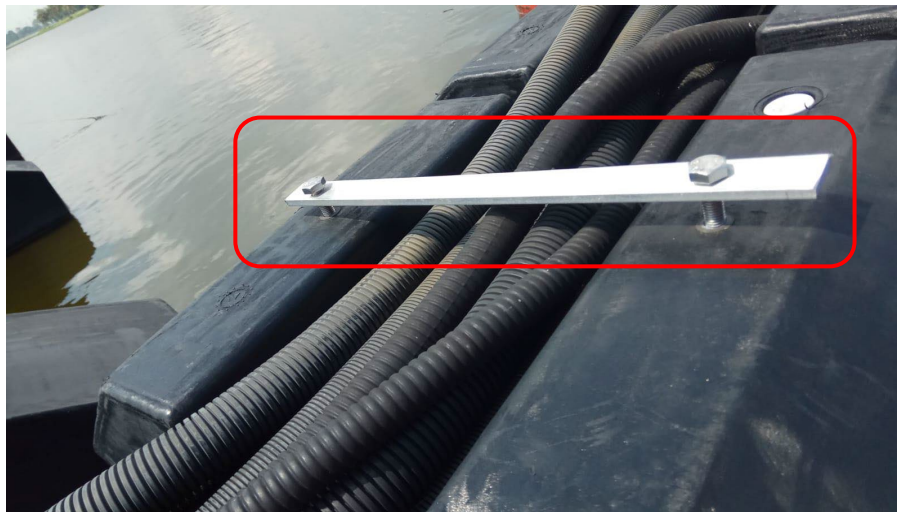
Issue 2: Cable management

Abrasion of sharp edges of the cable ties or cable fasteners (like the metal guide plate shown below) on the cables

- ❑ Causes: Lack of slackness in the cable run to accommodate for movements and inappropriate usage of cable ties / fasteners
- ❑ Consequences: Risk of electrical safety, arcing, fire hazard and leakage path to current

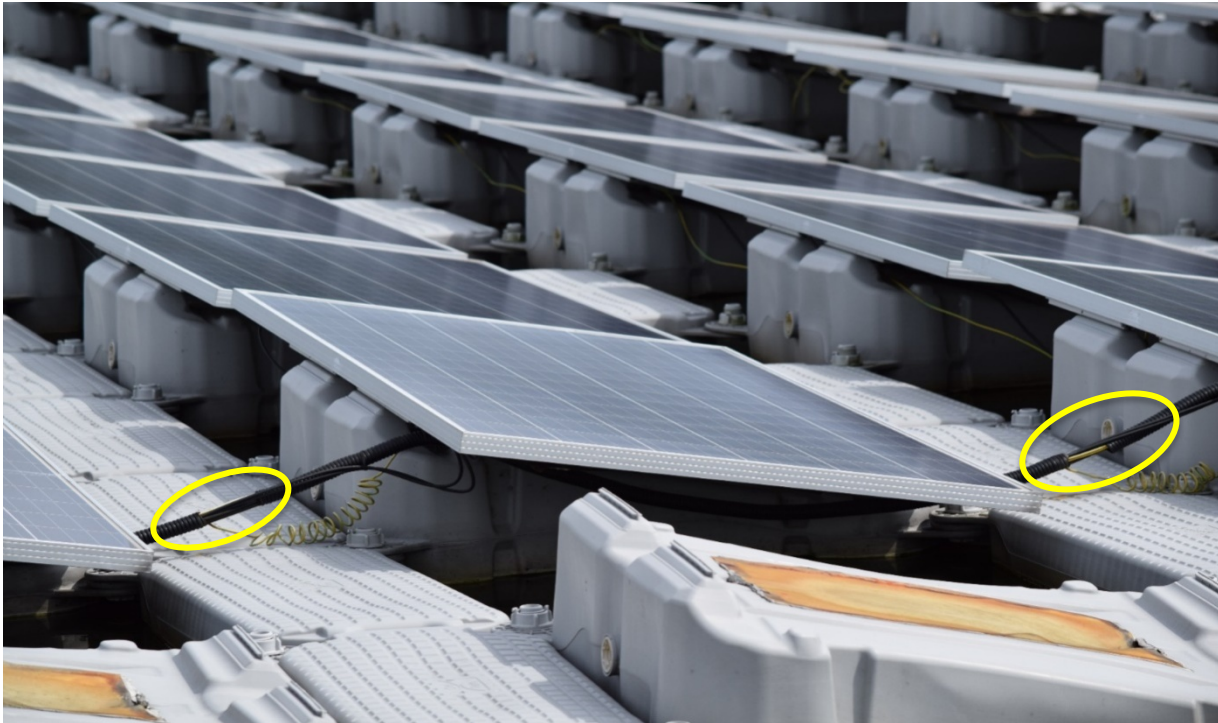
Issue 2: Cable management

- ❑ Conduit opening allows rainwater to enter

- ❑ Result: Permanent exposure to water, possible cable degradation

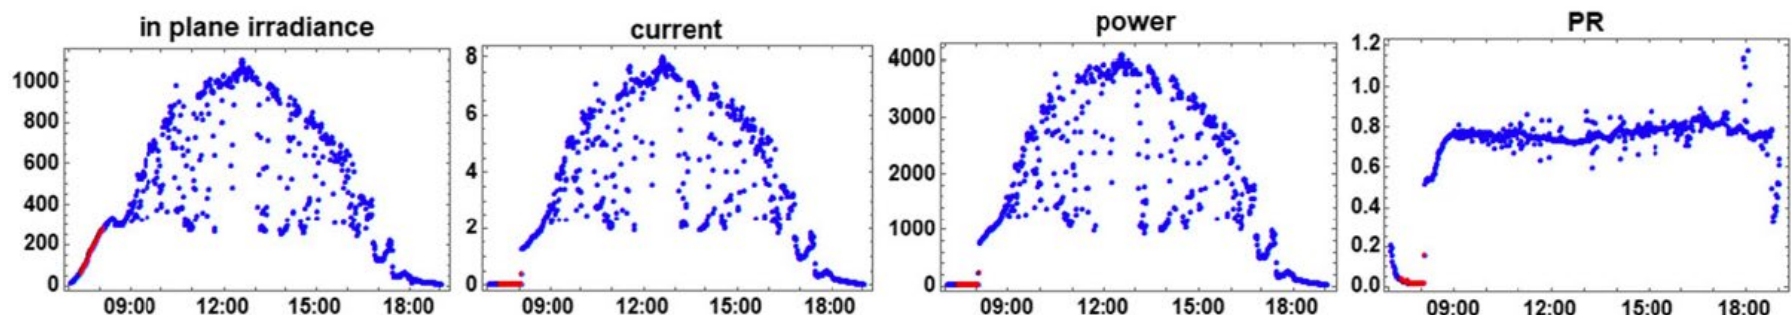
Issue 3: Insulation Resistance

❑ Insulation faults observed for some systems

- The insulation resistance (R_{iso}) is low for some floating PV strings.
- Inverters measure R_{iso} . When R_{iso} does not meet the preset threshold, inverters do not start.
- Result: inverters start late (till the R_{iso} limit is passed) and thus loss of energy.

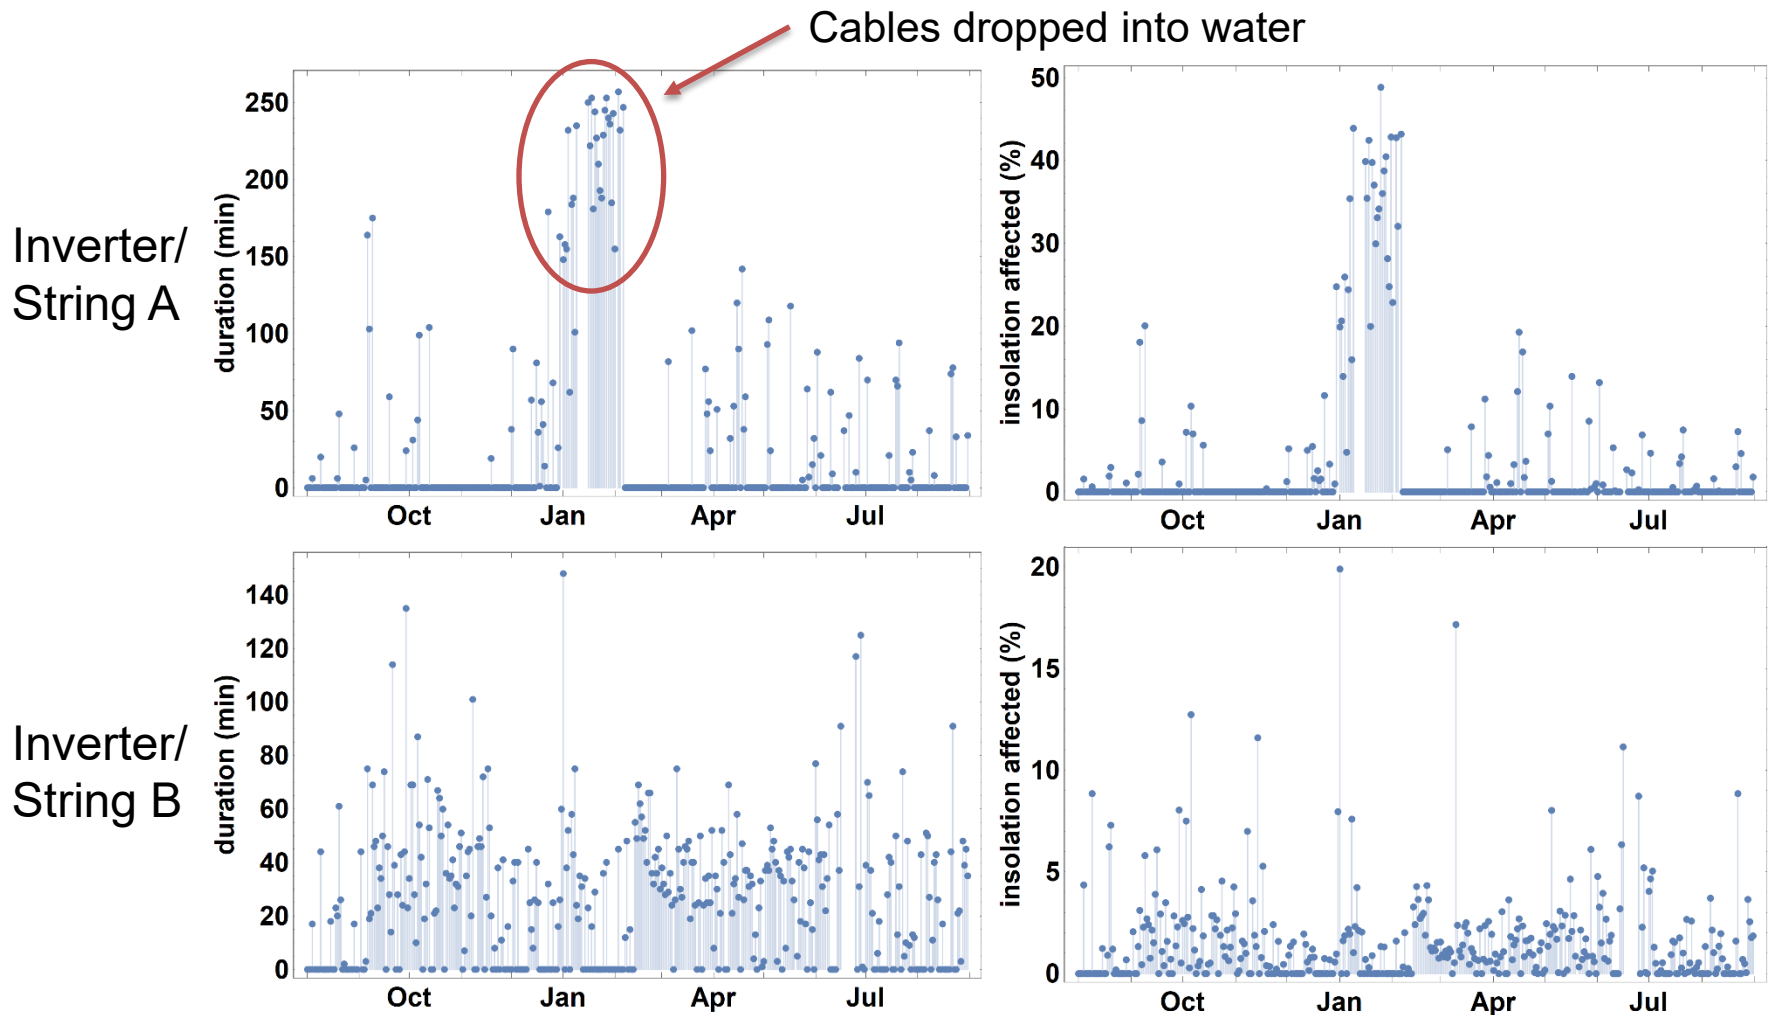
Issue 3: Insulation Resistance

Reduced insulation resistance can lead to power loss

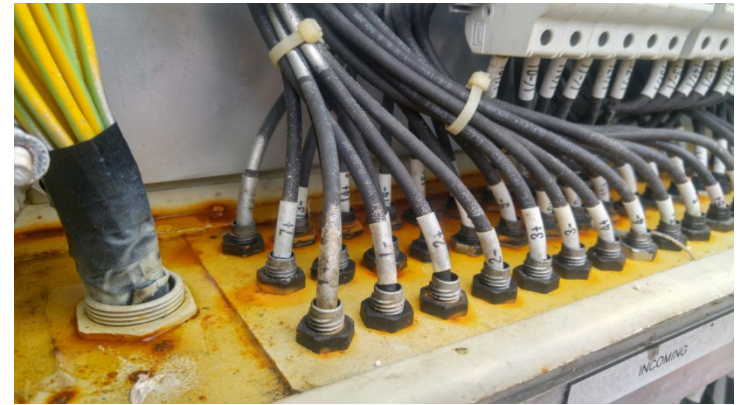
Water ingress and mild corrosion

- ❑ Electrical boxes and cabinets are generally exposed to rain and spill water
- ❑ Constant movement
- ❑ Needs high ratings for Ingress protection (IP65 or above)
- ❑ Keep insects out as well

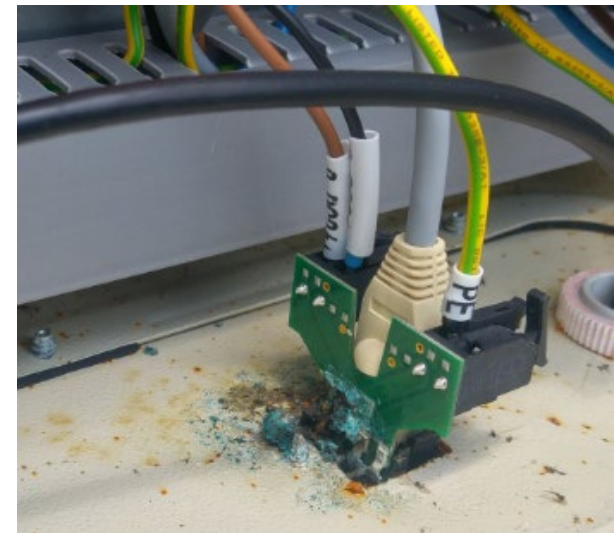
Water leakage through cable gland

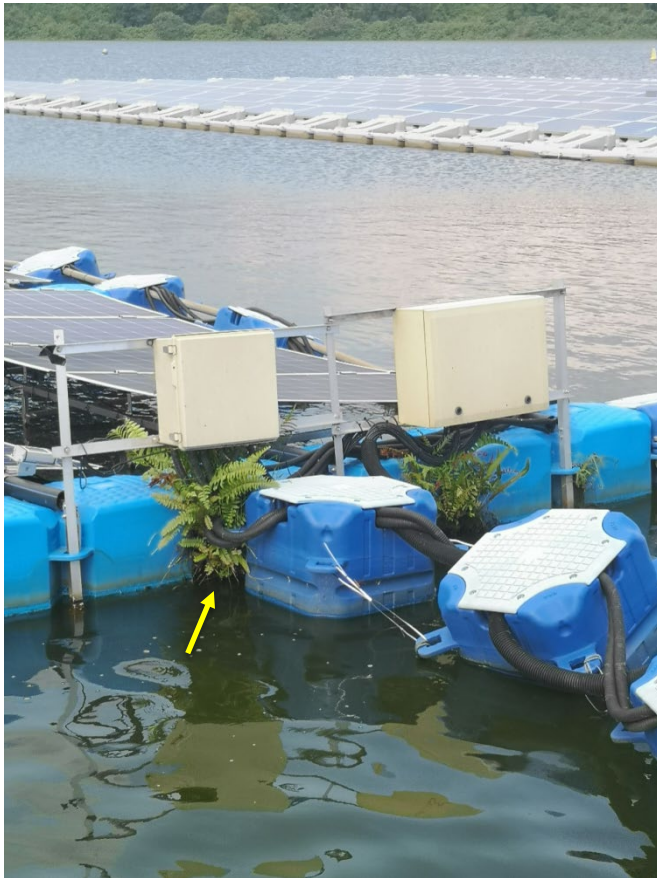
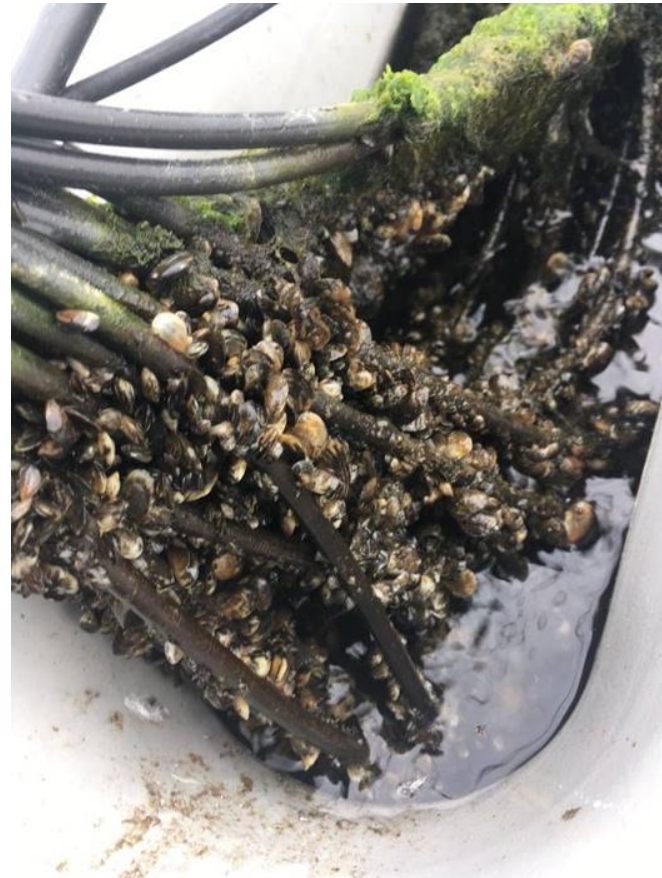
Issue 5: Vegetation & Biofouling

Leading to additional stress on the cables
