# How aerial data directs O&M crews to the right place, right time

# How Aerial Data Directs O&M Crews to the Right Place, Right Time

# North American Solar Scan

## Simple Solar Asset Ratings Create Instant Visibility for Prioritization of O&M

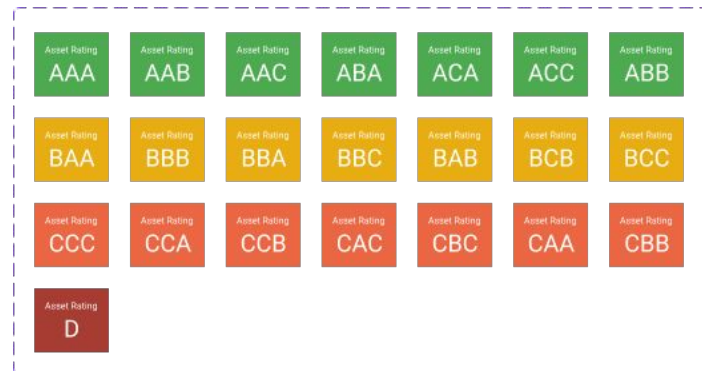
Through thermal imaging & anomaly detection, each asset has a quantitative rating based on a three letter ranking method, each letter representing an aspect of the plant.

**Equipment rating:** Anomalies per megawatt peak (DC)

**Temperature rating:** Highest temperature delta within a given asset

**Operating rating:** Estimated percentage DC losses

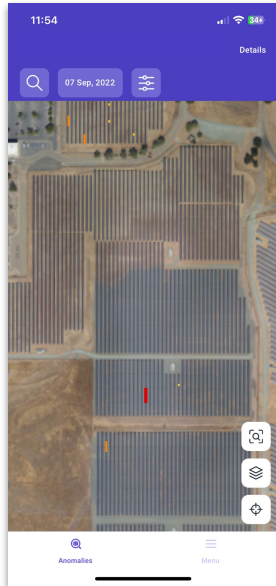
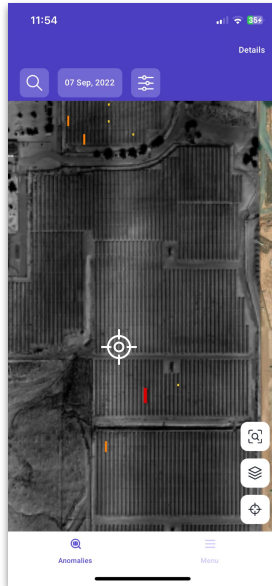
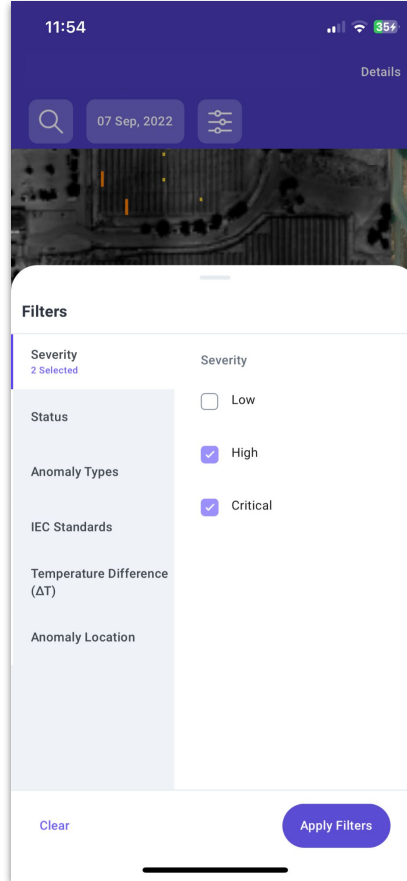
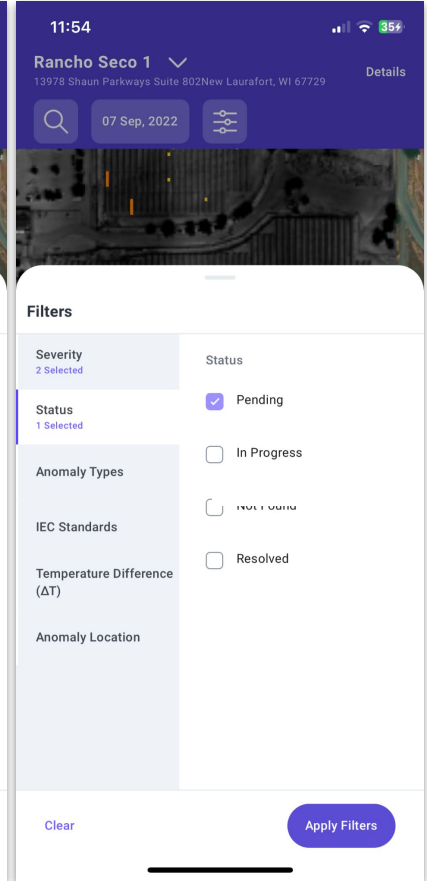
Simplified mobile app makes it easy to navigate the sea of glass from your smartphone

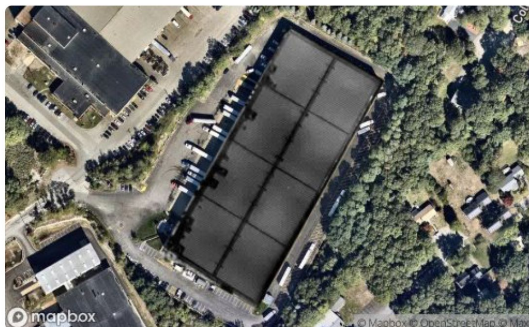
# Rooftop Mount NASS Report

Age: 8yr 6mo | Module: crystalline | Temperature: 17.6 | Humidity: 47.0 | Avg. Radiance: 854W/m<sup>2</sup>

Asset Rating  
**ADA**

This report was generated from a site flyover on 29 May 2023 2PM. The site began commercial operation on 30 Dec 2014 and used crystalline modules and central inverters. The site owner as of today was registered as American Capital Energy.

Ratings	Operating	Temperature (may be indicative of safety)		Equipment
		Roof mounted &/or capacity is < 2MWdc	Ground mounted &/or capacity ≥ 2MWdc	
Definition	DC capacity (MWdc reported) - Estimated DC loss due to observed hot cells / DC Capacity	Highest delta temperature of the hot cells present (ΔT = THOTSPOT - TNORMAL)	Delta temperature of the hot cells present (ΔT = THOTSPOT - TNORMAL)	Anomalies/MWp
A	If ratio is ≥ 99.5%	If ΔTHighest is < 10°C	If ΔT is 10°C for less than 10 hot cells / MW	0 - 19.9
B	If ratio is ≥ 97.5%	If ΔTHighest is ≥ 10°C and < 15°C	If ΔT is 5°C-10°C for 10-30 hot cells / MW and/or ΔT is 10°C-15°C for 5 hot cells / MW	20 - 84.4
C	If ratio is ≥ 80% and < 97.5%	If ΔTHighest is ≥ 15°C and < 20°C	If ΔT is 10°C-15°C for 10-30 hot cells / MW and/or ΔT is 10°C-15°C for 5 hot cells / MW	84.5 - 148.9
D	If ratio is ≤ 79.9%	If ΔTHighest is ≥ 20°C	D if ΔT is < 20°C for more than 5 hot cells / MW and/or ΔT > 15°C for more than 10 hot cells / MW	149+

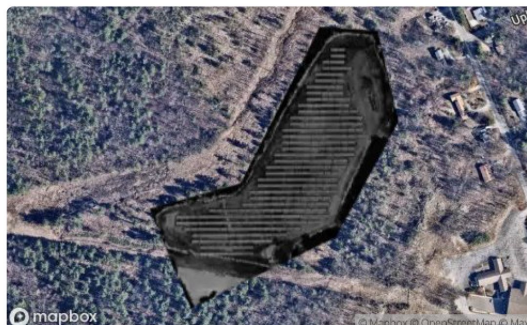
# Ground-Mount NASS Report

Age: 1yr 6mo | Module: crystalline | Temperature: 14.8 | Humidity: 51.4 | Avg. Radiance: 816W/m<sup>2</sup>

Asset Rating  
CAD

This report was generated from a site flyover on 30 May 2023 11AM. The site began commercial operation on 28 Dec 2021 and used crystalline modules and central inverters. The site owner as of today was registered as N/A.

Ratings	Operating	Temperature (may be indicative of safety)		Equipment
		Roof mounted &/or capacity is < 2MWdc	Ground mounted &/or capacity ≥ 2MWdc	
Definition	DC capacity (MWdc reported) - Estimated DC loss due to observed hot cells / DC Capacity	Highest delta temperature of the hot cells present (ΔT = THOTSPOT - TNORMAL)	Delta temperature of the hot cells present (ΔT = THOTSPOT - TNORMAL)	Anomalies/MWp
A	If ratio is ≥ 99.5%	If ΔTHighest is < 10°C	If ΔT is 10°C for less than 10 hot cells / MW	0 - 19.9
B	If ratio is ≥ 97.5%	If ΔTHighest is ≥ 10°C and < 15°C	If ΔT is 5°C-10°C for 10-30 hot cells / MW and/or ΔT is 10°C-15°C for 5 hot cells / MW	20 - 84.4
C	If ratio is ≥ 80% and < 97.5%	If ΔTHighest is ≥ 15°C and < 20°C	If ΔT is 10°C-15°C for 10-30 hot cells / MW and/or ΔT is 10°C-15°C for 5 hot cells / MW	84.5 - 148.9
D	If ratio is ≤ 79.9%	If ΔTHighest is ≥ 20°C	D if ΔT is < 20°C for more than 5 hot cells / MW and/or ΔT > 15°C for more than 10 hot cells / MW	149+
