Glass breakage – a growing phenomenon in large-scale PV

Glass Breakage

A Growing Phenomenon in Large-scale PV

Thomas Weber, Muktaparna Boruha, Redemption Agada, Jerry Pyles, Matthew Lu, Steven Xuereb; PI Berlin Tristan Erion-Lorico, Jean-Nicolas Jaubert; PVEL Susann Radicke, Dominique Brun, kiwa GmbH

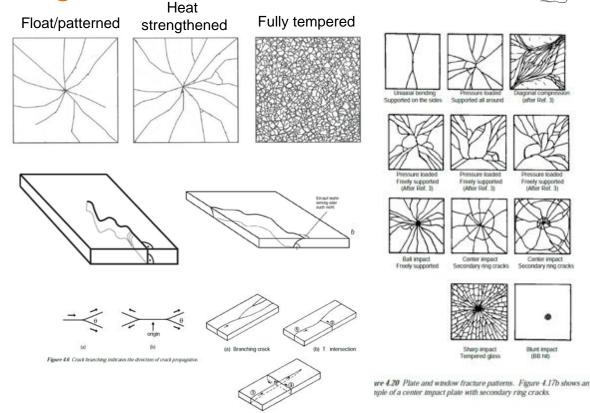
Secondary ring cracks Secondary ring cracks

Supported on the sides Supported all around

What can be distinguished / What does it look like?

- Type of glass (heat strengthening process)
- Front or rear side
- Clear impact (edge or plane induced)
- Thermal or mechanical induced
- Origination with clamps or junction box

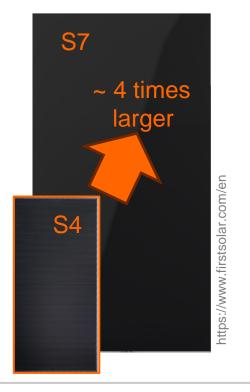
Thinner frames and larger module areas while also shortening the mounting rail

- G/BS -> G/G
- The modules have almost doubled in size compared to 10 years ago
- Half-cut cell-modules:3 holes in the rear glass

→ Relying on the glass to bear a significant portion of the load

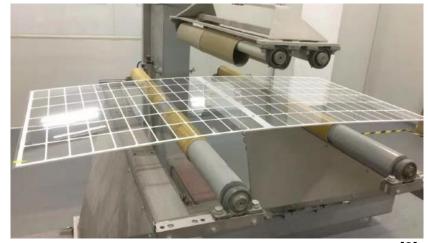
- Missing specification and quality control
 - No PV specific tests exists; only in the construction industry *
- Current safety factors do not provide enough design margin for additional stresses
- Minimum test loads of 2400 Pa are often not met
 - Henry Hieslmair, DNV: "The module has become a load-bearing element" but is a rather flimsy material that breaks more easily [6]
 - Daniel Chang, RETC: "Test for inhomogeneous loads missing" [8]

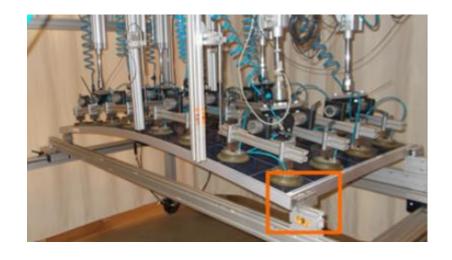
- SML test (UL2703/IEC 61215:2021 within module type qualification) relies on only one module [4] and is provided as evidence of 'compatibility' between module and mounting
- Retesting guideline and certificates ignored: often the testing is done only on a few clamps/module combinations and not for every combination of clamp and tracker
- Alf Oschatz, SBP Sonne: "The module in the simulation is only considered as load element but no load-bearing element"; "usability issues are missing [...tracker, Resonance] the module is the weakest part in the chain" [7]

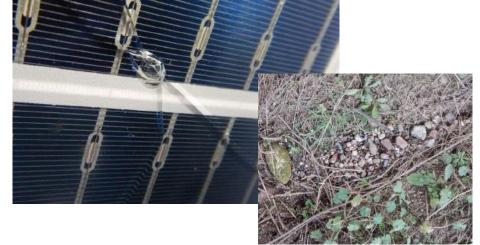
Location	Poland		
Project size	20 MW		
Date	2023		
Issue / Services	 On-site inspection: Visual, RCA Reporting Issue: rear glass breakage < 1% wrong clamp position, deviating torques impact from pebbles during mowing

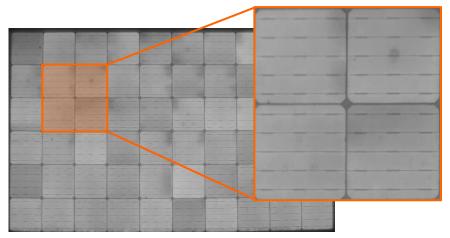
Location France

On-site inspection: IR, Visual and EL

- Expert Opinion and Claim support
- Issue: Soldering defect on BB
