Optimizing and Validating UVID Tests for TOPCon PV Modules

Dr. Paul Gebhardt
Fraunhofer Institute for Solar Energy Systems ISE
pv magazine Week Europe, December 3, 2025, online

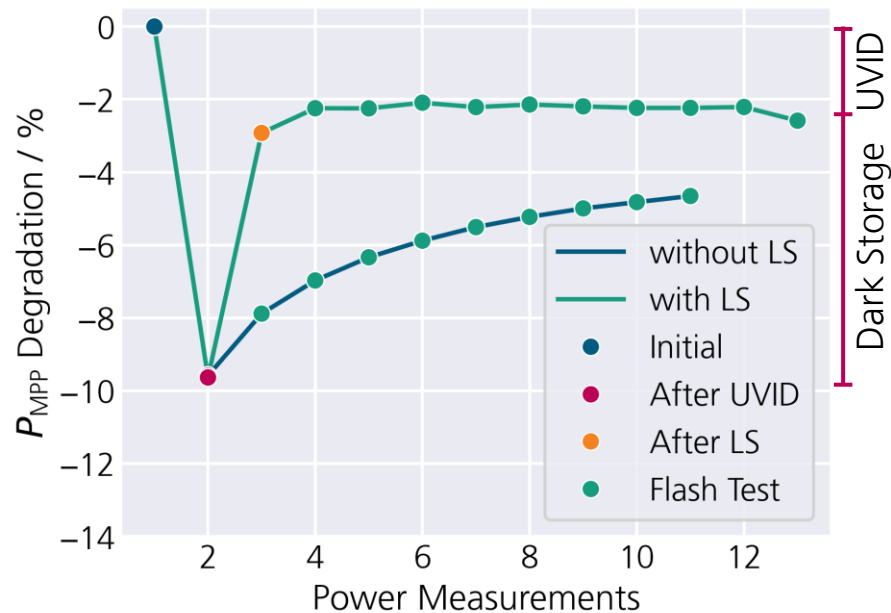
Wording: "Stabilization" = measurement is not affected by metastability

- Degradation in "Dark Storage" not only when completely dark
- Lightsoaking @1000 W/m² very effective
 - UV portion mainly responsible [2]

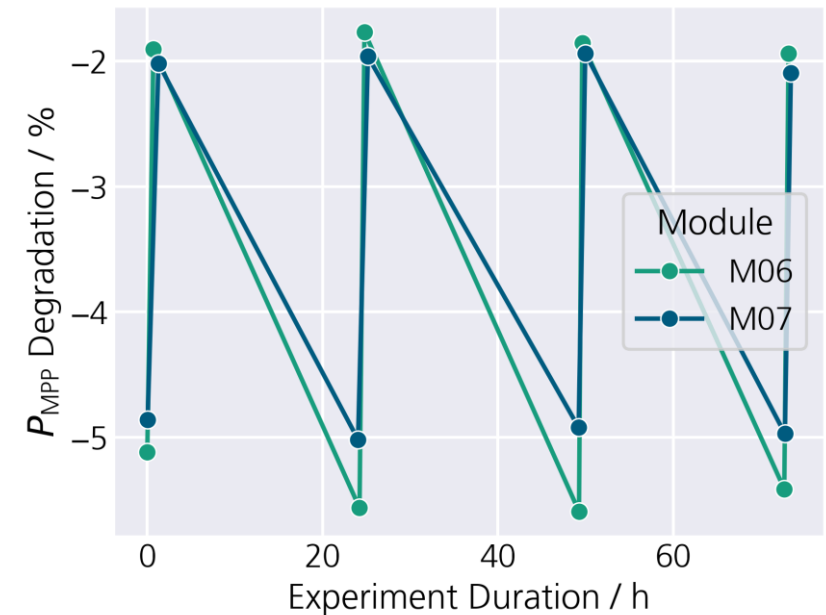
- Degradation in "Dark Storage" not only when completely dark
- Lightsoaking @1000 W/m² very effective
 - UV portion mainly responsible [2]

Reversible behavior after UVID

- Degradation by dark storage
- Stabilization by light soaking

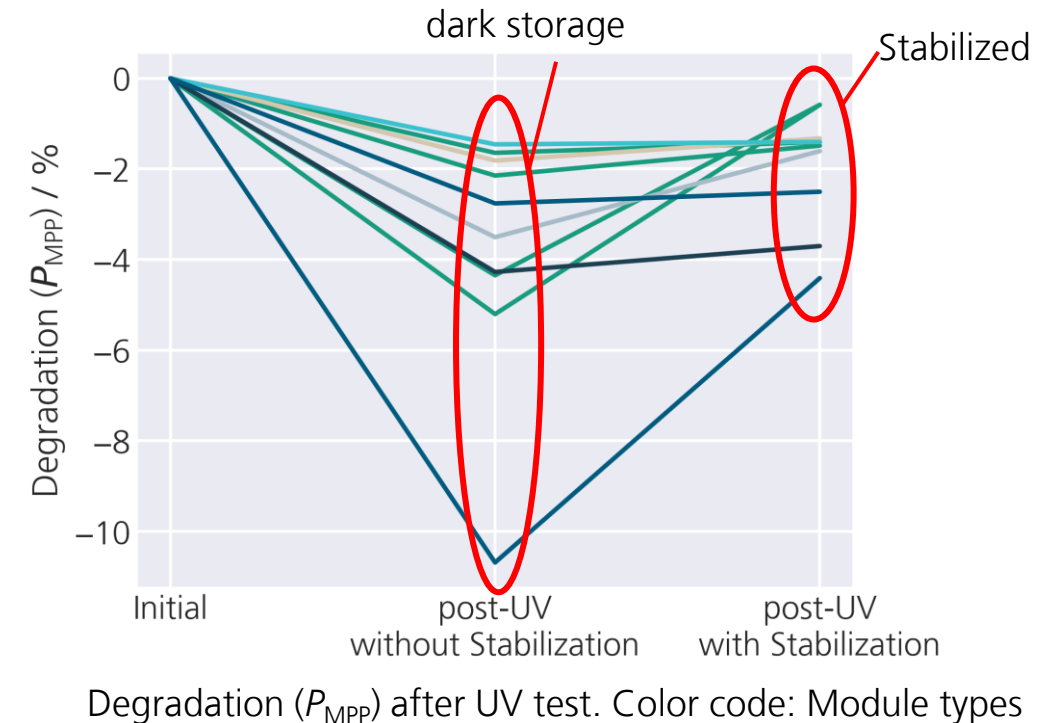
Comparison of UVID test methods

- Test according to standard (i.e. without stabilization) leads to exaggerated degradation
- After stabilization: still significant UVID observed for some module types

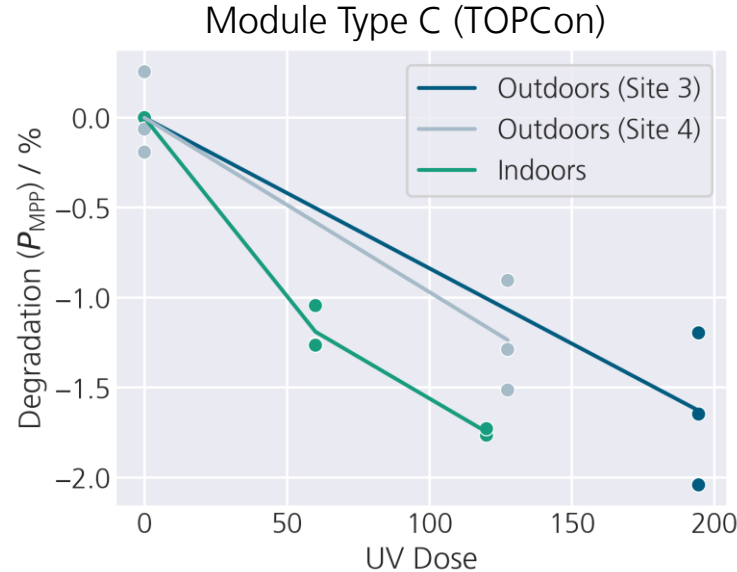
Outdoor Aging (Type C)

- Power measurements in lab after ~2 years
- Mean of spare modules as reference

UV Aging in the Lab (Type C)

- According to IEC 61215-2, MQT10
- Light stabilization after UV aging

- Modules with lab-induced UVID also degrade in the field
- TOPCon: *Consistent* trend of slight overestimation of UVID by lab tests

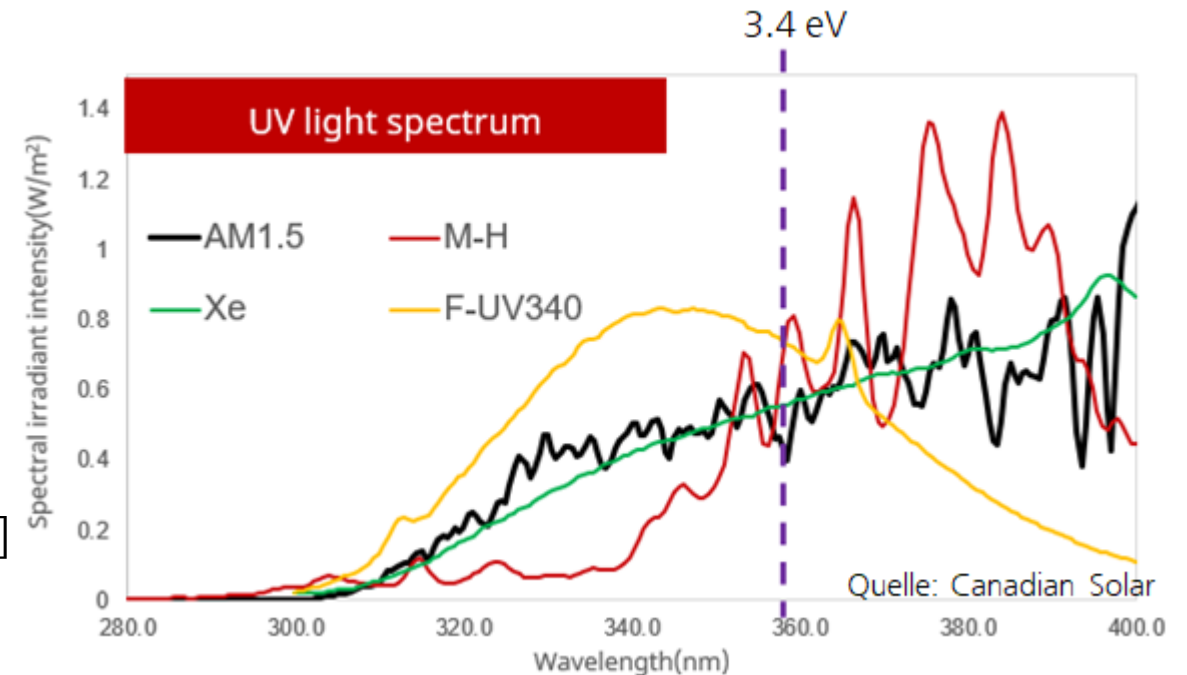
- Initiated by cleavage of Si-H bonds (3.4 eV) [1]
- UVB light causes stronger UV degradation than UVA [2]
- Considering only light below 3.4 eV in calculation of UV dose results in better correlation between indoor and outdoor

Normalized spectra of different artificial light sources compared with AM1.5 sun spectrum
