Sept 20 2018

# Field Evaluation of Backsheet Quality

Dr. Hong-Jie Hu

DuPont Photovoltaic Solutions

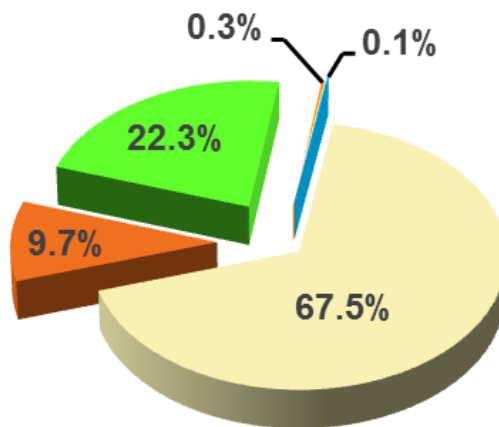
**Roof mounted  
19 MW**

## Overall Higher defect rates for roof vs ground installations

- Backsheet defects are > 2.5X higher on roof systems
- Cell defects are similar for Roof and Ground

## Differences are likely due to higher temperatures for roof systems

- Roof Systems are typically 15 °C higher than Ground Mounted<sup>1</sup>
- This trend with temperature is similar to the effect seen in climates

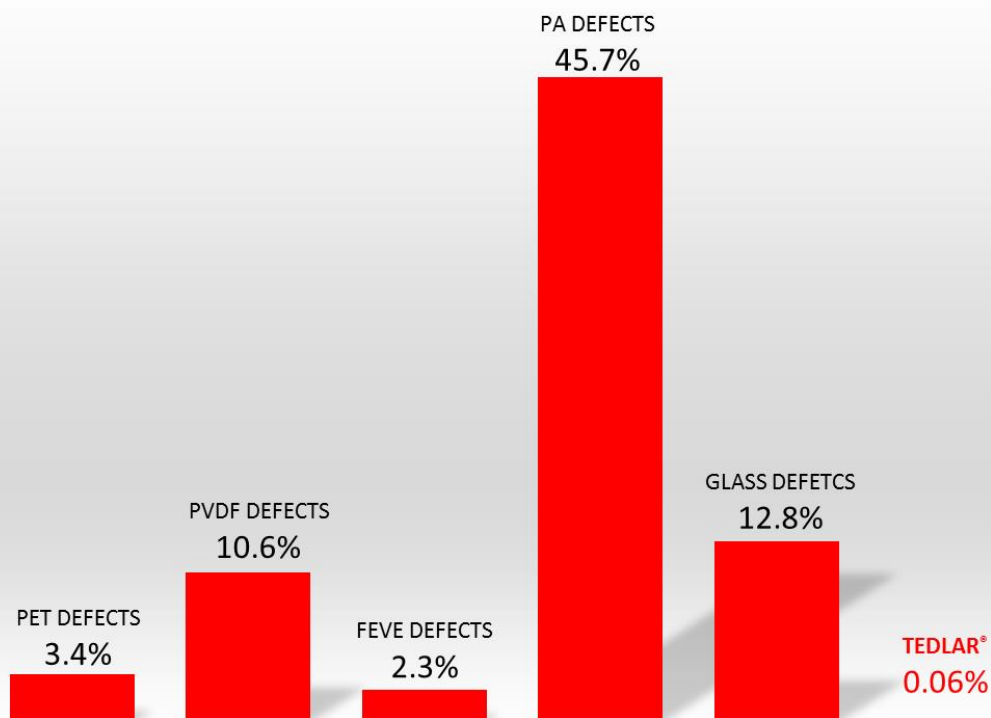
**Backsheet defects increased by 27% vs 2016 Analysis**

- Polyamide increased by 18%
- PVDF increased by 51%
- Glass / Glass starting to show up
- Tedlar rate unchanged

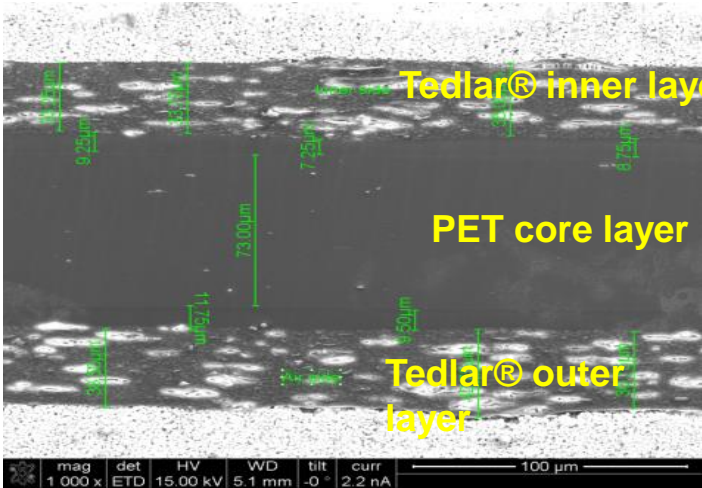
Low Tedlar® thickness reduction in both air side and inner side Tedlar® film (0.22µm/year)

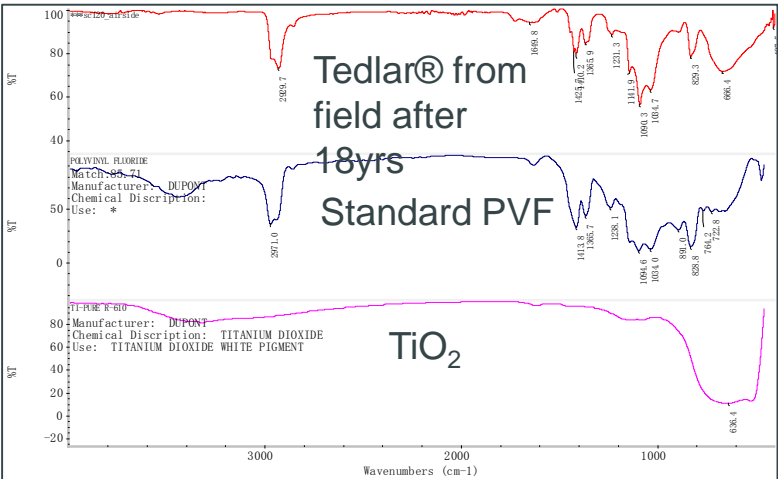
Tedlar® film shows no degradation after 18yrs field service

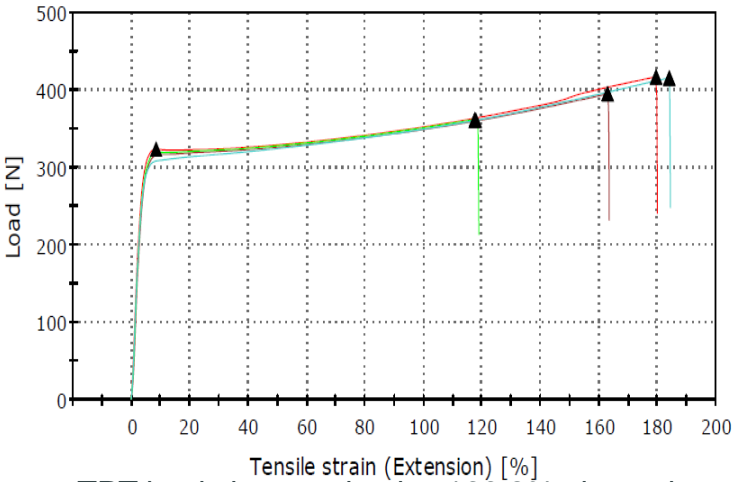
TPT backsheet maintains 160.8% elongation and 92.1 Mpa tensile strength

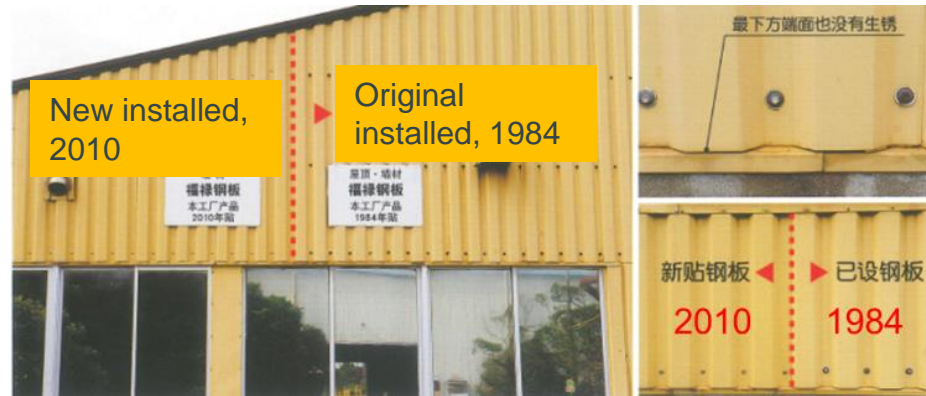
- Industrial plants and public buildings, mainly use metal-color steel tile. This steel is easily **corroded**.
- Once the rooftop is corroded/damaged, there is a huge O&M cost to repair the rooftop or change the solar panels. The cost will **strongly impact the lifetime and LCOE of the solar farm.**
