# Backsheet cracking – a global phenomenon

# PROBLEM OF BACKSHEET CRACKING OVERVIEW OF POSSIBLE REPAIR SOLUTIONS

Gabriele C. Eder & Yuliya Voronko - OFI, Austria

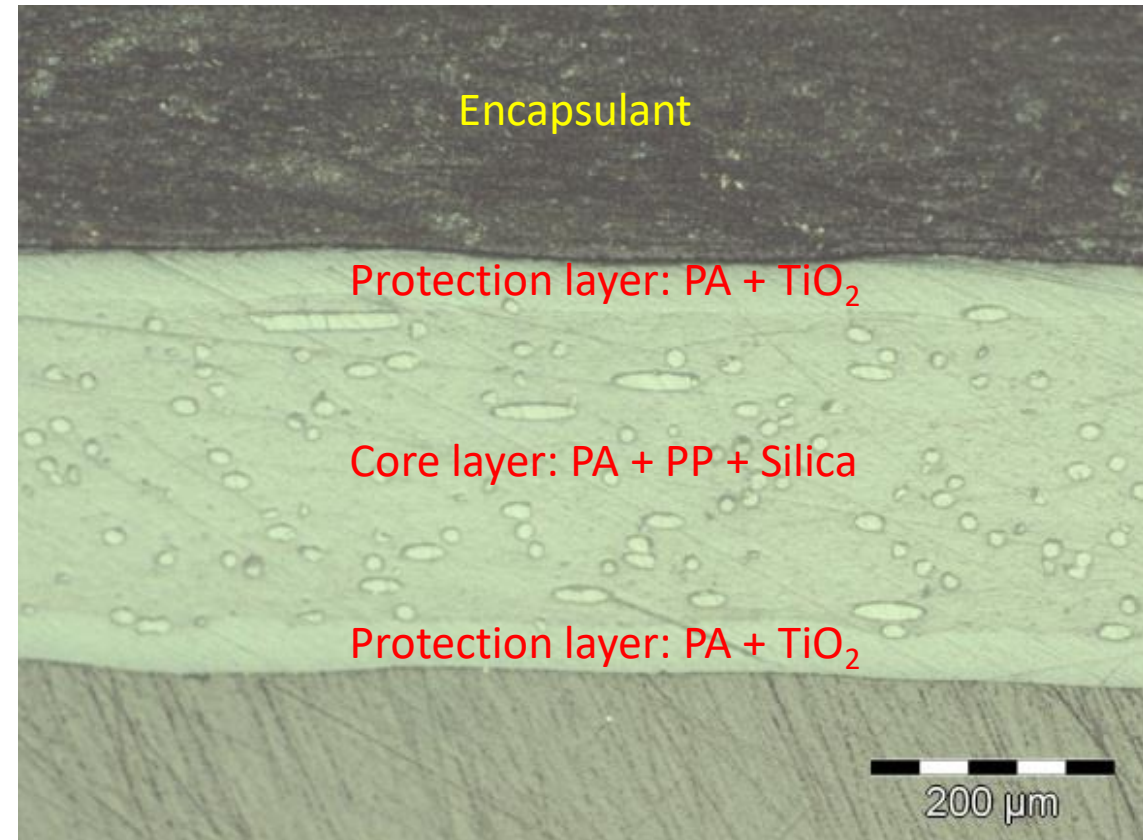
Cross-section of co-extruded  
backsheet

Polyamide-Backsheet:

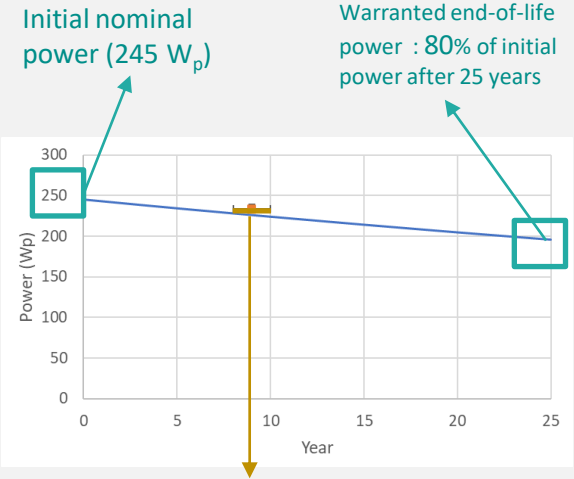
Module 6 cells cracked due to impact during transport,  
significant power drop to be expected

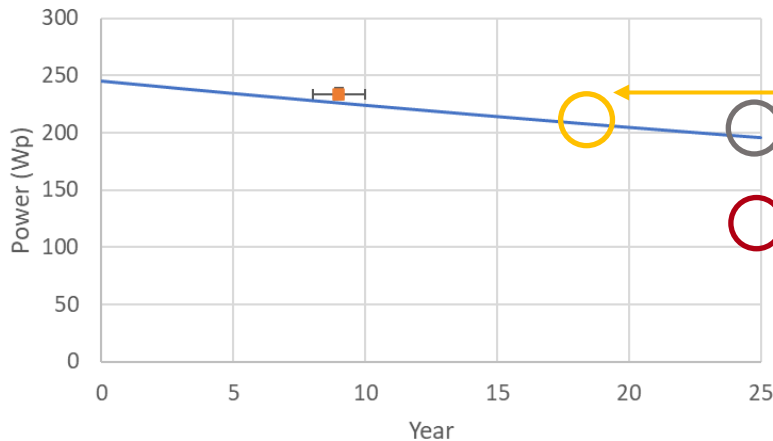
Power decrease for modules 1 and 4 after Sequence B aging falls within expected range for field-aged modules.

Module with impact damage during transportation : Severe power decrease as expected for broken cells, due to further cell cracking during thermal cycles

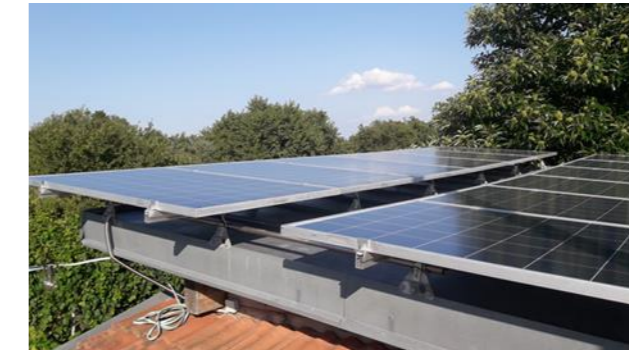
- NO electrical performance degradation, NO insulation problems under wet conditions;
- Material degradation -> **chalking and micro-cracking** of outer backsheet layer (polyamide)

Microcracks between busbars

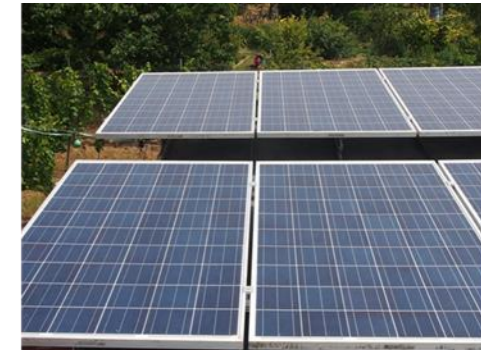
- Safety and operation problems: **insulation resistance under wet conditions broke down**; no pronounced power degradation
- material degradation -> **chalking and deep longitudinal cracks** (whole PA-backsheet affected)  
→ **repowering of PV-plant / insurance claim (safety issue)**

Longitudinal cracks along busbars

- no changes in electrical characteristics
- no inverter tripping events due to leakage current
- good adhesion and material stability of coatings; cracks filled
