# Best practice guidelines for high quality utility scale project development and module manufacturing

Quality Roundtable – Renewable Energy India Expo 2019

# Learning from 2GW Field Data

**Specifying the right PV materials to achieve maximum solar returns**

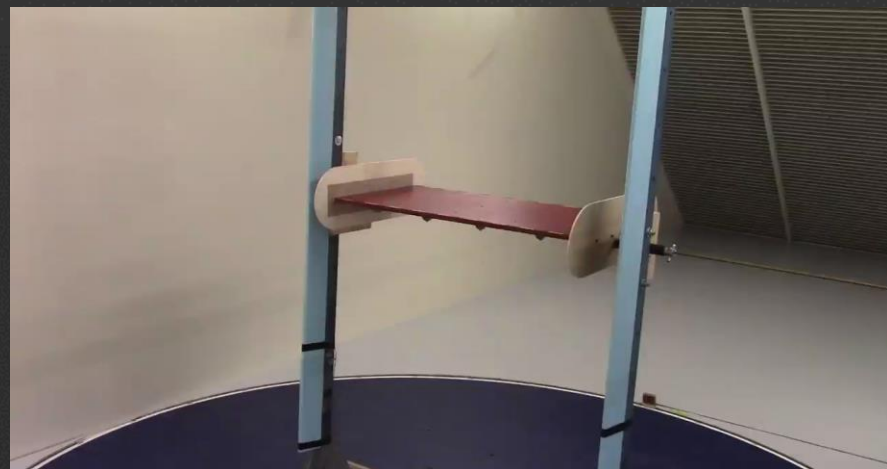
# Dynamic Analysis

- Scaled PV Trackers are placed in a wind tunnel to observe dynamic effects
- Aeroelastic Instability was observed where tracker did not stay in 0 degree position
- Vortex Shedding of wind leads to Torsional Galloping where wind loads will cause an unbalanced system, leading to the tracker rotating out of 0 degrees
- Sustained Torsional Galloping will lead to Vortex Lock-In, where the tracker rotates in an excited back and forth state
- Torsional Galloping or Vortex Lock-In can result in huge damages to a PV System

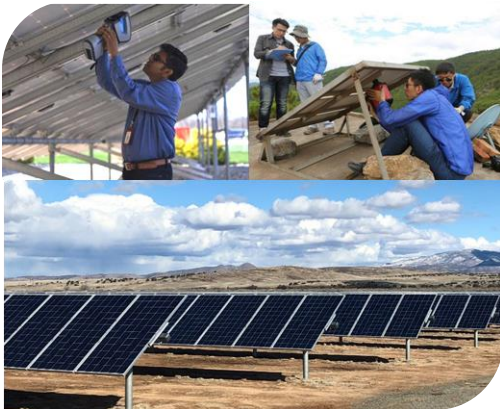
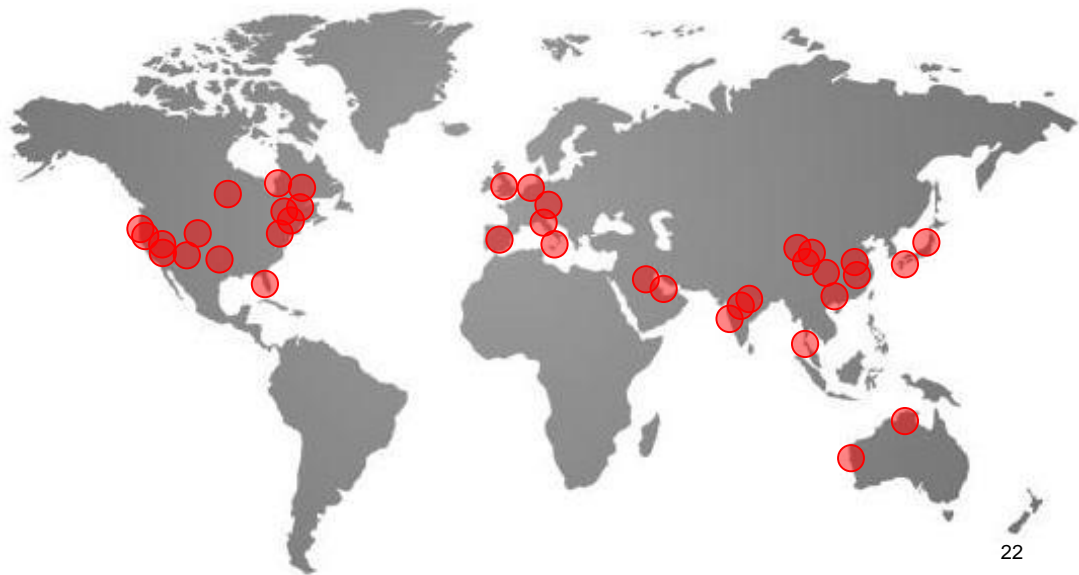
# DuPont global field reliability program

- Quantitative analysis: components, materials, age, failure mode
- Post-inspection analytical characterization
- Collaborative: field partners, developers, government labs, universities

**6.5 M**  
modules

**355**  
Installations

**1.8 GW**  
modules

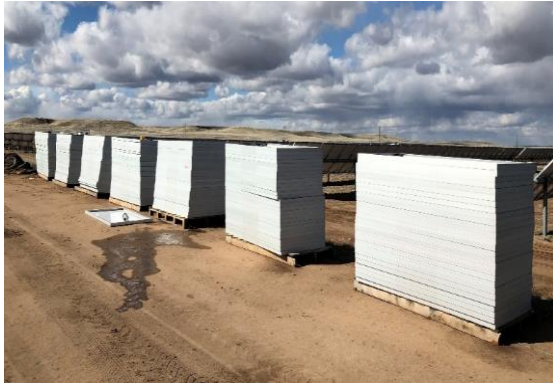
New replacement modules

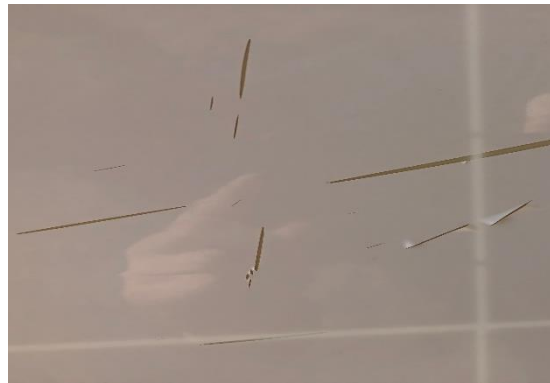
widespread cracking of backsheet outer layer

- PVDF-based backsheets **100% cracked**
- 3 MW of modules had cracked PVDF and were replaced
- Tedlar® PVF backsheets- no defects in the same installation

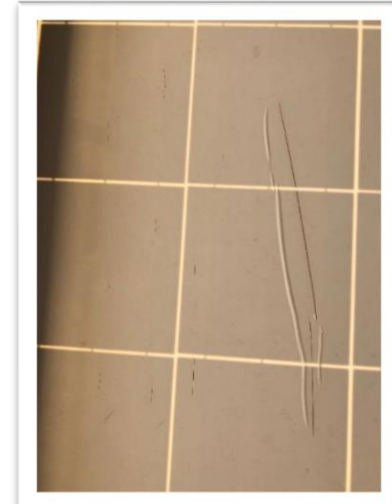
# PVDF Field Cracking- Northwest India

Initial year of operation	Nov 2011
• Service Time	7.5 years
• Backsheet	PVDF
• Climatic conditions	Hot & Arid
• Mounting configuration	Ground mounted

- Outer layer cracking & delamination of 15% of PVDF modules, 480kW affected
- Modules experiencing ground faults and inverter tripping with power loss.
- No issues with modules using Tedlar® PVF-based backsheets

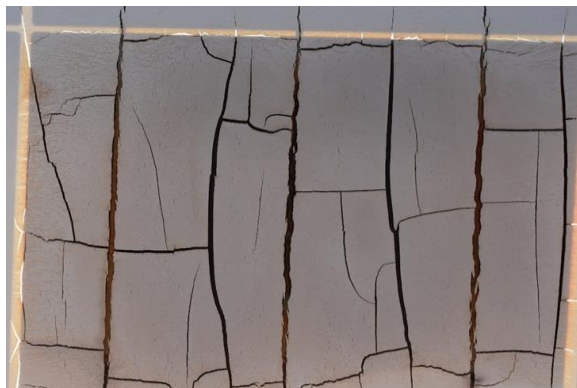
Significant large scale cracking

- 100% PA backsheets cracked along busbar ribbons and/or between cells- 12 MW total
- Cracks facilitate interconnect corrosion and present an electrical safety risk
- Ground faults cause interruptions leading to power loss
- Overheating and burning seen.

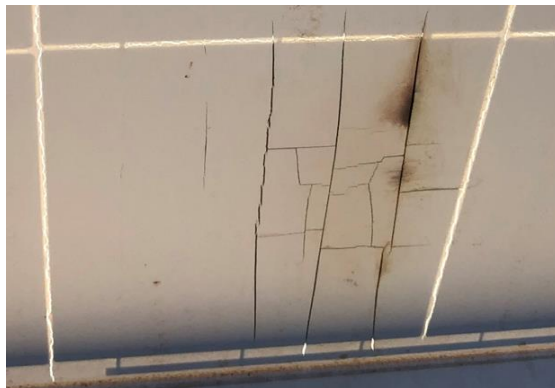
Overheating at cracks

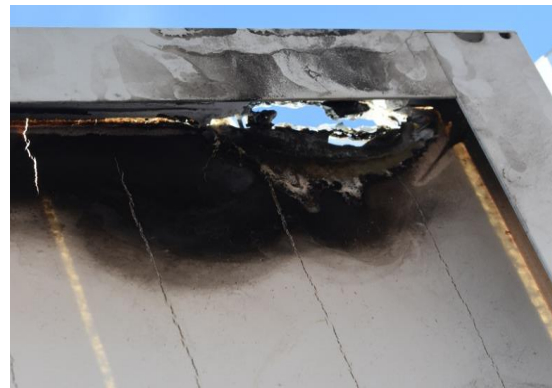
Overheating leading to burning

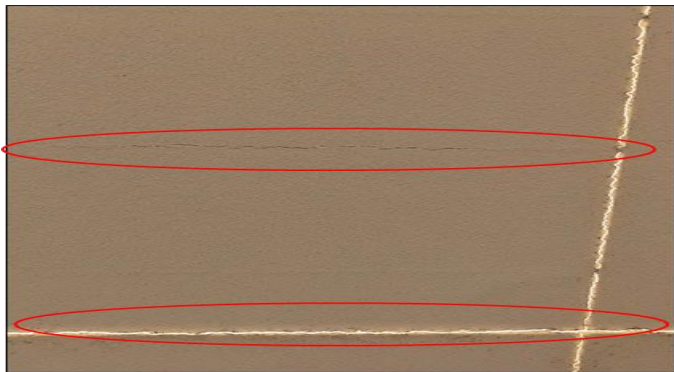
## Case 4 1.2 MW

- Initial year of operation Nov 2011
- Service Time 7.5 years
  - Backsheet Polyamide
  - Climatic conditions Hot & Arid
  - Mounting configuration Ground mounted

Cracks extend the length of the module across busbars

- Cracking of PA backsheets (100% of 1.2MW)
- Ground faults, inverter tripping
- ~4200 modules replaced between 2015 and 2016

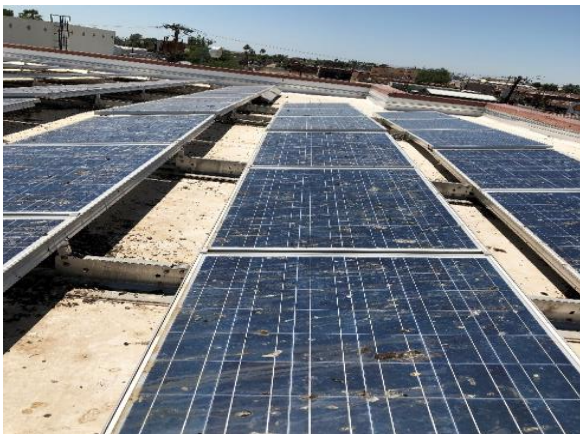
Initial year of operation	2011
• Service Time	8 years
• Backsheet:	FEVE
• Climatic conditions	Hot and Arid
• Mounting configuration	Roof mounted

Roof mounting

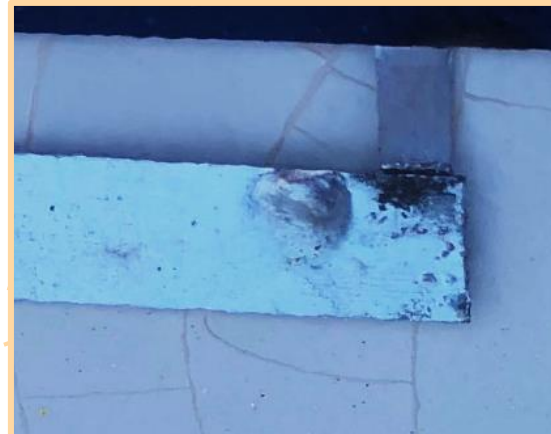
- Inner layer cracks observed in roof-mounted modules
- Roughly 5% of 2MW cracked, 100kW
- Areas could not be accessed, cracking percentage may be higher
- Crack observed leading into areas of corrosion

Cracking leading to corrosion
