HOW PVEL IS ADDRESSING CELL CRACKING: IN THE LAB AND IN THE FIELD

Tristan Erion-Lorico

PVEL

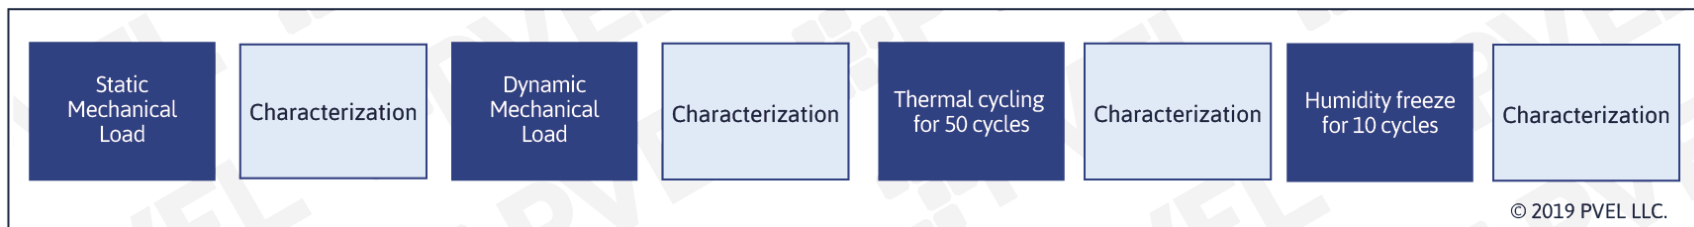
PVEL's mechanical stress sequence for cell cracking

Step 1:
Creates cell cracks in
susceptible modules

Step 2:
Articulate cracks,
opening them in
susceptible modules

Step 3:
Reduces power output in
susceptible modules

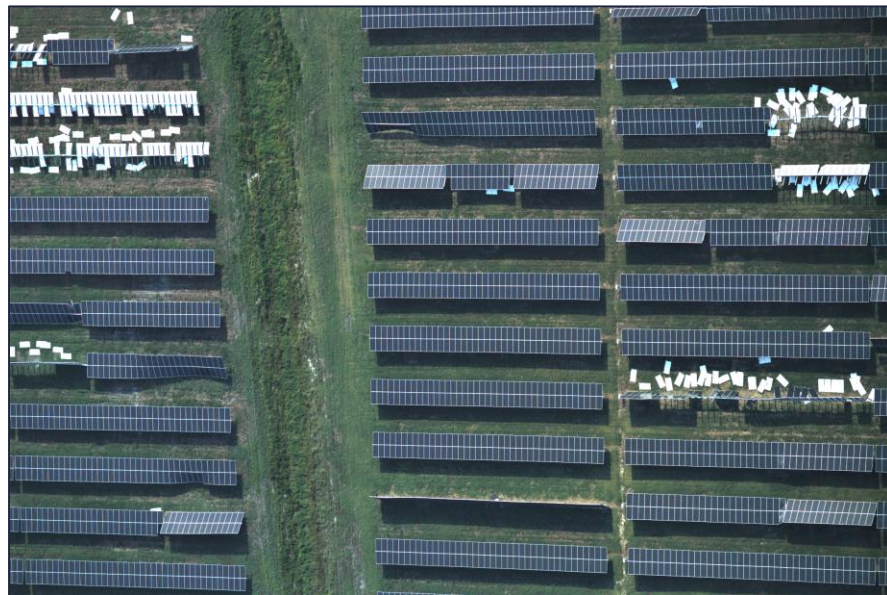
Hypothetical: A 100 MW site is hit by major wind and hail storm

- › 270,000 370W modules on site are visually inspected
- › 5% show visible damage and must be replaced – 13,500 modules
- › Assumptions:
 - \$0.35 USD/watt for PV modules
 - \$50/module for labor

*100 MW site damaged by
major wind and hail storm*
