Quantify the impacts of cell cracking in the field

HOW PVEL IS ADDRESSING CELL CRACKING: IN THE LAB AND IN THE FIELD

Understanding cell cracking in PV modules

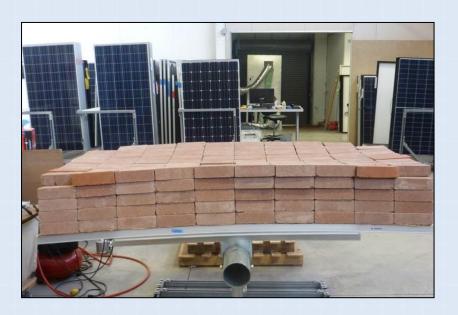
Certification testing for cell cracks

> IEC 61215

- Static mechanical load testing at 2400
 Pa with options for up to 5400 Pa
- Includes minimum hail testing: 1" hail balls at 50 mph

> Challenges

- No thermal cycling after stress
- No dynamic mechanical loading
- A pass means:
 - <5% power loss</p>
 - No physical damage
 - EL imaging not required

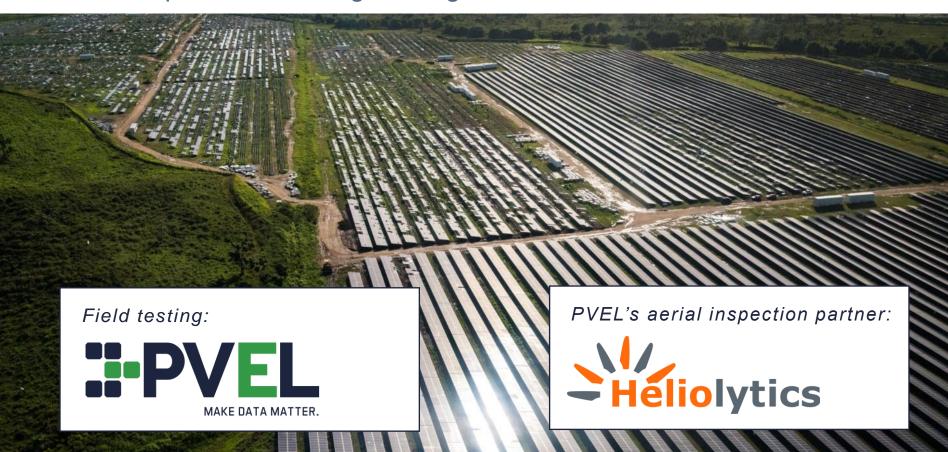
New Incident Response testing combines advanced field and aerial inspection to safeguard against financial losses

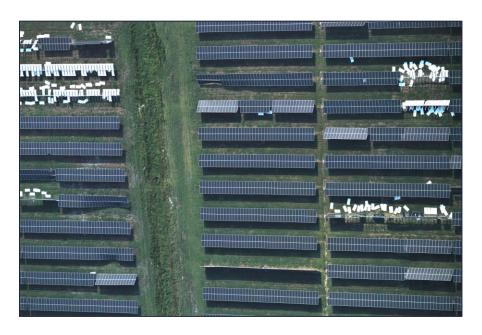
Hypothetical: A 100 MW site is hit by major wind and hail storm

- > 270,000 370W modules on site are visually inspected
- 5% show visible damage and must
 be replaced 13,500 modules
- Assumptions:
 - \$0.25 USD/watt for PV modules
 - \$50/module for labor

Value of insurance claim for visually inspected PV modules: \$1.92M

100 MW site damaged by major wind and hail storm
(Image Source: Heliolytics)
