# Preventing costly solar junction box failures from factory to field

# Preventing Costly Solar Junction Box Failures from Factory to the Field

**Ankil Sanghvi**, Sr. Engineering Manager  
**Mike Scott**, Sr. Manager

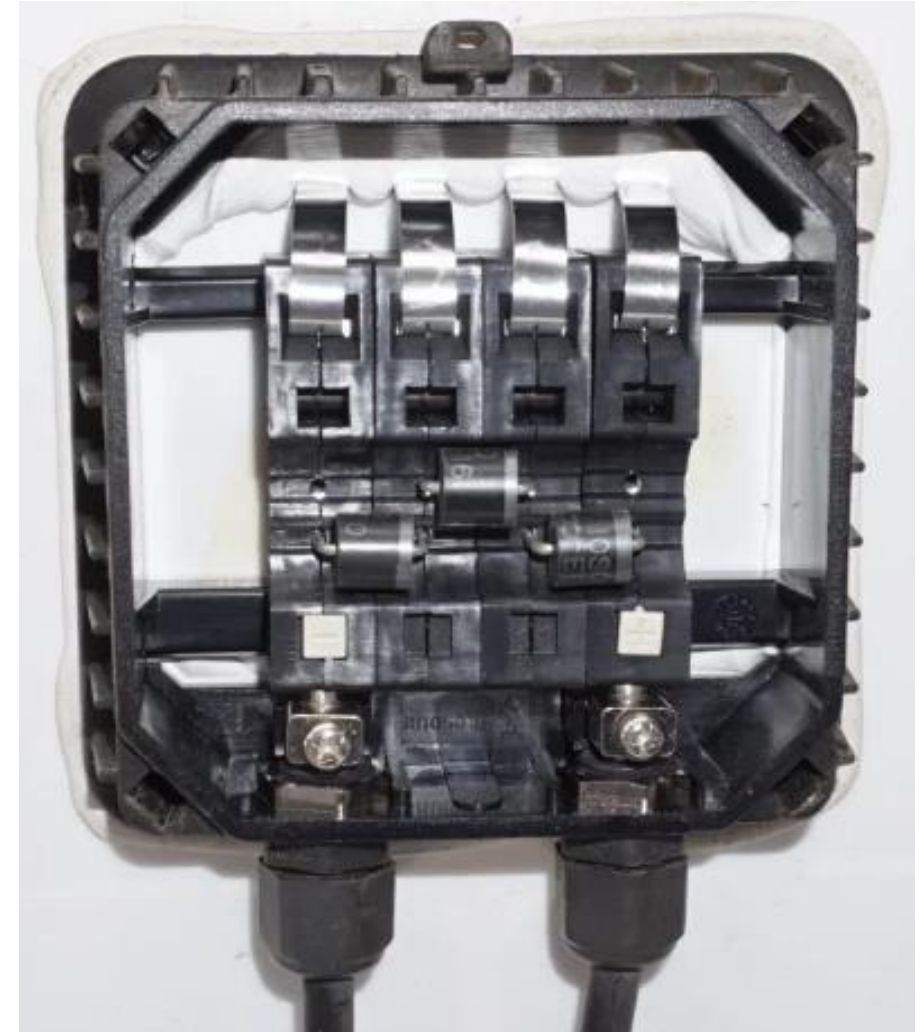
# Junction boxes have changed

**Bulky, single-piece design → Multiple pieces**

- Module power increase → larger surface, higher currents, shading protection
  - Microinverters, communications, etc

**O-ring sealed → Potted**

- Better encapsulation but poor visibility and difficult repair.

**Bifacial Modules → Minimizing area**

25+ year-old modules still operating because of  
**manufacturing quality**

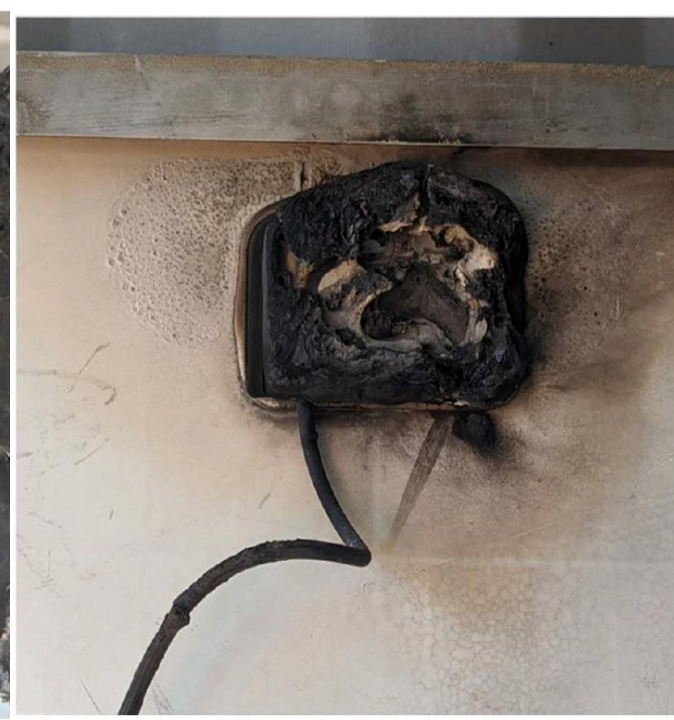
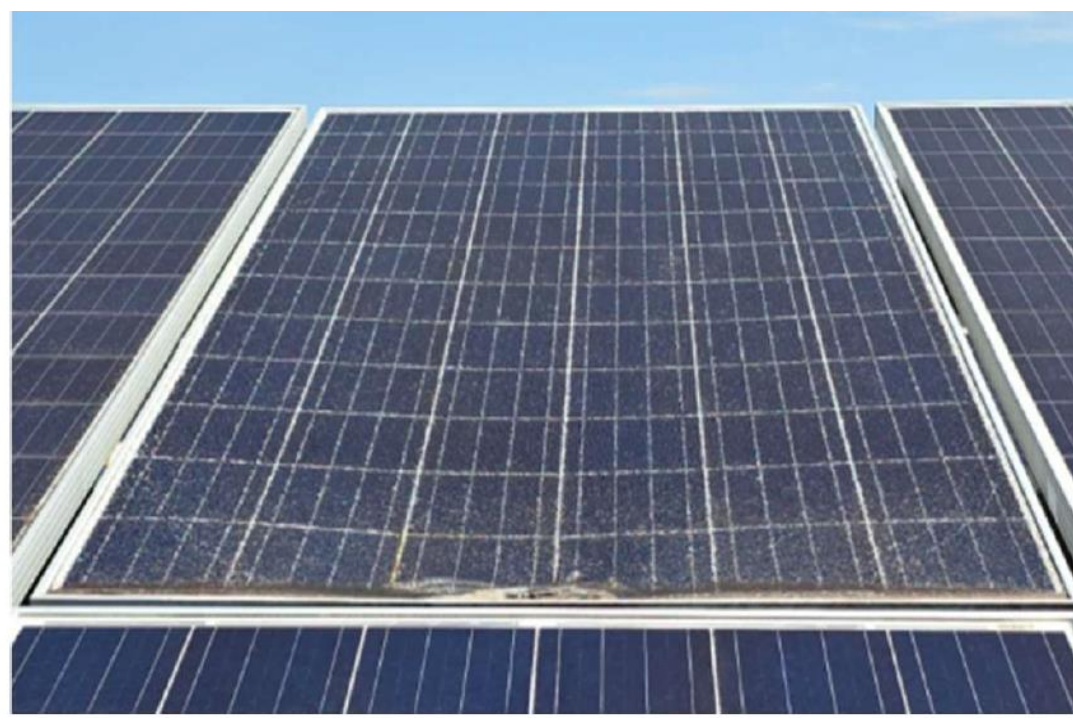
## J-Box Findings

J-Box failures have increased to 60% in 2025, up from 38% a year before

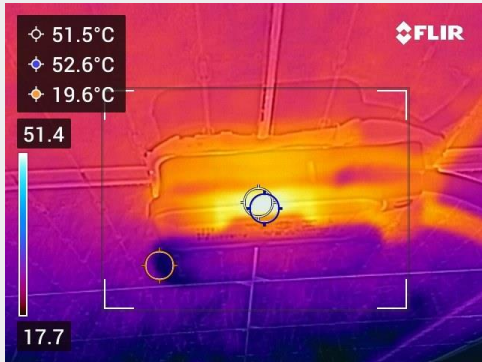
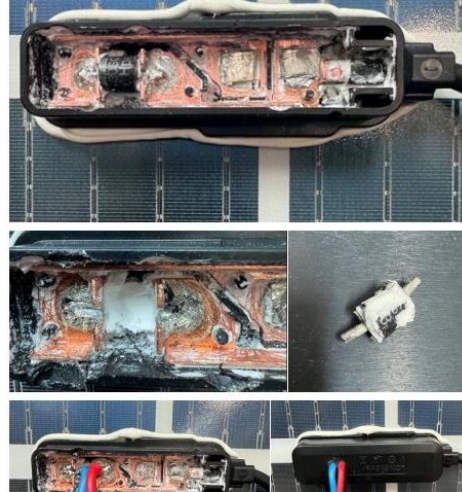
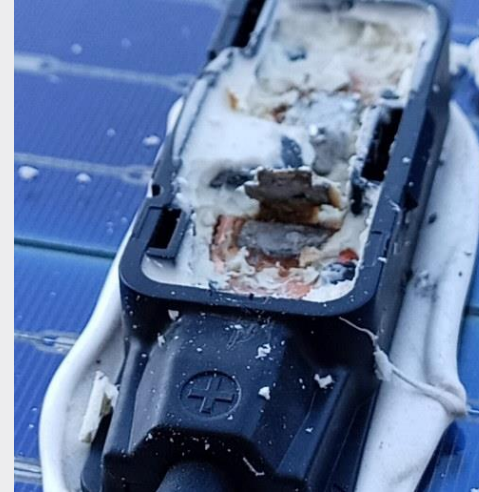
# Junction box failures: what shows up on an operating site

**113.2 °C**

peak junction box surface temperature recorded in a site thermal survey

**61 of 80**

thermal measurement points on that survey showed a heated junction box

**66.4 °C**

peak cable temperature — and 44 °C at the cell busbars, on the same survey

**The junction box is the hottest thing on the module — by a wide margin.**

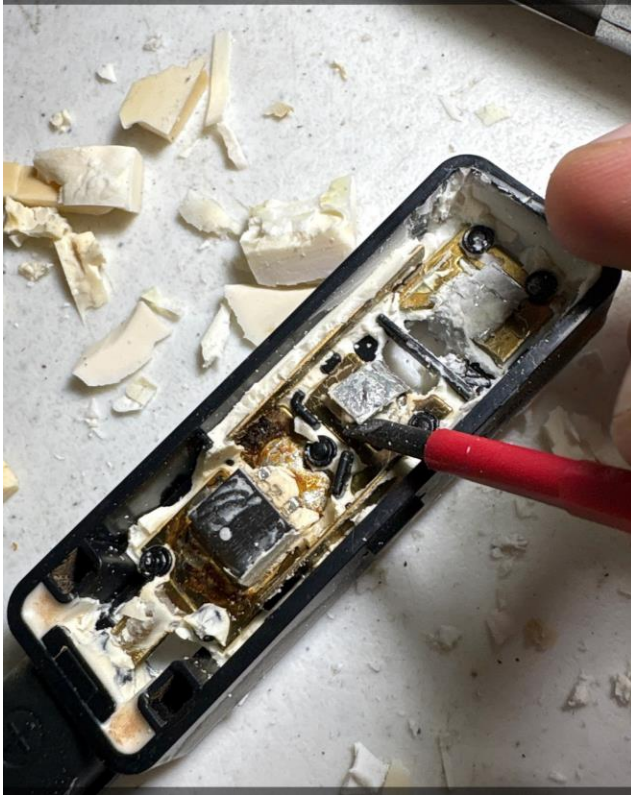
*Teardown: ribbon not bonded to the contact pad*

**100%**

of disassembled modules showing a sub-module anomaly had a ribbon that was not connected

of modules with a suspected shorted diode signature had heating at the diode and a loose diode connection

**8 of 10**

modules sent for independent lab teardown showed burn marks or discoloration near the diode, with a loose cable at the positive junction box entry

**Pottant**

found between ribbon and solder on several units — encapsulant cannot migrate into a joint that was properly soldered

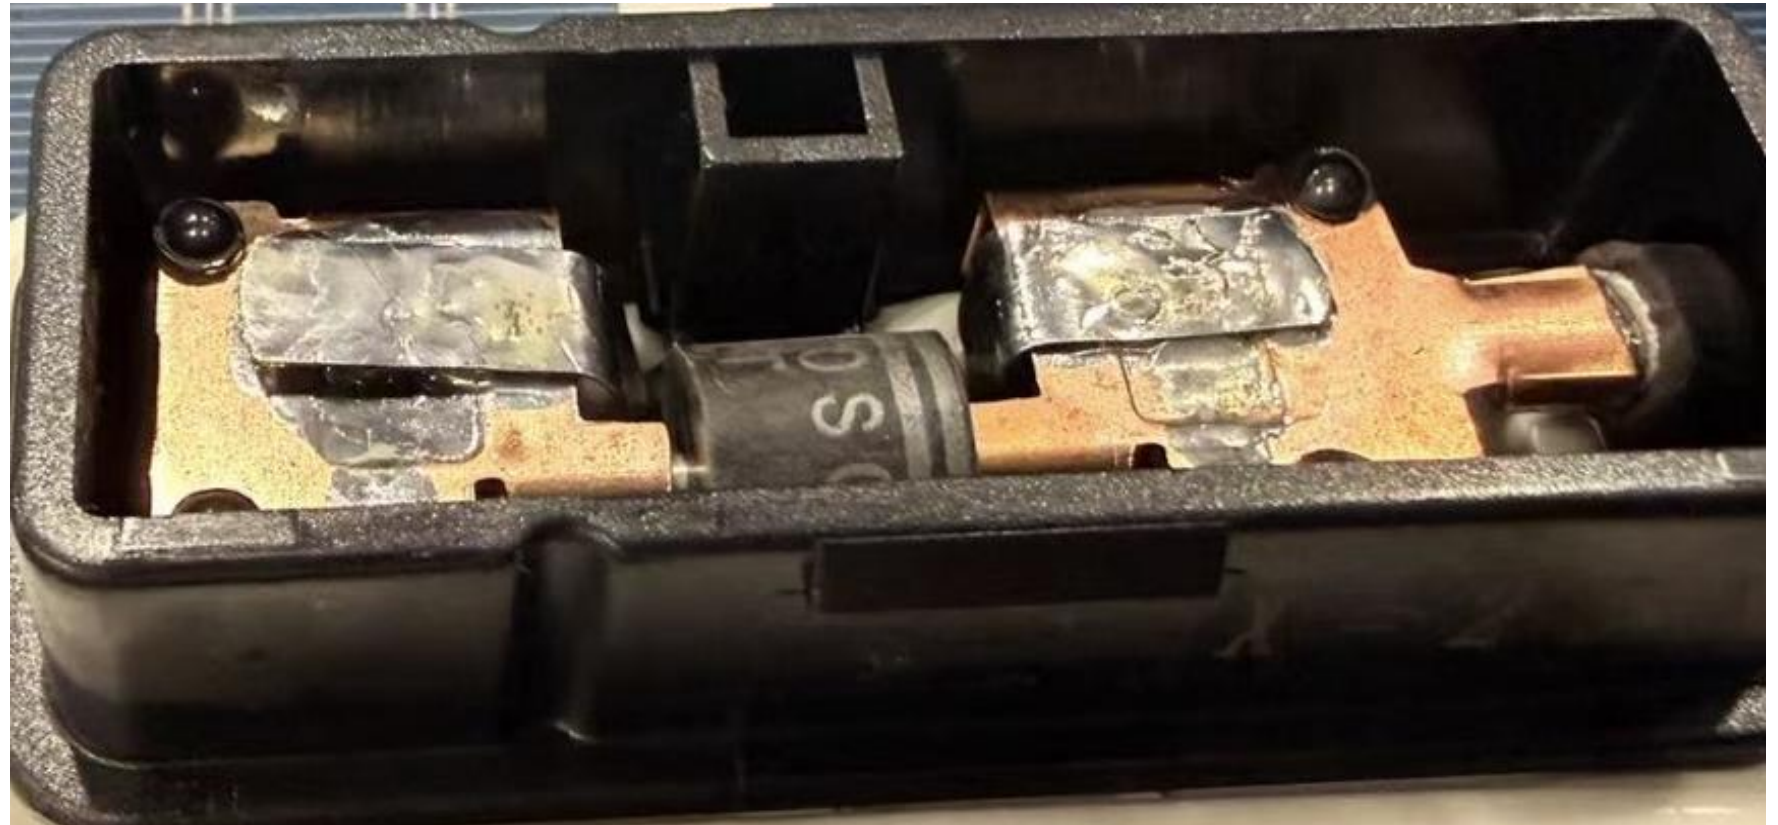
# Worst case

- Enough contact for flash test
- Becomes a heating element in the field

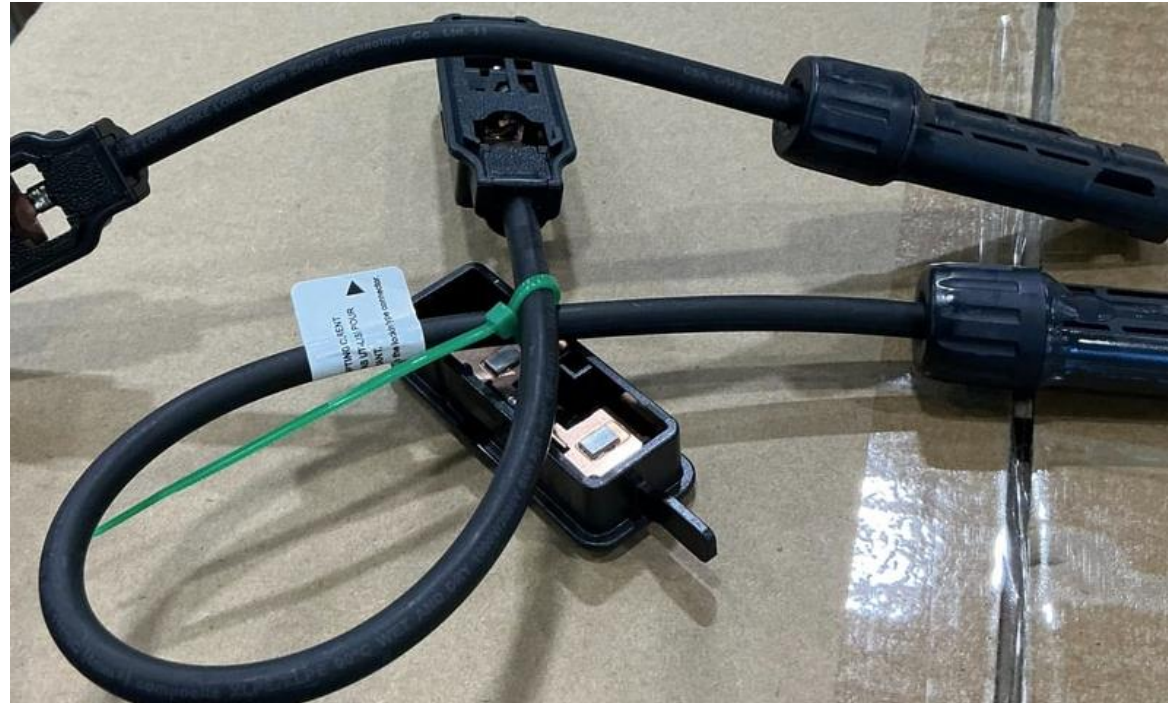
# Junction box manufacturing

- **Plastic housing**
  - ABS injection molding
- **Assembly**
  - Terminal placement
  - Diode installation
- **Connector installation**
  - Wire crimping
  - Connector attachment

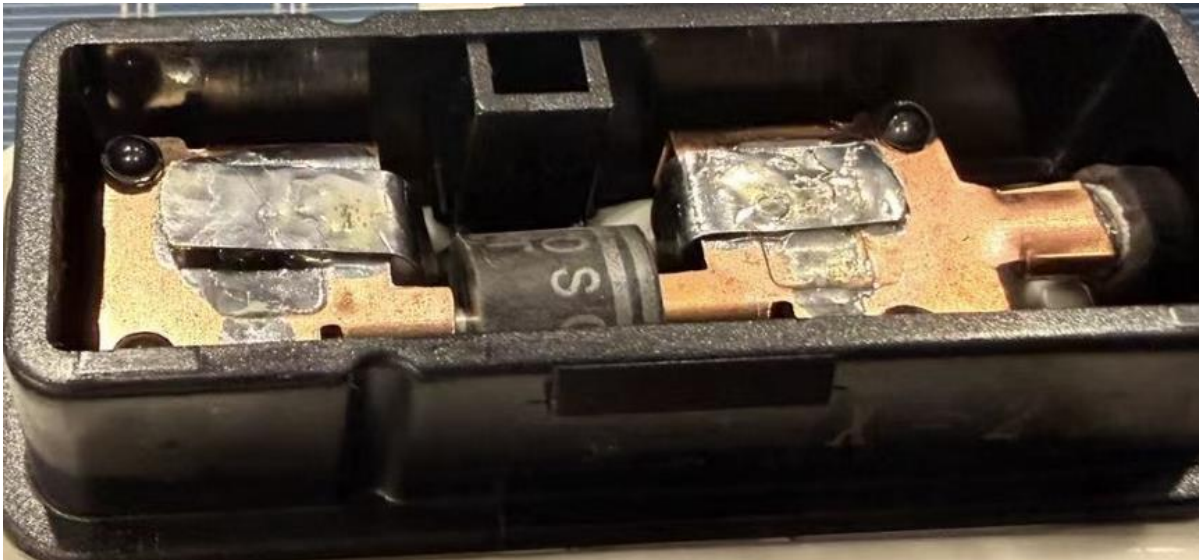
# Advanced manufacturing process – Laser welding

- Conventional process melts solder to join ribbon to J-Box terminal
  - Silver blob for AOI
- Laser Welding leaves discrete weld spots that make AOI “easier”
- Significant but worthwhile investment
