CEA | PV MAGAZINE TEST PROGRAM TEST REPORT

SUPPLIER | AIDUO

Date: 13 October 2017

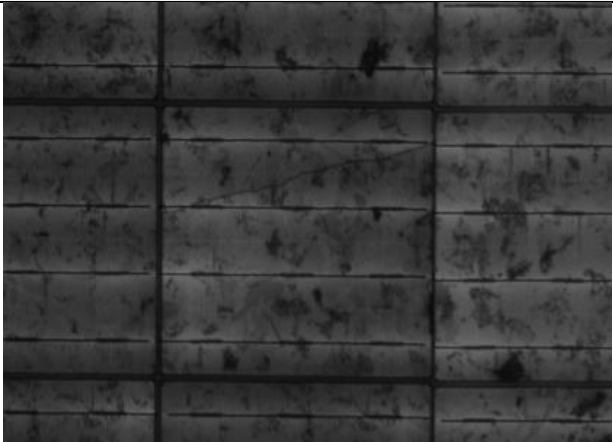
Defect type	Sample	Defect description	Image
H2/Major	Aiduo-AD265-60P Sample 2	Micro cracks

Aiduo-AD265-60P	Sample 1	Sample 2	Sample 3	Sample 4	Sample 5	Score	Grade
EL image inspection	None	H2/Ma	None	None	H2/Ma	11	61
