CEA I PV MAGAZINE PROGRAM TEST REPORT

SUPPLIER | NSP

Author: George Touloupas Date: 28 June 2018

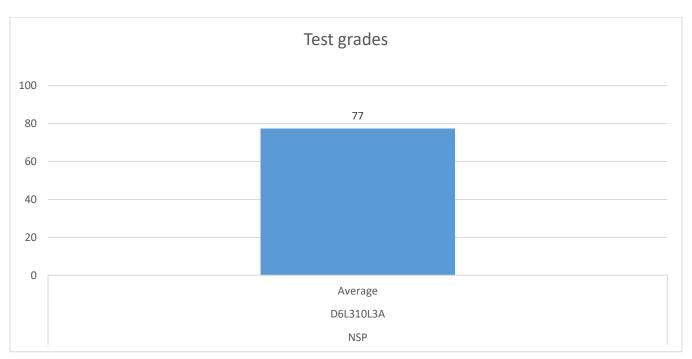
3.8. Comparison charts and average grade

NOTE: The Average grade does **NOT** include the LID test, as it is optional and not performed for all products.
