Quality Roundtable at Solar Power International 2017

Quality first: an industry-wide discussion of the path forward

Backsheet and encapsulant failure

A failure of backsheets and encapsulants at a solar project resulted in various module- and cell-level problems and power loss, leading to a dispute between the module maker and the company which procured the modules.

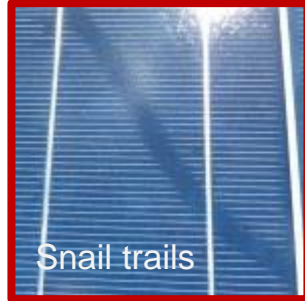
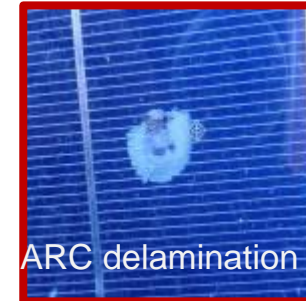
Cell defects

- Snail Trails
- Corrosion
- ARC
- Delamination

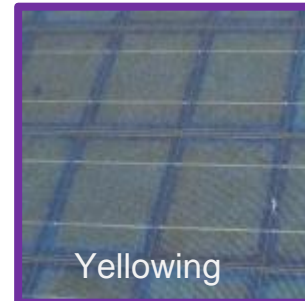
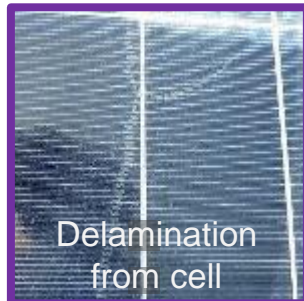
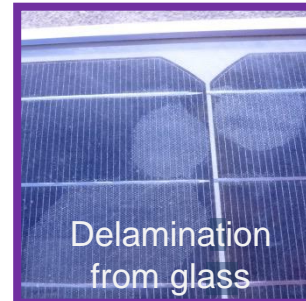
EVA defects

- Yellowing
- Delamination

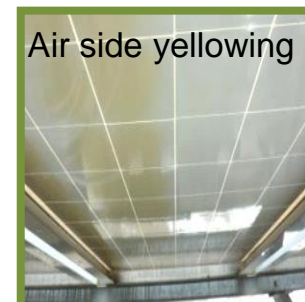
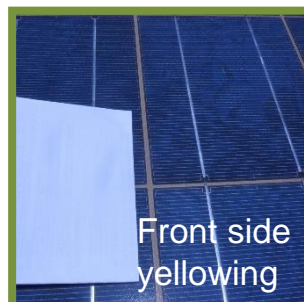
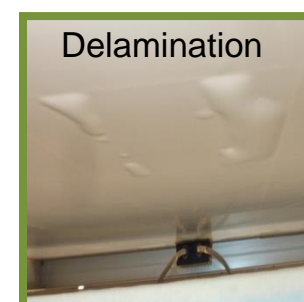
Backsheet defects

- Air Side Yellowing
- Front Side Yellowing
- Cracking
- Delamination
- Bubbling
- Other
